Task 2 Report – Close Minor Research Gaps
USE OF FIBER-REINFORCED POLYMER COMPOSITES
FOR BRIDGE REPAIRS IN MONTANA

Civil Engineering Department
College of Engineering
Montana State University – Bozeman

Prepared for the
MONTANA DEPARTMENT OF TRANSPORTATION
in cooperation with the
U.S. DEPARTMENT OF TRANSPORTATION
FEDERAL HIGHWAY ADMINISTRATION

August, 2025

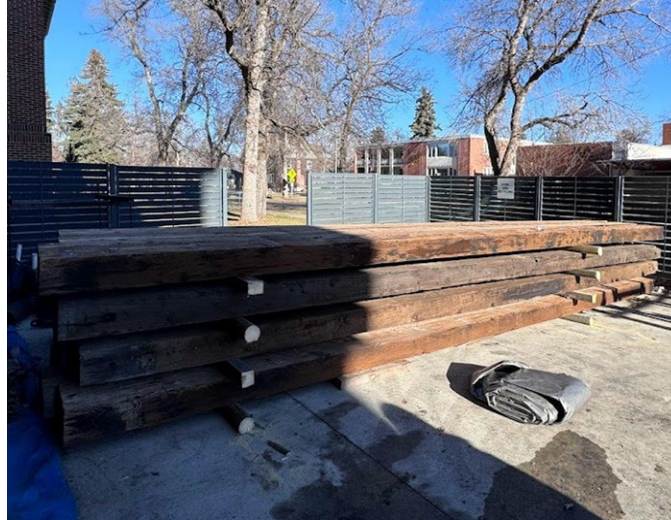
Figure 1: Example Timber Beams

The timber beams for this investigation were originally salvaged from bridges across the state and were collected from the MDT storage yard in Lewistown, MT. The beams include two common sizes historically used in Montana bridges, 6"x18"x20' and 8"x18"x26'. The beams (examples shown in Figure 1) are Douglas-fir/Larch (dense No. 1) with allowable bending and shear stresses of 1.55 ksi and 0.085 ksi, from Table 13.5.1A, AASHTO [6], respectively, though some of the beams have lower values because of existing defects. The actual dimensions of the beams and pre-existing (before testing) cracks or splits are documented in Appendix B.

(a) Beam stack prior to testing

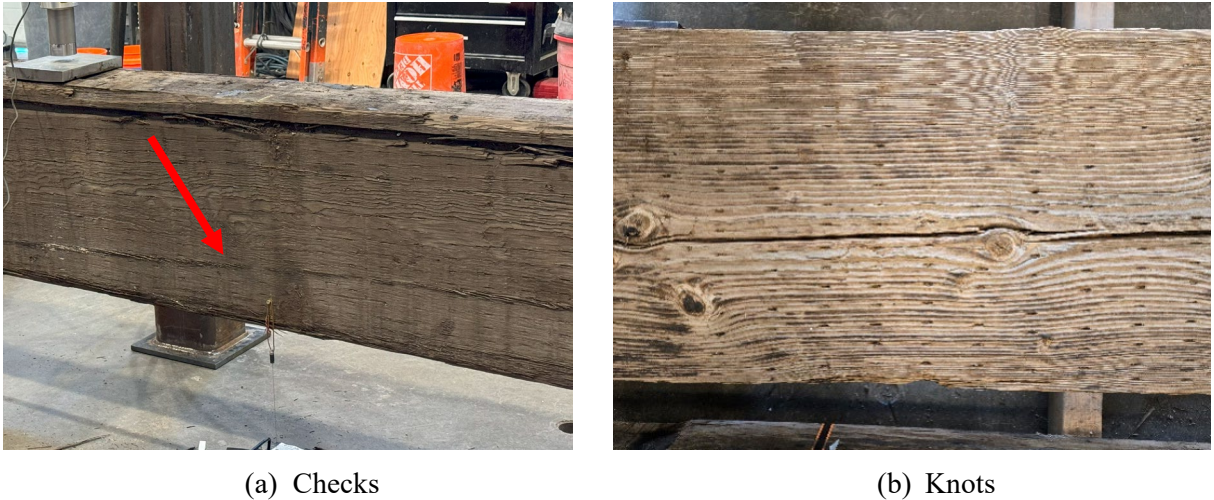
Figure 2: Examples of checks and knots

Timber beams often have natural imperfections that can impact their performance. These imperfections, such as knots, checks, waning, and grain deviations, are not classified as damage. However, if they are significant enough, they can contribute to premature failure. Figure 2 shows a couple of examples of natural imperfections.

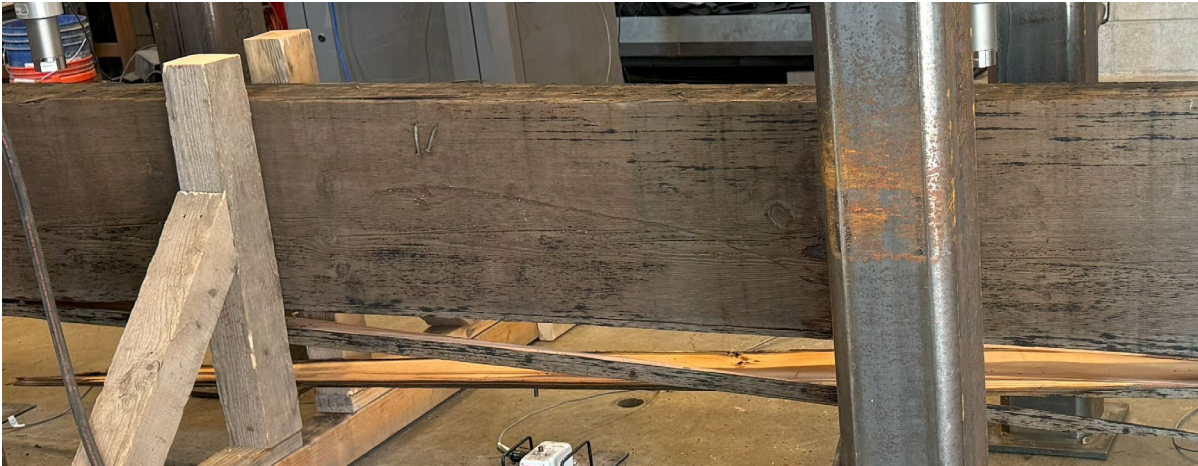
Figure 3: Example of a tension crack failure

Tension cracks are commonly formed due to flexure-induced stresses on the tension face of the beam, and extend at an angle through the member, generally along the grain of the wood (as shown in Figure 3). They often begin near mid-span (where tension stresses are greatest) and initiate at imperfections such as knots or checks, or at the site of impact or handling damage.

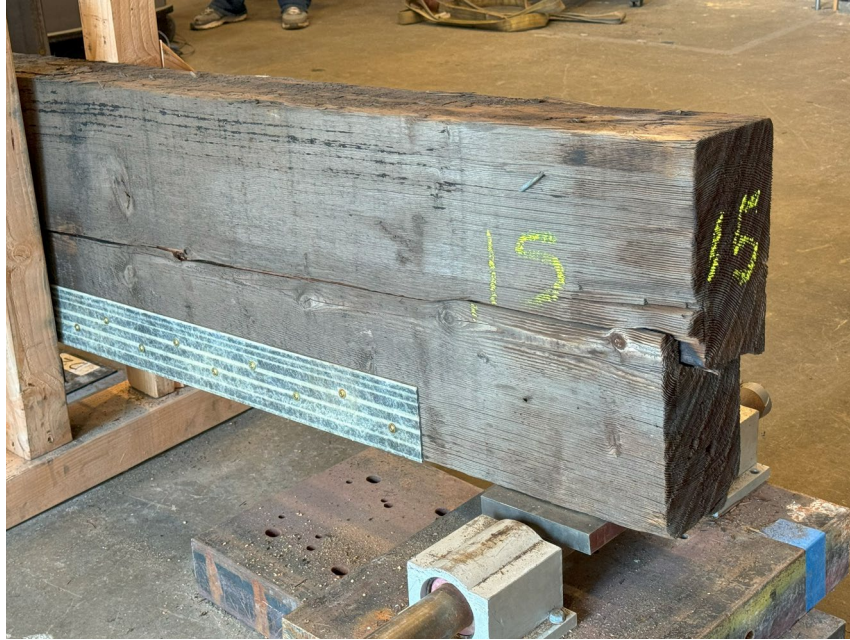
Figure 4: Example of a shear split failure

Shear splitting (as observed in Figure 4), result from horizontal shear stresses induced from loading. They run parallel to the top and bottom faces and initiate near the ends of the beam where the shear forces are the greatest. Like in tension failures, these failures often initiate at imperfections in the beam.

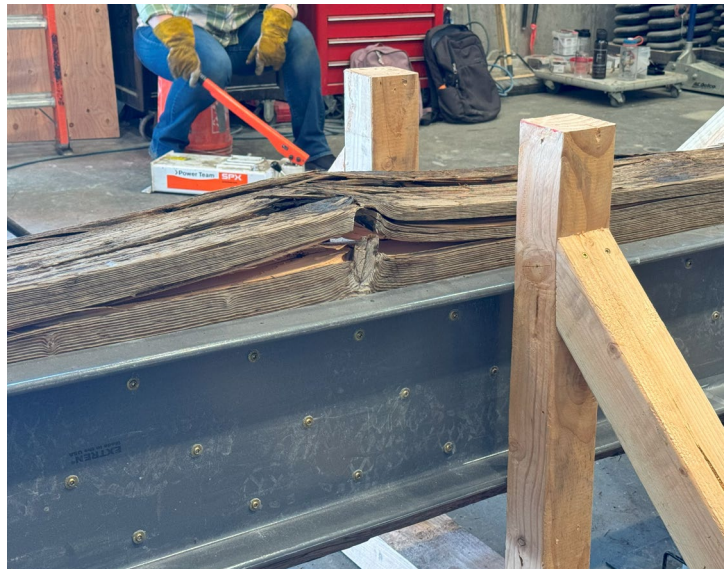
Figure 5: Example of a compression crushing/cracking failure

Another failure mechanism of timber beams is longitudinal (parallel to the grain) crushing of the wood in compression zones (as observed in Figure 5). In the beams in this research this occurred at the top mid-span of the beam where the positive moments were the highest.

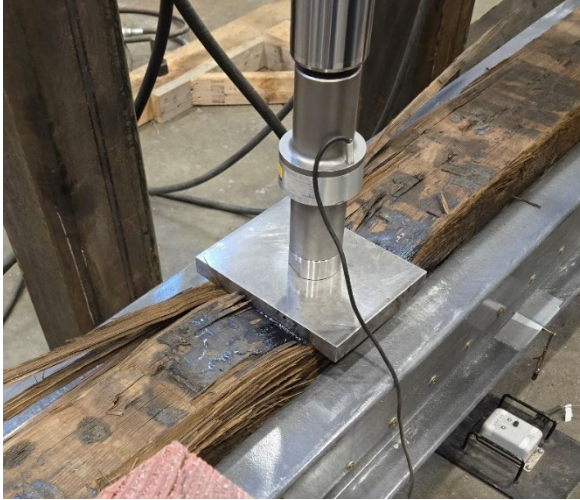
Figure 6: Examples of bearing failure.

Bearing failure (crushing of the wood perpendicular to the grain) is another form of damage that can occur in timber beams. In the beams tested in this research this failure mechanism was observed under the applied loads (Figure 6-a) and at the supports (Figure 6-b).

(a) At load-bearing block

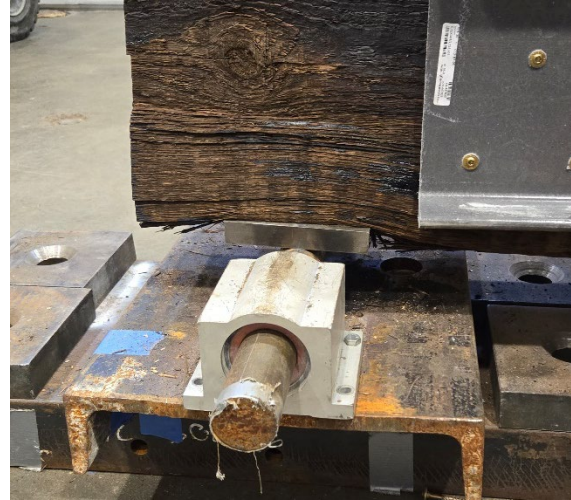
(b) At the reaction-bearing plate

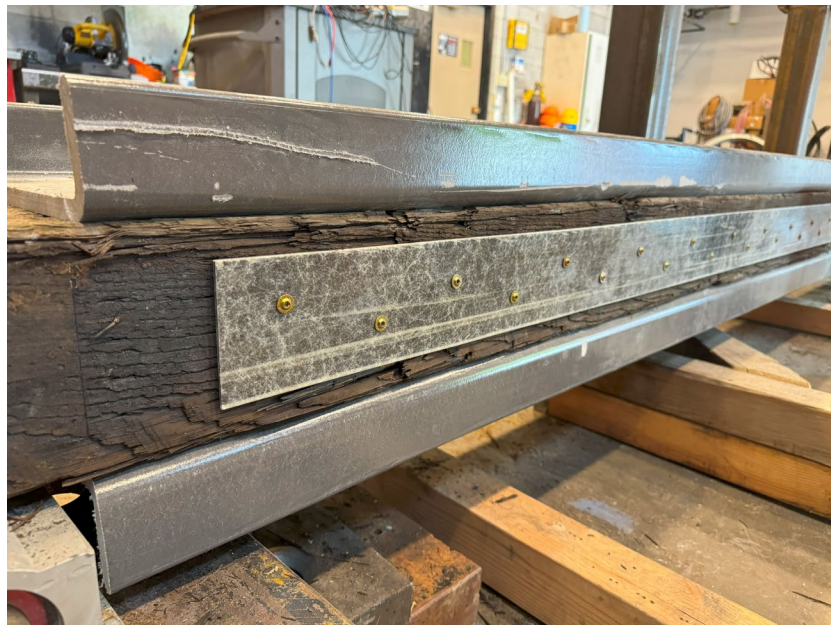
Figure 7: Example timber beam with FRP materials attached

Multiple FRP materials were selected to repair/strengthen the timber beams. This section discusses the FRP materials used in this research, including the Glass FRP channels, the Carbon/Glass hybrid FRP strengthening strips, and the fasteners. An example of the FRP materials attached to a timber beam are shown in Figure 7 and the following subsections discuss each composite in detail.

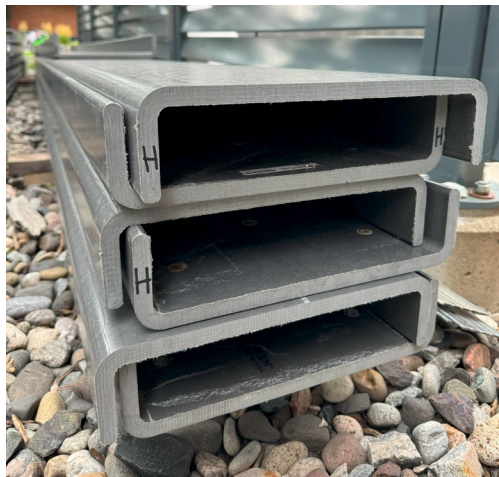
Figure 8: Example FRP Channels

The glass FRP channels (Figure 8) used in this study are the EXTREN Series 525, manufactured by Strongwell [7]. This series offers a combination of high strength, durability, and enhanced fire resistance. The channels are made with a general-purpose polyester resin that provides excellent corrosion resistance, making them suitable for various structural applications, especially in harsh environmental conditions. The resin is formulated with UV inhibitors and flame-retardant additives to enhance performance. The EXTREN Series 525 channels have a standard slate gray color.

The manufacturer-specified longitudinal tensile strength and elastic modulus of the FRP channels are 30 ksi and 2500 ksi, respectively. However, coupon testing conducted as part of this study revealed higher values. The control channel coupon exhibited a tensile strength of 53.2 ksi and an elastic modulus of 4090 ksi, representing 177% and 164% of the tabulated values, respectively. Moreover, the channel coupons extracted from full-scale tested beams (mid-span and end-region) retained high mechanical performance, with tensile strengths exceeding 150% of the tabulated values and elastic modulus values remaining above 120%. These results indicate strong durability and performance retention of the GFRP channels after beam application. Detailed procedures and results of the coupon testing are provided in Appendix E .

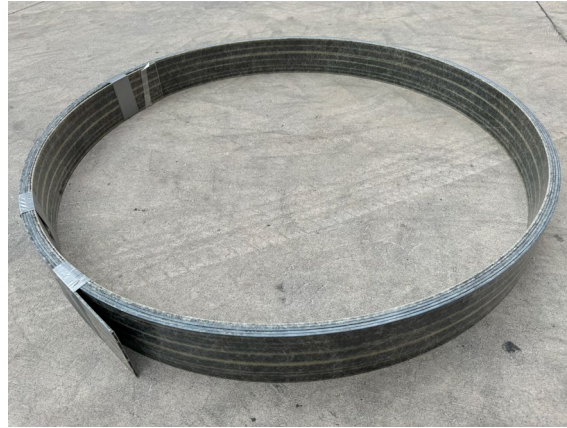
Figure 9: Safstrip sample in rolled/shipped condition

The FRP strengthening strip (SAFSTRIP®, see Appendix D for material properties and manufacturer information), manufactured by Strongwell [7], is a pultruded composite strip designed to enhance the strength of an existing structural member when mechanically fastened to the structure. This strip is 4" wide and 1/8" thick and is typically shipped in rolls up to 100' long (Figure 9). The FRP strip is a carbon/glass hybrid and is comprised of carbon tows sandwiched between layers of fiberglass mats and rovings, bonded together by a highly corrosion-resistant vinyl ester resin. The inclusion of carbon fibers increases the stiffness of the strip, while the glass mat provides the necessary bearing strength.

The manufacturer-specified tensile strength and longitudinal elastic modulus of the strip are 92.90 ksi and 9020 ksi, respectively. Coupon testing showed that the control strip specimens had higher measured properties, with tensile strengths of up to 133.7 ksi (107–109% of the tabulated value) and elastic moduli up to 9822 ksi (109%). The tested coupons removed from full-scale beams also performed well, maintaining

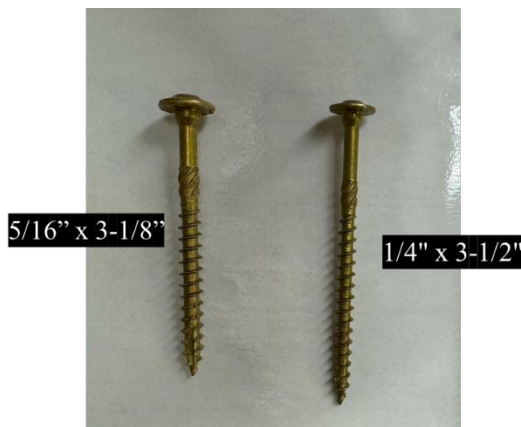
Figure 10: Fasteners used in repair/strengthening

RSS-GRK screws (Figure 10-a) were used as the fasteners in this study to attach the channels and strips to the timber beams. These screws feature a washer head design that effectively addresses potential bearing issues. For the channels, $5/16'' \times 3-1/8''$ screws were used, while $1/4'' \times 3-1/2''$ screws were selected for the strips. These fasteners were chosen for their specified high shear capacities of 982 lb and 754 lb, respectively. In addition, #12x6-3/8" R4-GRK screws (Figure 10-b) were used to close the cracks before attaching the channels and strips to the repaired beams.

(a) RSS-GRK screws for attaching FRP to timber beams

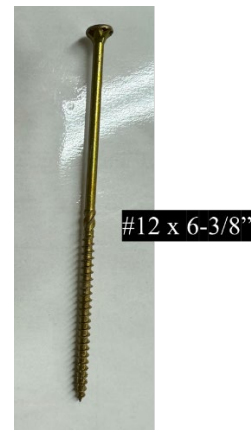
(b) R4-GRK screws for repairing crack beams prior to FRP installation

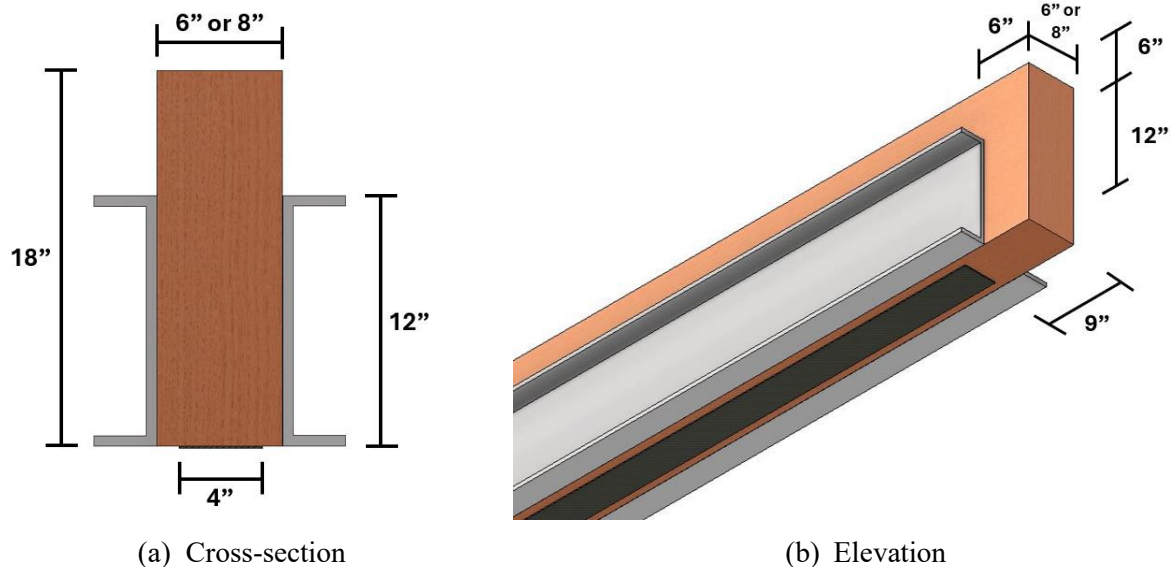
Figure 11: Schematic of FRP channels and strip repair technique (bottom channel)

This technique was used to strengthen undamaged beams and repair beams with tension cracks and shear splits, to be tested in a flexure-controlled manner. This technique was used for both beam sizes used in this study, and consisted of two GFRP channels screwed to the faces of the beam (either at the bottom or top) and a GFRP/CFRP strip screwed to the tension face (bottom) of the beam. Note that the location of the channels was at times dependent on existing damage within the beam. That is, the channels were installed on the bottom of the beam to repair tension cracks, while they were installed in the middle to repair shear splits. Schematics of this repair/strengthening technique are shown in Figure 11 and Figure 12, while actual beams with this technique employed are shown in Figure 13.

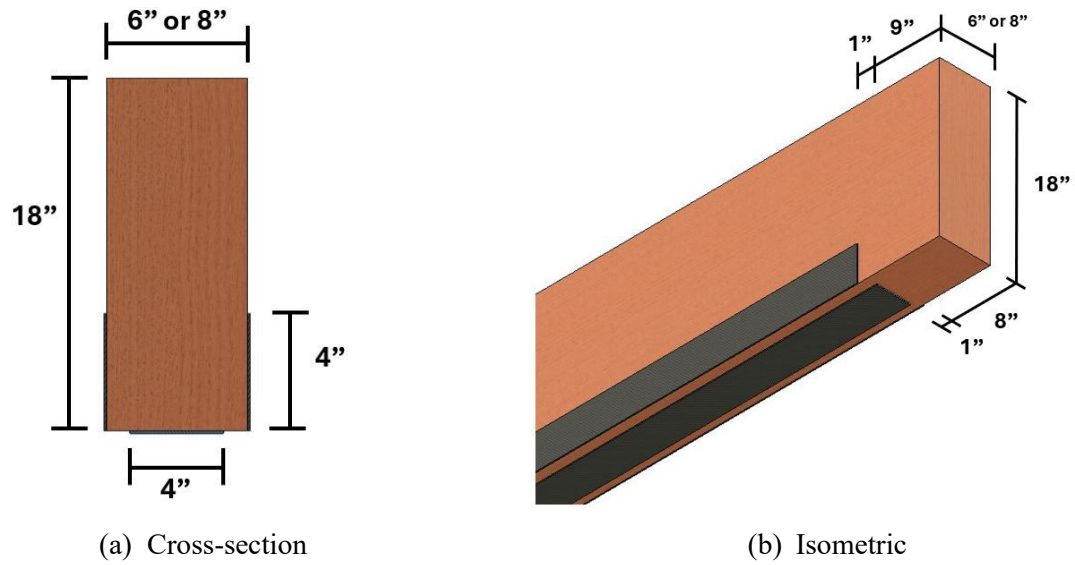
Figure 14: Schematic of FRP strips for flexure-controlled beams – one strip per side

With this technique, on beams to be tested in flexure, FRP strips were used without channels to strengthen undamaged beams and repair beams with tension cracks. Strips were screwed to the sides and bottoms of the beams, as shown in Figure 14-Figure 16. On each side, either one or two strips were included depending on the severity and location of tension cracks.

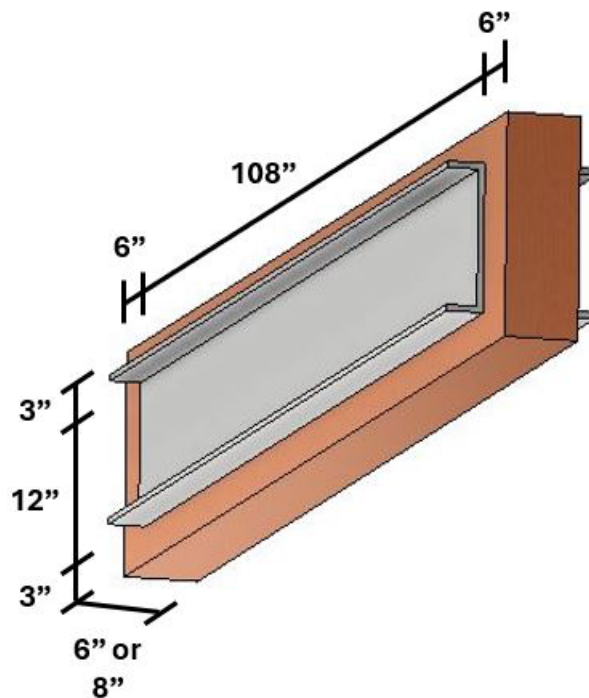
Figure 17: Schematic of FRP channels for shear-controlled beams

This technique was used to strengthen undamaged beams and repair shear-split beams to be tested in shear. This technique consisted of GFRP channels screwed to the sides of the beams (in the middle), as shown in Figure 17 and Figure 18.

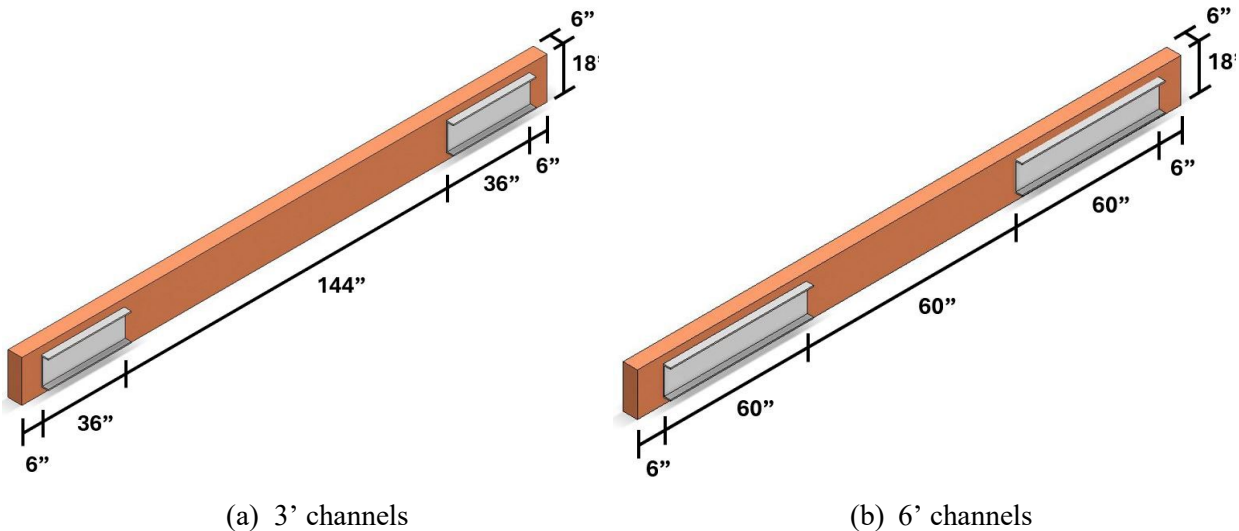
Figure 19: Schematics of localized split repairs with channels

In some cases, the test beams had localized shear-splits near their ends, and FRP channels were used at these specific locations to repair this damage. After repair, these specimens were tested in flexure. This technique consisted of either 3' or 6' channels attached to the sides of the beams (in the middle), as shown in Figure 19 and Figure 20. Two different lengths were used to evaluate the effect that this parameter has on the performance.

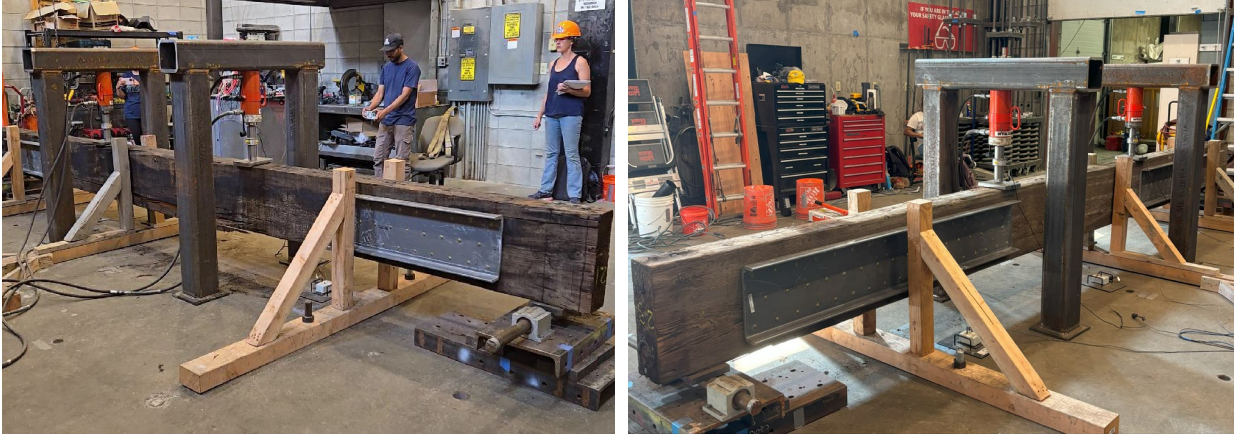
Figure 20: Localized split repair technique applied to test beams

(a) 3' channels

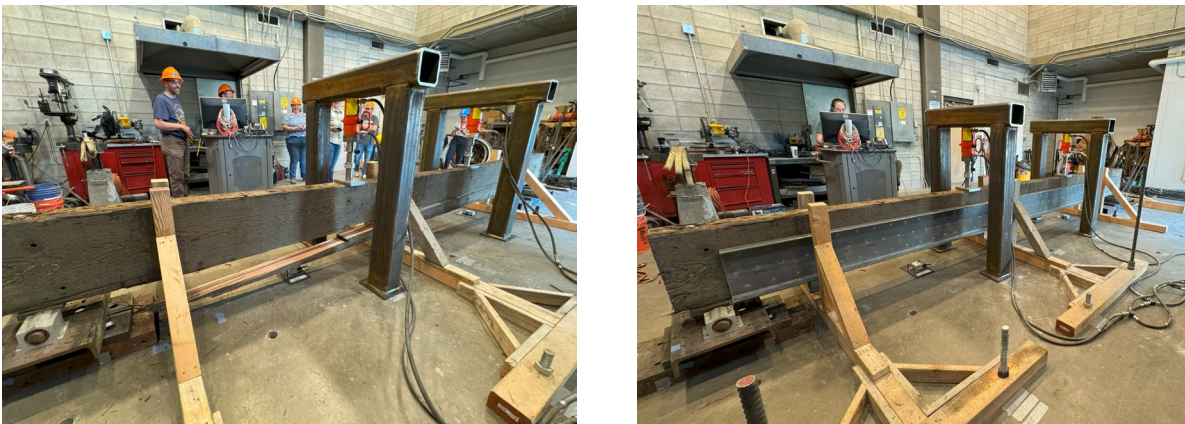
Figure 21 shows a flexure-controlled beam that failed due to a large tension crack that was repaired with the FRP channel and strip method discussed above. Figure 22 shows another beam that failed due to a tension crack that was repaired with FRP strips alone. Figure 23 shows a shear-controlled beam that failed due to a shear split and repaired with FRP channels. Finally, Figure 24 shows a beam that had an existing shear split, that was repaired with FRP channels and a strip.

(a) After initial failure, before repair

(b) After repair, before re-testing

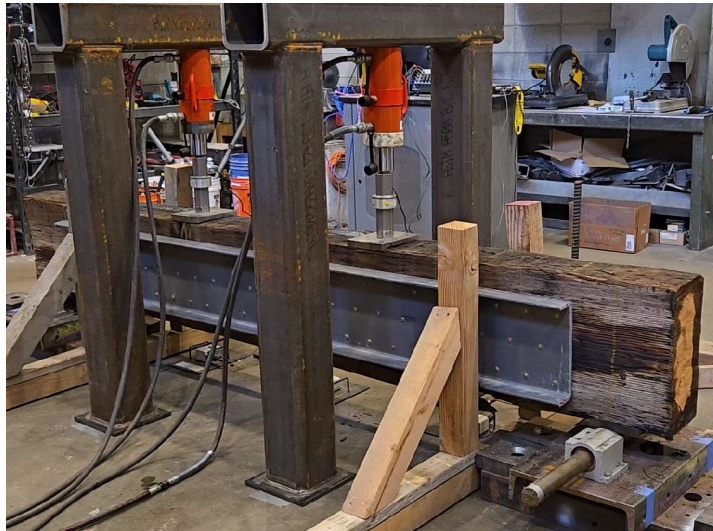
Figure 23: An example of the shear-split repair with FRP channels

(b) After repair, before re-testing

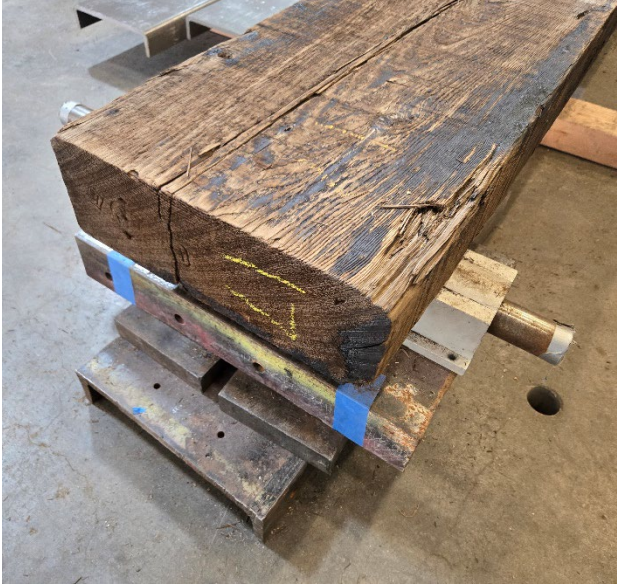
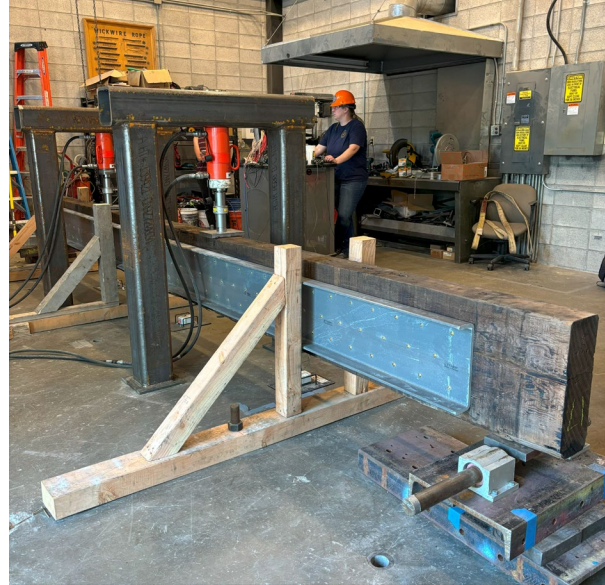
(a) Existing split, before repair

(b) After repair, before testing

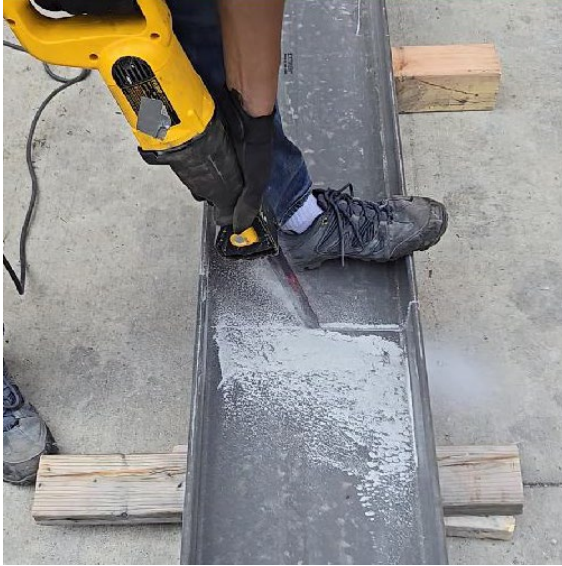
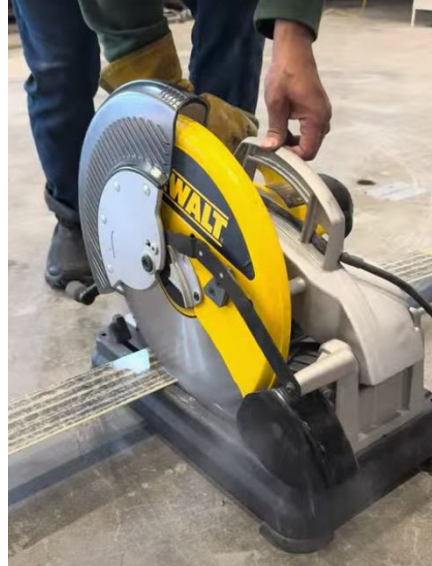
Figure 25: Cutting the FRP material

The FRP strips were supplied from the manufacturer in 100' rolls, while the FRP channels were shipped in 24' lengths. The channels were cut to length using a reciprocating saw with a metal cutting blade (Figure 25-a). The strips were cut with a standard miter saw with a metal blade (Figure 25-b).

(a) Channel

(b) Strip

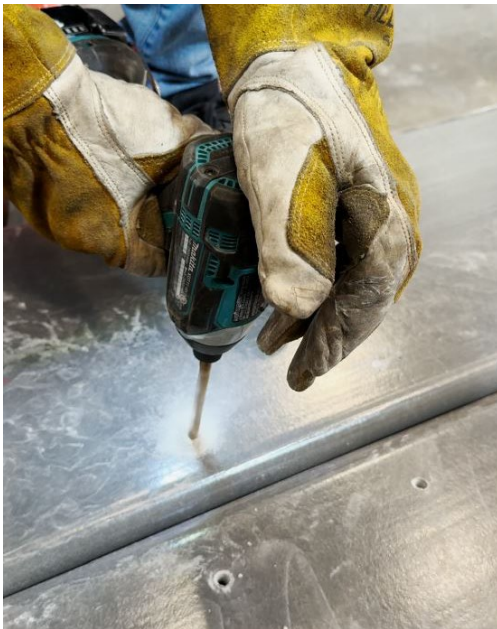
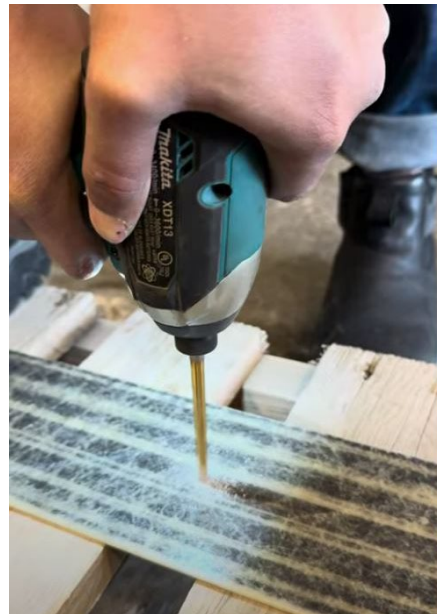
Figure 26: Pre-drilling the FRP

Strongwell recommends predrilling sections thicker than $5/16''$, and therefore the channels and strips in this research were predrilled prior to installation. Details on the screw count calculations and screw pattern schematics are provided in Appendix C (C.2). The channels and strips were drilled (Figure 26) with a standard impact drill with $5/16''$ and $1/4''$ Milwaukee titanium twist metal drill bits, respectively.

(a) Channel

(b) Strip

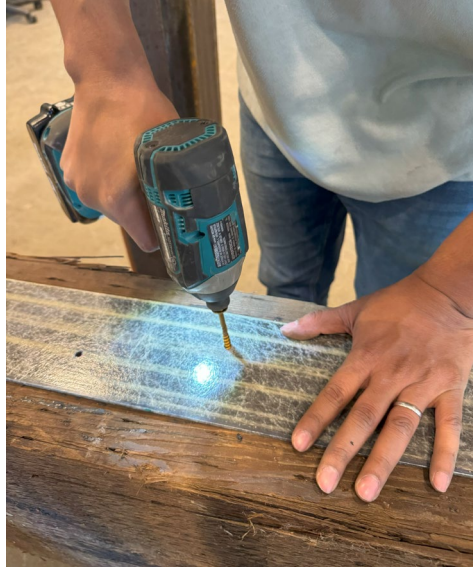
Figure 30: Attaching strip to the beam

The FRP strips were secured to the beams using 1/4"x3-1/2" RSS-GRK screws, starting in the center of the beam and working towards the ends, while ensuring the strip remained aligned with the beam and taught (Figure 30). Similarly, the channels were attached to the beams with 5/16"x3-1/8" RSS-GRK screws, Ratchet straps were occasionally used to align the channels with the beams, especially when the beams were not perfectly straight. The channel installation process involved securing one end of the channel with a few screws first, then aligning the channel with the beam (Figure 31-a), securing the opposite end, and then completing the screwing along the length (Figure 31-b). When used to repair shear splits, care was given to position the FRP to span across the splits.

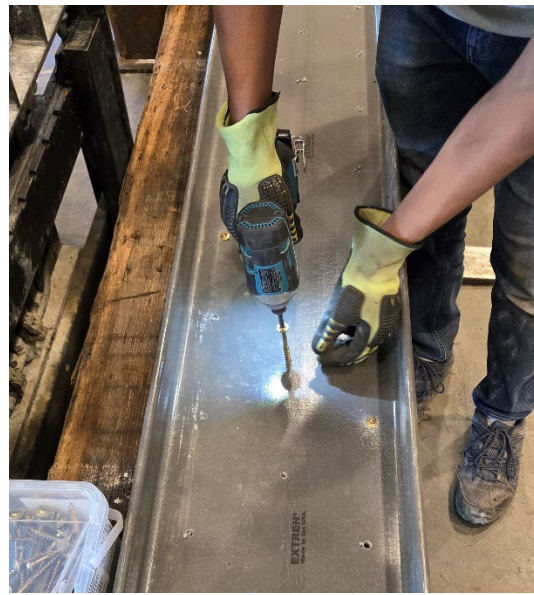
Figure 31: Attaching channel to the beam.

(b) Screwing along the length

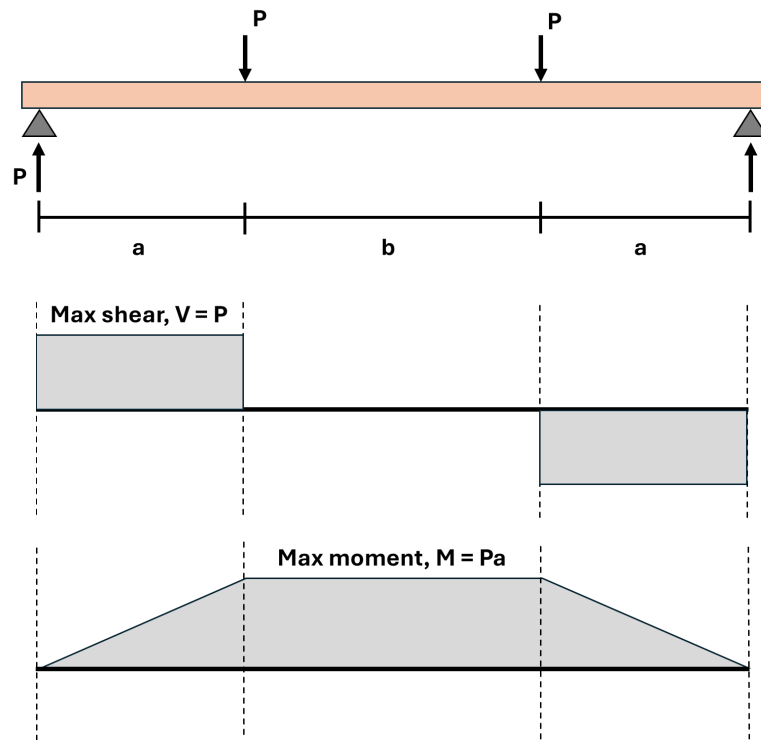
Figure 32: General 4-point bending test setup

All the beams in this investigation were tested in 4-point bending, following ASTM D198 – 22a [8], which includes both flexure and shear setups. The flexure test setup was designed to induce a flexural (bending) failure at mid-span (high moment region), whereas the shear test setup was intended to cause a shear failure at the beam ends (high shear region). Figure 32 illustrates the load configuration diagrams (free-body, shear, and moment) for the four-point bending tests.

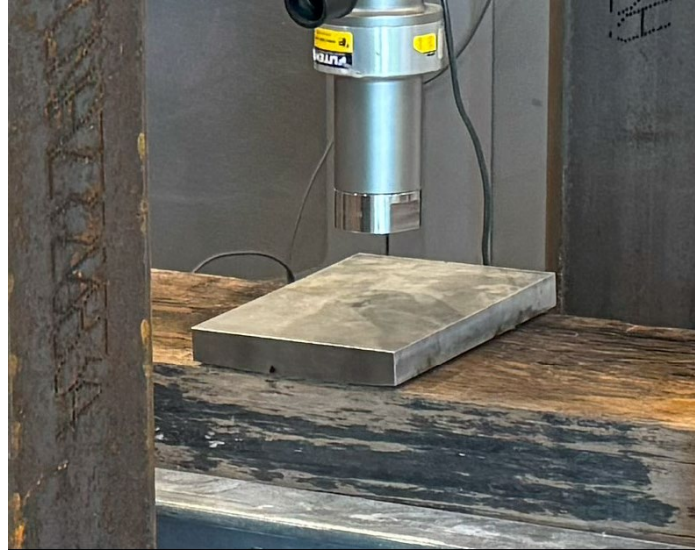
Figure 35: Bearing plate with curvature

In the setups, the loads were applied with two power-team 110 kip hydraulic actuators on the same hydraulic line, which resulted in equal loads on each actuator. Steel bearing plates (6''x8''x1'') were included between the supports and the beams. Similarly, steel bearing plates were also included (6''x8''x1'') between the actuators and the tops of the beam specimens. It should be noted that in accordance with the ASTM specifications, the plates between the actuators and the top of the beam had a radius of curvature of 4' on the loading surface of the block (Figure 35). Lateral bracings were provided at intermediate locations along the beam length to address any out-of-plane lateral instability and to prevent lateral torsional buckling.

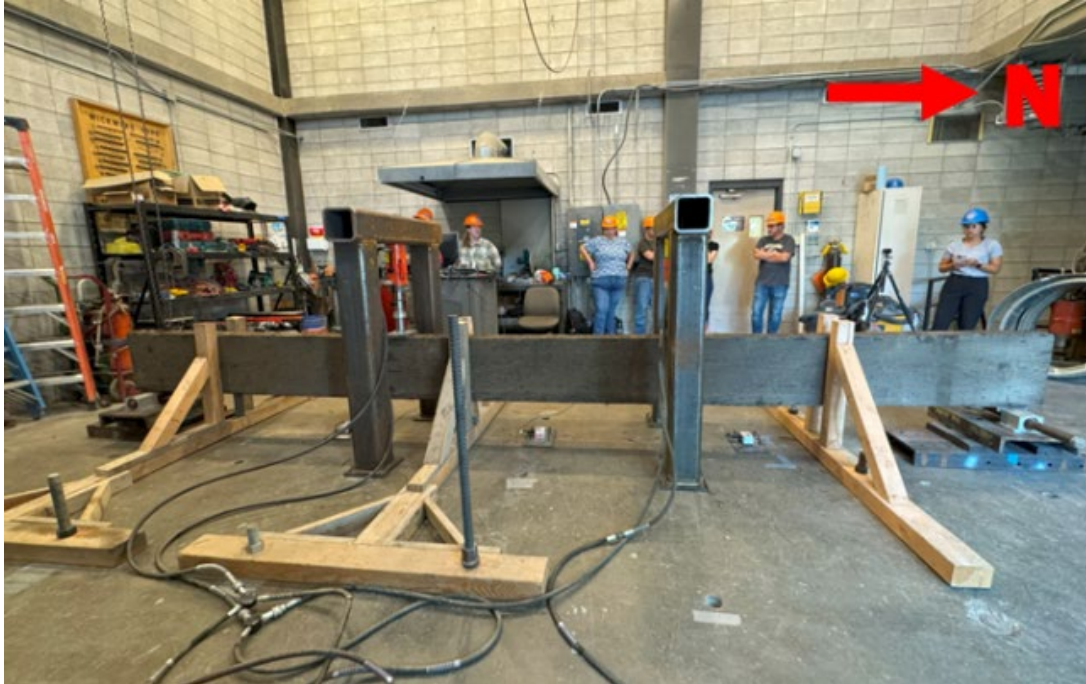
Figure 36: Flexure test setup for 19' span beam

The specimens were tested until failure while recording the applied load and resultant deflections. The load was recorded with load cells attached to the ends of the actuators, and string potentiometers were used to record deflections at three points (midspan and quarter spans). Additionally, photographs were taken throughout testing and two GoPros were used to record videos of each test. Actual beam configurations in the lab are shown in Figure 36 - Figure 38.

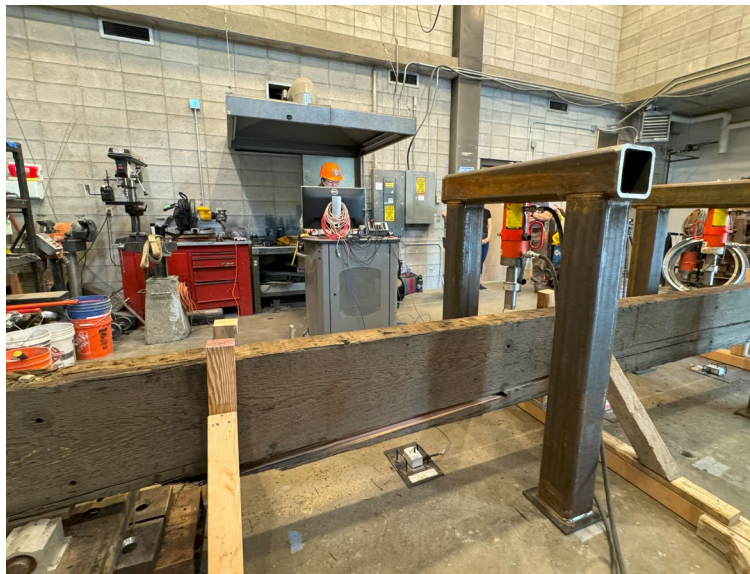
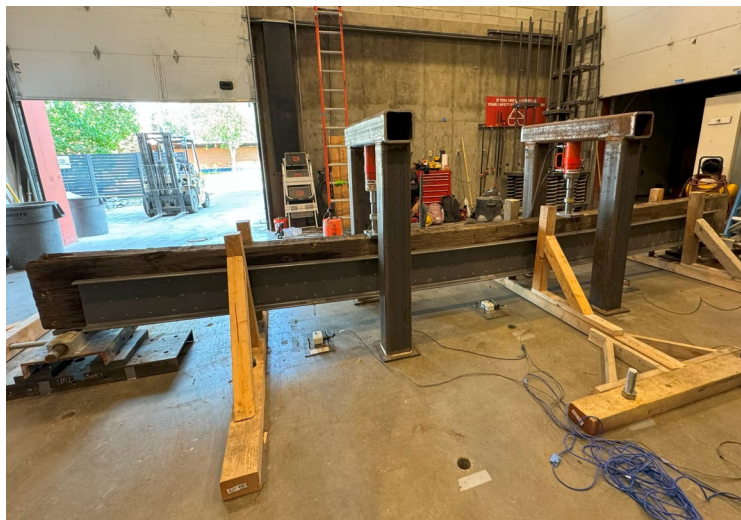
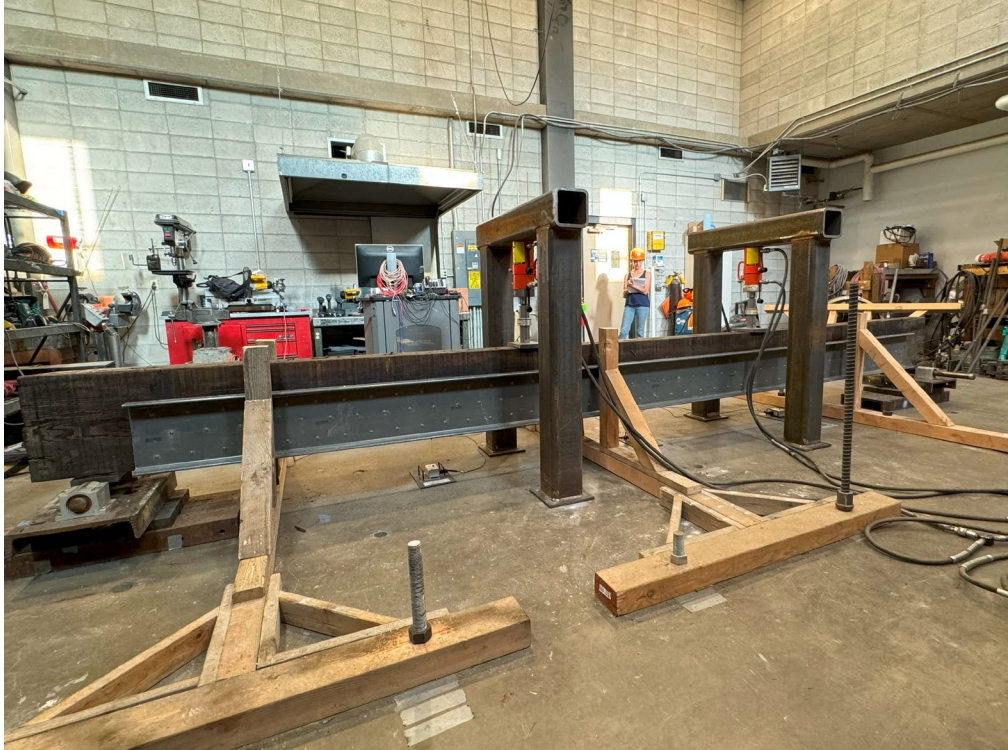
Figure 39: Control, crack-repair and strengthened 6"x18" beams with C-S combination

Figure 39 and Figure 40 show the three tested configurations of 6"x18" and 8"x18" timber beams, respectively: control, crack repair with C-S, and strengthened with C-S. The control beam displays the damage from testing. The repair beam is the same beam retrofitted with C-S combination, while the strengthened beam is an intact beam reinforced with C-S combination.

(a) Control – 6-Fl(1)

(b) Crack repair - 6-Fl(1)-CR(C-S)

(a) Strengthened - 6-FI-St(C-S)

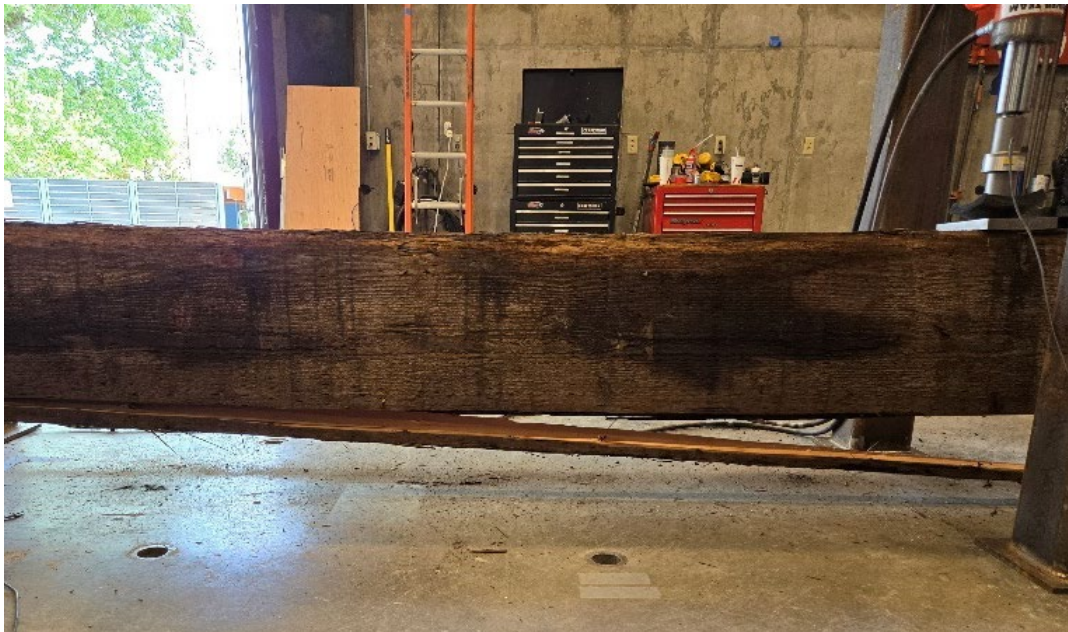
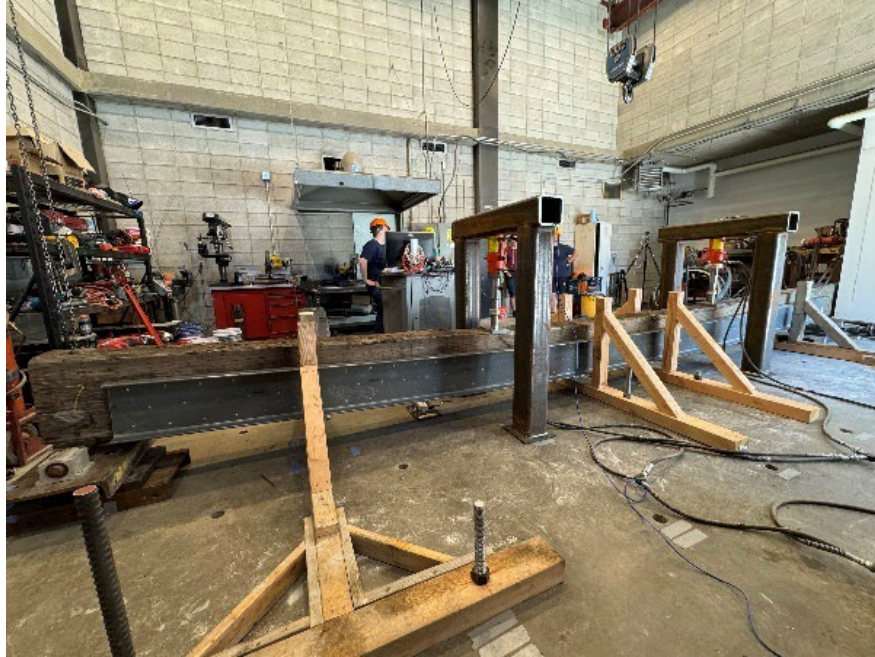
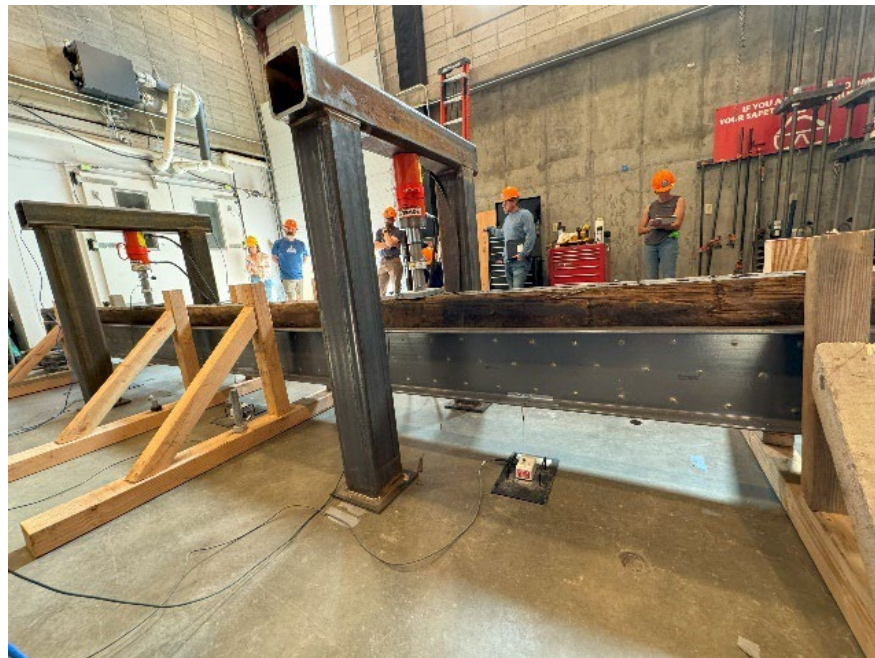
(a) Control - 8-FI(1)

(b) Crack repair - 8-FI(1)-CR(C-S)

(c) Strengthened - 8-FI-St(C-S)

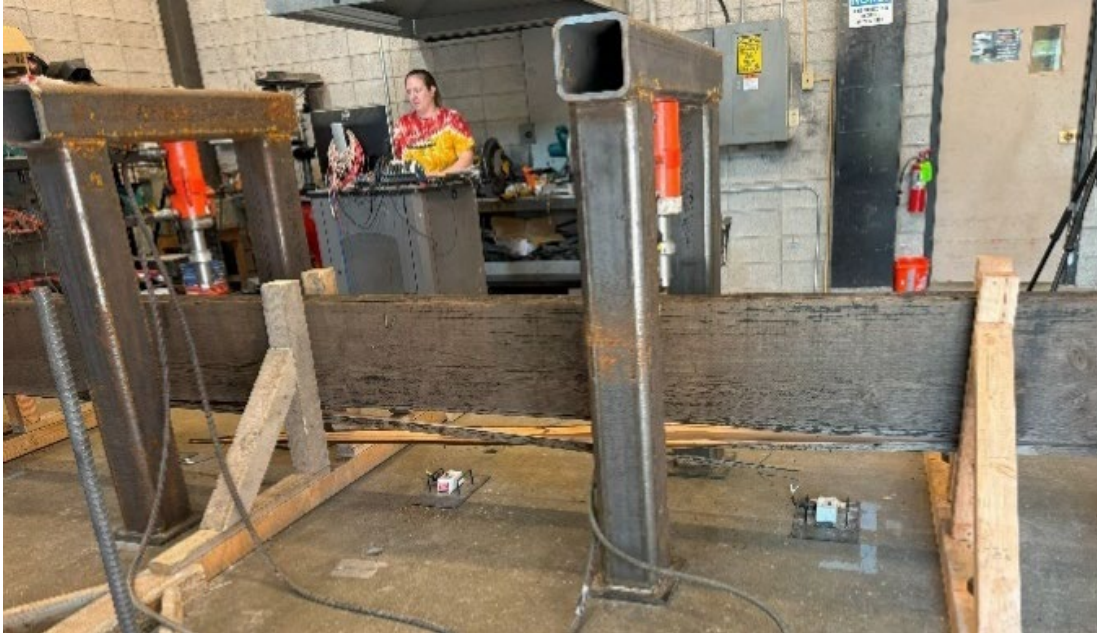
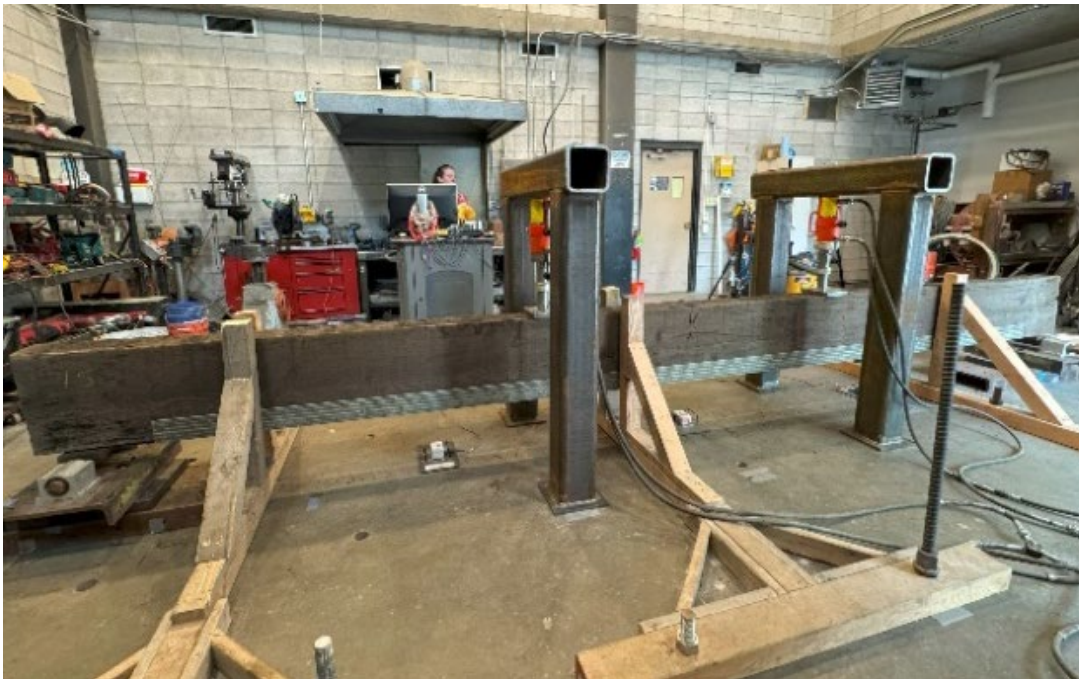
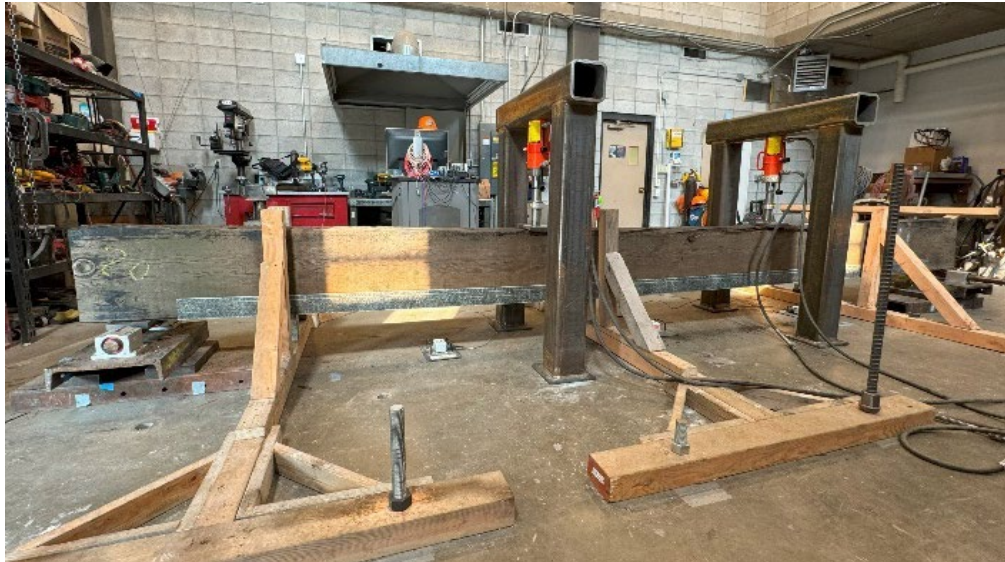
Figure 42: Control, crack-repair and strengthened 6"x18" beams with strip only

Figure 42 and Figure 43 show the three tested configurations of 6"×18" and 8"×18" timber beams, respectively: control, crack repair with strip only, and strengthened with strip only. The control beam displays the damage from testing. The repair beam is the same beam retrofitted with strip only, while the strengthened beam is an intact beam reinforced with strip only.

(a) Control - 6-FI(2)

(b) Crack repair - 6-FI(2)-CR(S)

(c) Strengthened - 6-FI-St(S)
