Task 2 Report – Close Minor Research Gaps
USE OF FIBER-REINFORCED POLYMER COMPOSITES
FOR BRIDGE REPAIRS IN MONTANA

Civil Engineering Department
College of Engineering
Montana State University – Bozeman

Prepared for the
MONTANA DEPARTMENT OF TRANSPORTATION
in cooperation with the
U.S. DEPARTMENT OF TRANSPORTATION
FEDERAL HIGHWAY ADMINISTRATION

August, 2025

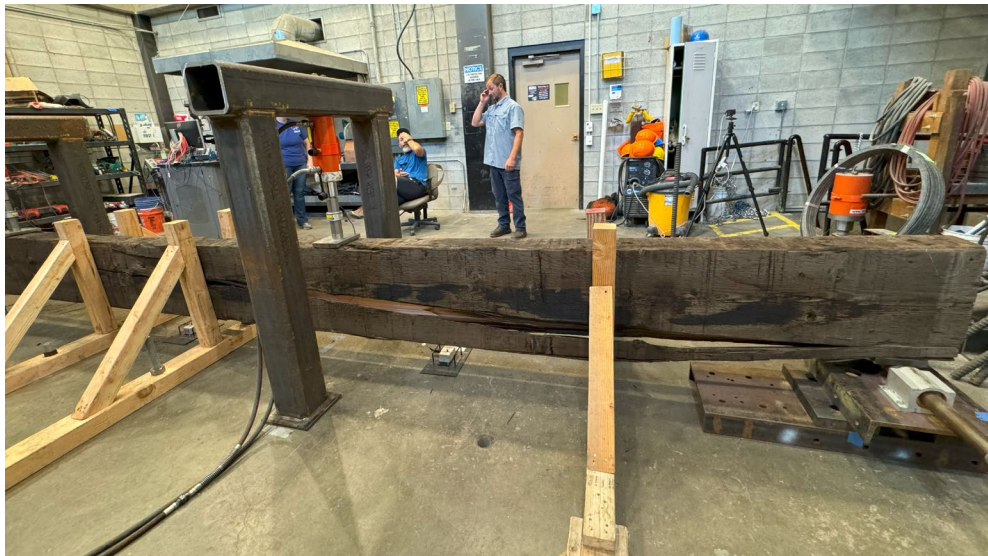
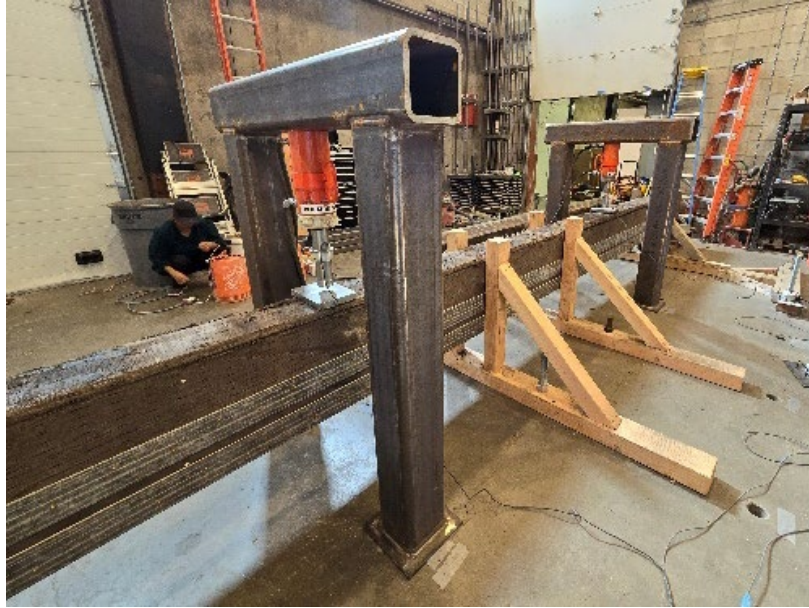
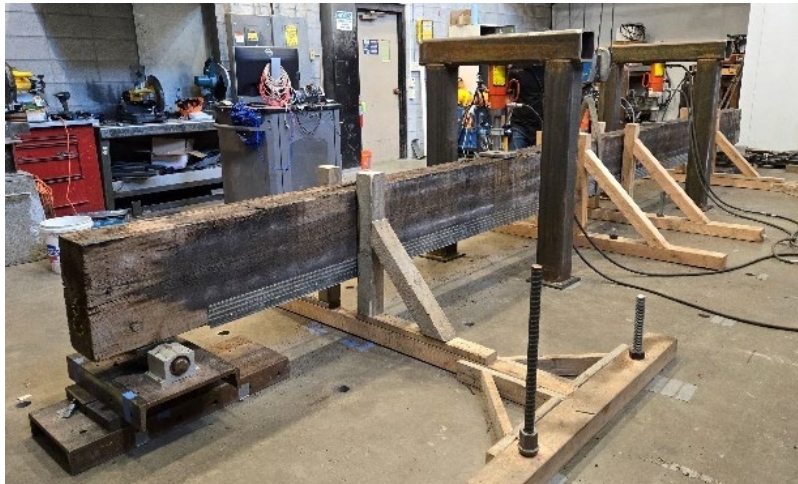
Figure 42 and Figure 43 show the three tested configurations of 6"×18" and 8"×18" timber beams, respectively: control, crack repair with strip only, and strengthened with strip only. The control beam displays the damage from testing. The repair beam is the same beam retrofitted with strip only, while the strengthened beam is an intact beam reinforced with strip only.

(a) Control - 8-FI(2)

(b) Crack repair - 8-FI(2)-CR(S)

(c) Strengthened - 8-FI-St(S)

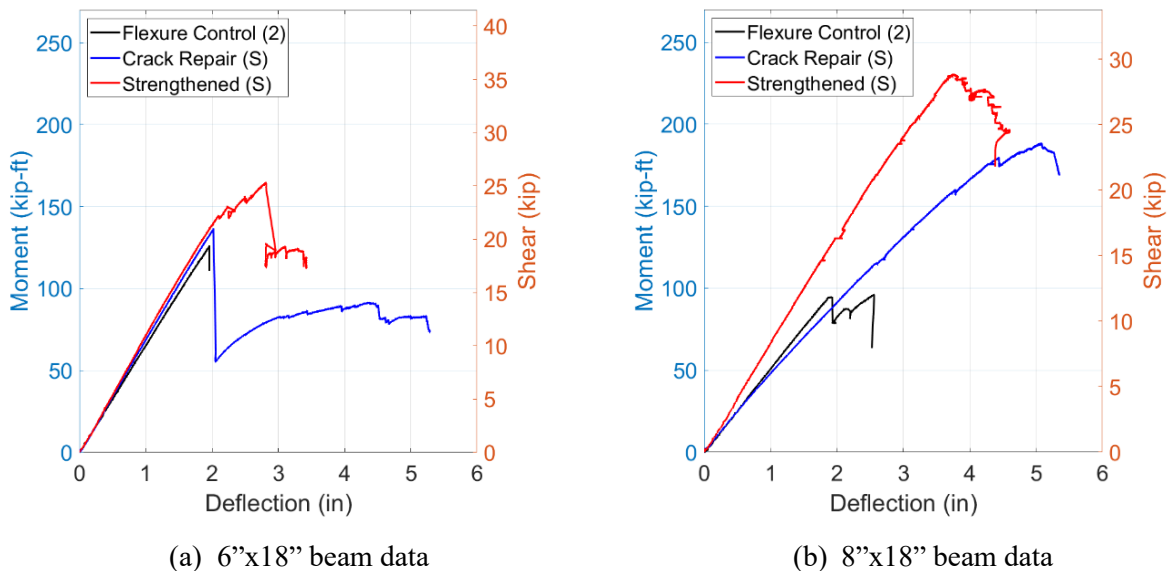
Figure 44: Comparison of control vs crack repair and strengthened beams with strips

The comparison of the moment-deflection curves for both sets of beams highlights the significant benefits of either crack repair or strengthening using the FRP strip reinforcement. The control beams in each set displayed typical brittle failure with sudden fracture. The crack repair restored and even improved the beams' original strength, but a sudden drop in the moment-deflection graph was still observed due to the splitting of the 6"×18" beam. In contrast, the strengthened beams demonstrated superior performance, carrying the highest moments and maintaining structural integrity even after initial signs of damage. This indicates that FRP strip reinforcement enhances moment capacity and improves the beams' overall stiffness and resilience, effectively delaying catastrophic failure.

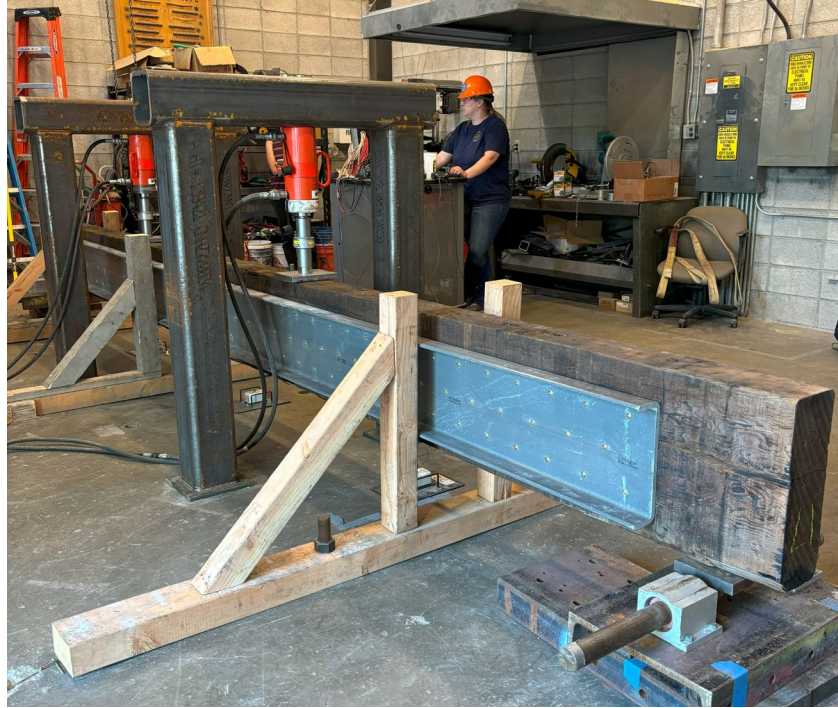
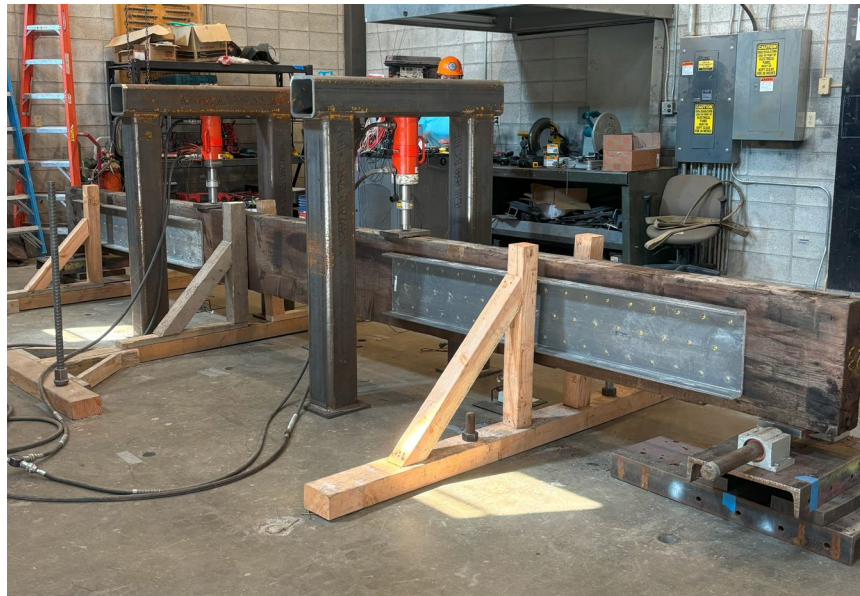
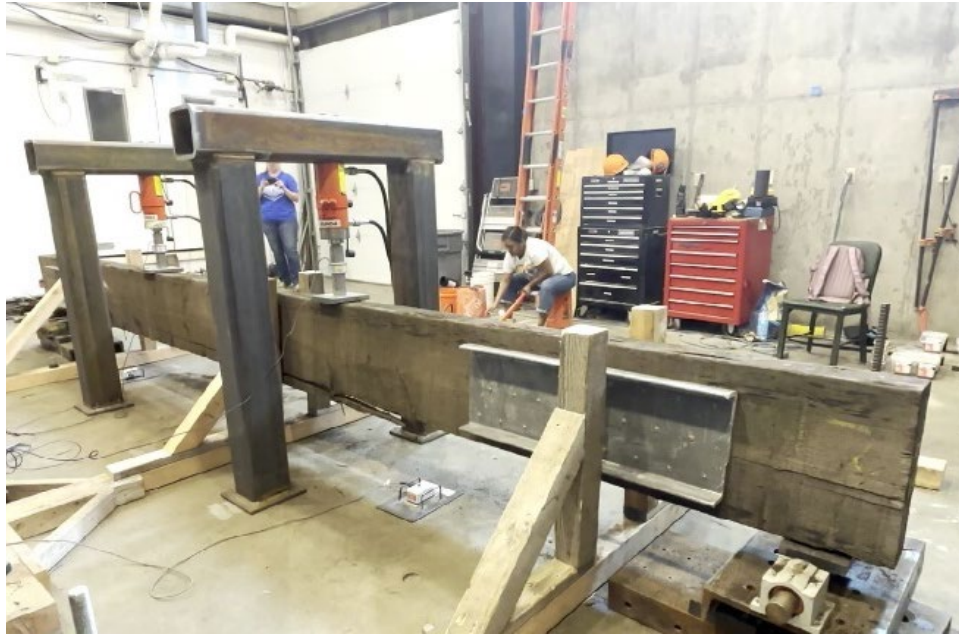
Figure 45: 6"x18" split repair beams tested in flexure setup

Several beams in the flexure test series have preexisting splits near their ends. This section demonstrates the effectiveness of several repair methods at repairing these splits. Figure 45 show the three split repair configurations for 6"×18", respectively: split repair with channel and strip combination, split repair with 6' channel, and split repair with 3' channel. The 8"×18" split repair beam with channel and strip combination is shown in Figure 46.

(a) Split repair – 6-FI-SR(C-S)

(b) Split repair - 6-FI-SR(C6)

(c) Split repair - 6-Fl-SR(C3)

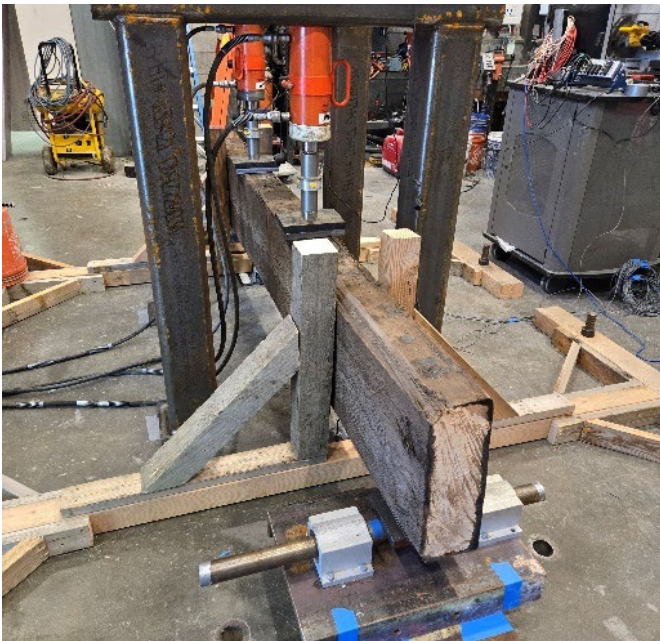
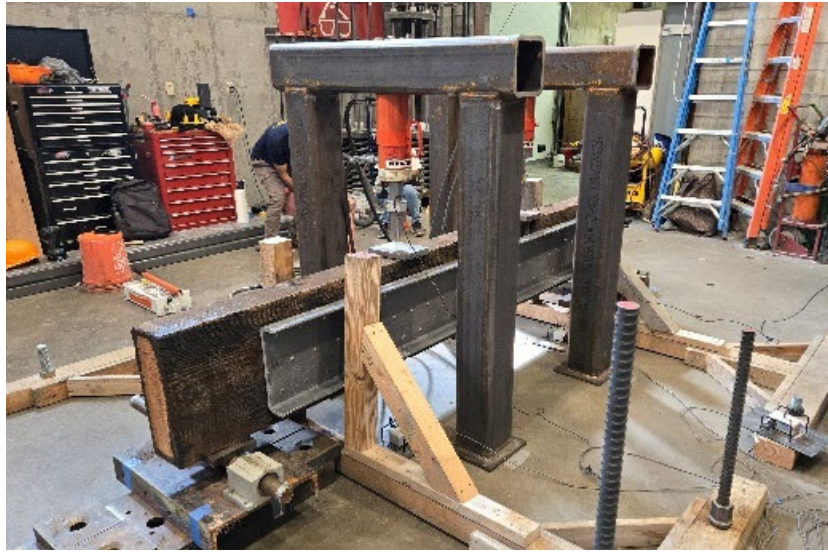
Figure 48: Control, split repair and strengthened 6"x18" beams with channel only

This section discusses the performance of beams tested in the shear setup, including control beams and those that were split-repaired or strengthened with side channels along the entire length of the beam, for both 6"x18" and 8"x18" members. Figure 48 and Figure 49 show the three tested configurations of 6"x18" and 8"x18" timber beams, respectively: control, split repair with channel, and strengthened with channel. The control beam displays the damage from testing. The repair beam is the same beam retrofitted with channel, while the strengthened beam is an intact beam reinforced with channel.

(a) Control – 6-Sh(1)

(c) Strengthened - 6-Sh-St(C)

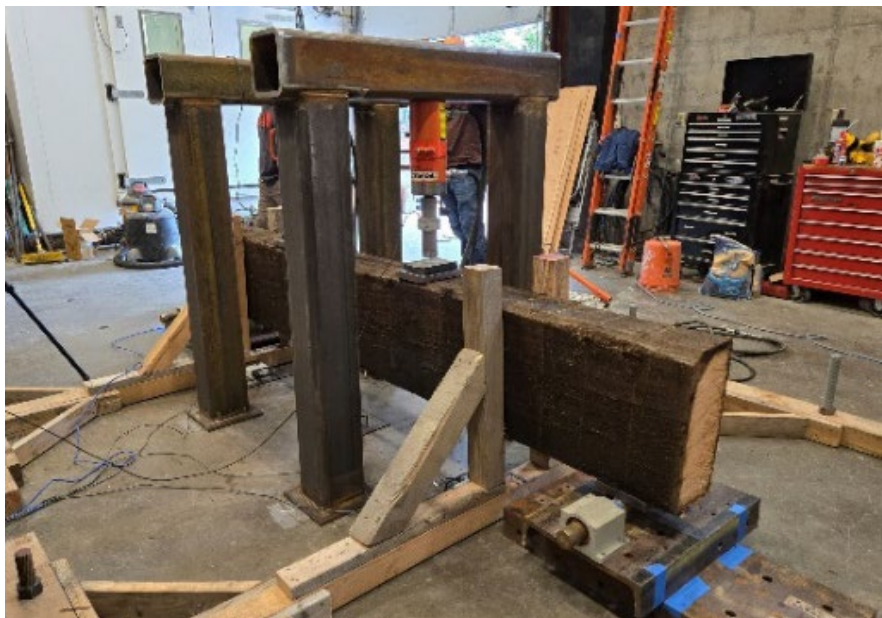
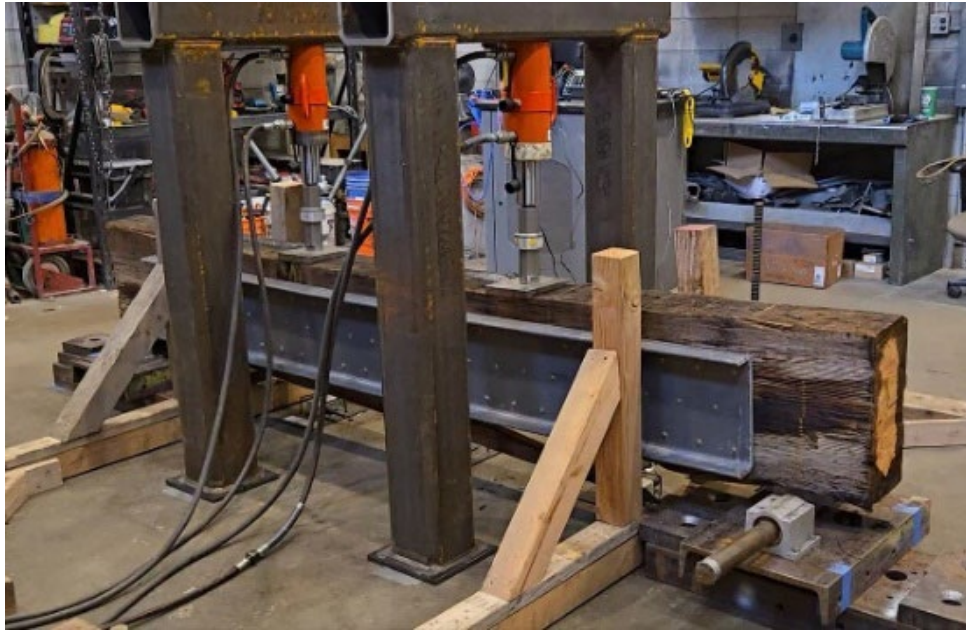
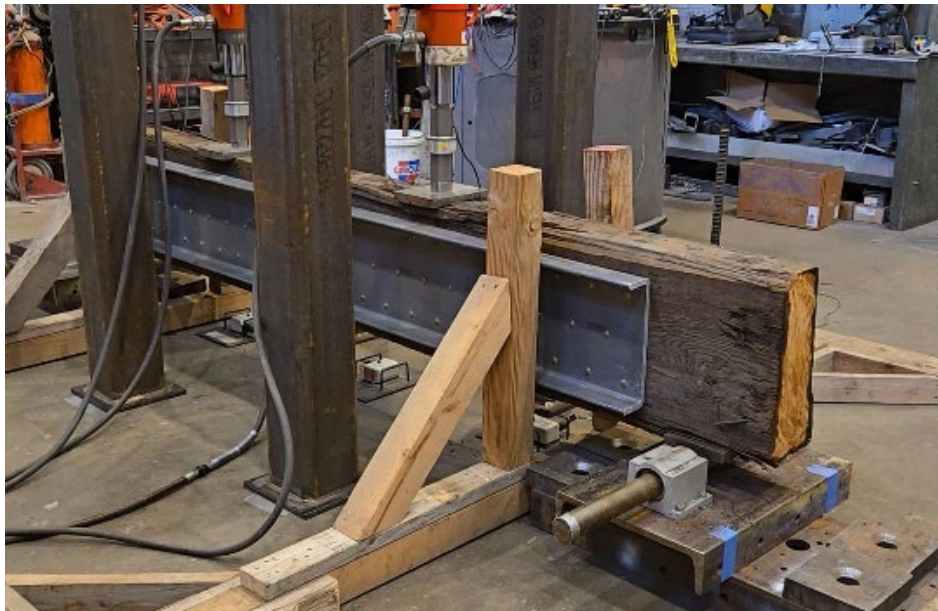
(a) Control – 8-Sh(1)

(b) Split repair – 8-Sh(1)-SR(C)

(c) Strengthened - 8-Sh-St(C)

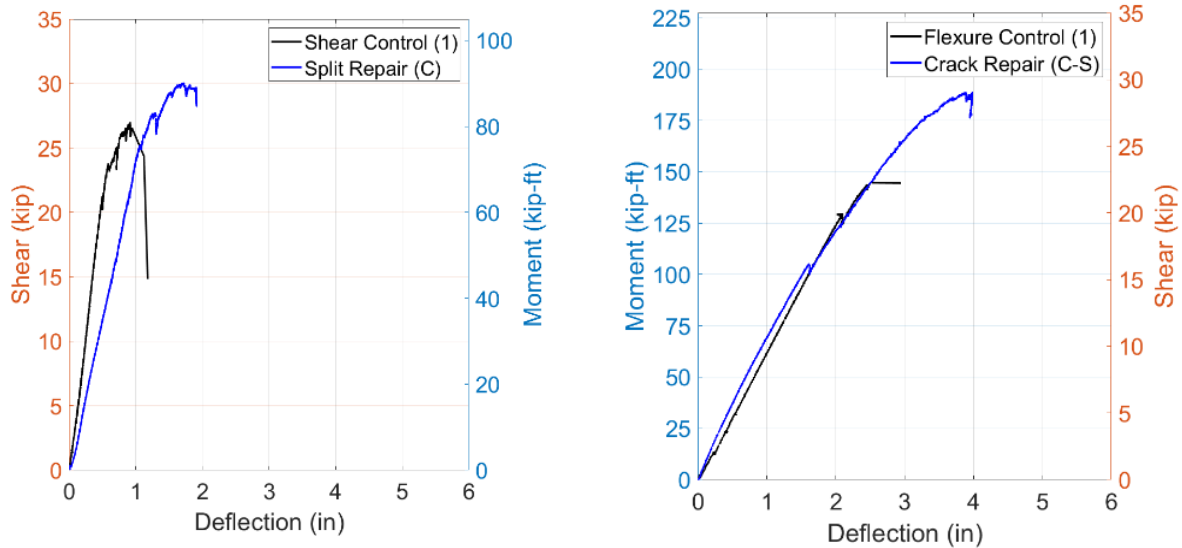
bottom, exhibited a substantial 30% increase in ultimate moment capacity compared to the control beam (Figure 54-b, black line). The crack-repair beam, strengthened with strips on the sides and bottom (Figure 54-c, blue line), showed a 9% increase in moment capacity compared to the control beam (Figure 54-c, black line). Although this was slightly less optimal than the performance of the beam reinforced with both channels and strips, it still demonstrates an effective repair.

(a) Shear control vs split repaired with channels (b) Flexure control vs crack repaired with channels and strip

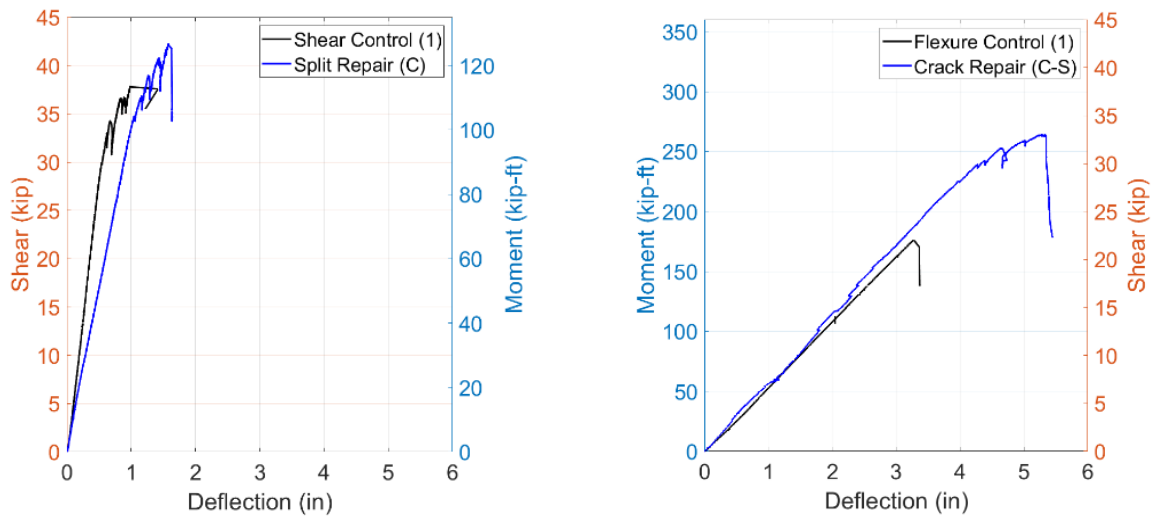
11.5% increase in shear capacity. This enhancement indicates that the side channels effectively repaired the split and strengthened the beam's shear resistance. For the flexure setup, the first control beam (Figure 55-b, black line) was repaired with channels on the sides and a strip on the bottom (Figure 55-b, blue line), which led to a substantial 50.1% increase in moment capacity. This approach significantly reinforced the beam against tension cracking and remarkably improved its performance. Similarly, the second flexure control beam (Figure 55-c, black line) was repaired with strips on the sides and bottom (Figure 55-c, blue line) resulting in an impressive 96.1% increase in moment capacity. The strips effectively confined cracking and greatly enhanced the flexural strength of the beam. However, it is important to note that the 96.1% increase may be artificially high as a result of the repaired capacity being compared with the lower capacity of the second control beam due to the pre-existing checking and wane defects.

(a) Shear control vs split repaired with channels (b) Flexure control vs crack repaired with channels and strip

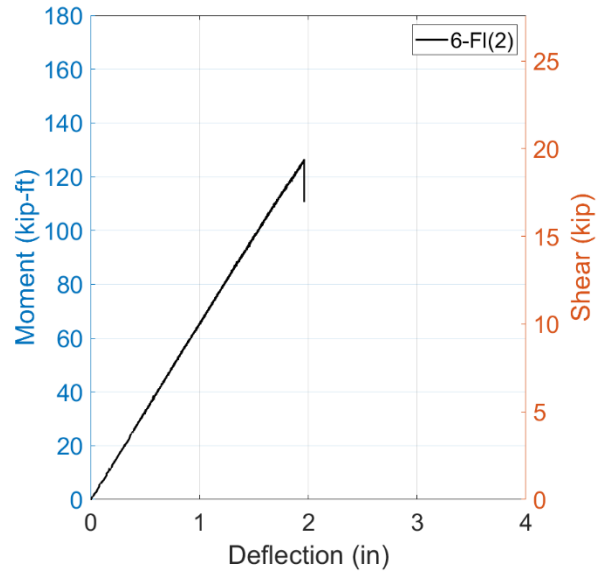
Figure 62: Moment vs deflection graph of 6-FI(2)

The beam's dimensions were 5.75" x 17" and 20' 0.75" in length. The beam had some minor checking. Figure 62 presents the moment vs deflection graph of the beam. The first creaking started at around 107.3 kip-ft. The beam failed due to a sudden flexure crack (Figure 63). The ultimate moment carried by the beam was 126.1 kip-ft at a deflection of 1.96".

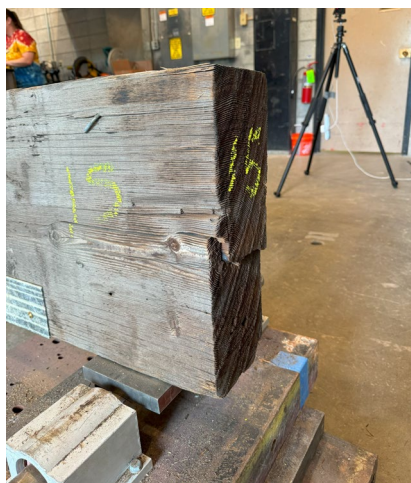
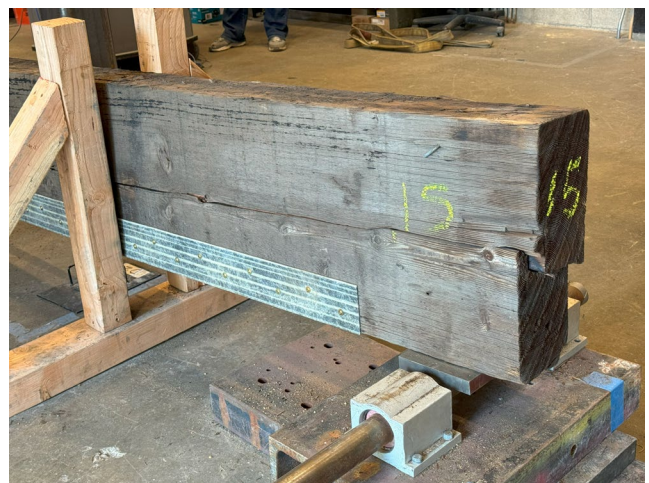
Figure 67: Failure propagation of 6-FI(2)-CR(S)

This was the crack-repair beam of flexure control 2 (6-FI(2)), following the repair steps discussed in section 3.3. The repair included attaching two strips on the sides and one at the bottom. The string potentiometers were anchored about 0.5" above the side strip. The moment vs deflection graph is depicted in Figure 66. The beam started making creaking sounds around the middle at around 97.5 kip-ft. When the moment reached 136.5 kip-ft at a 2.02" deflection, there was a loud pop, and the beam split (Figure 67) almost immediately at the end. The split rapidly propagated towards the center, causing the moment to drop sharply to 55.3 kip-ft, indicating that the beam had not been properly confined by the strip. When the moment was increased to 91.0 kip-ft, the split opened further. The test needs to be stopped because the stroke limit was reached, necessitating the removal of the load.

(a) Split started on the end

(b) Propagating to the middle

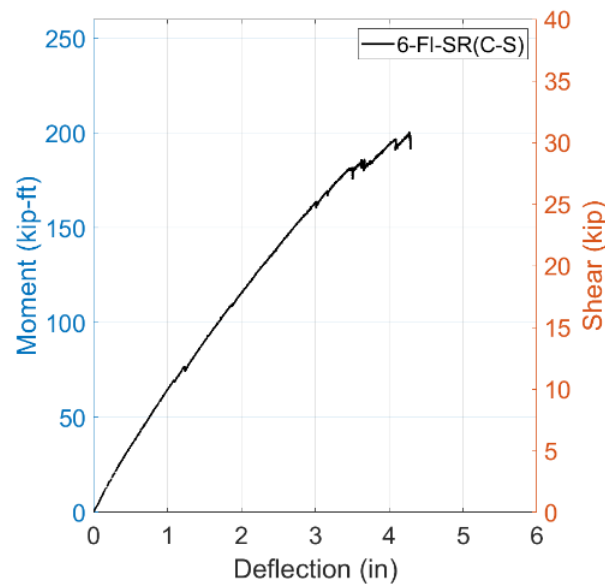
Figure 70: Moment vs deflection graph of 6-FI-SR(C-S)

The actual dimensions of the beam were 5.75" x 17" with a length of 20' 2". There was a small split on one end. The beam was repaired following the steps previously discussed in section 4. There was a missing screw on the east channel. The moment-deflection graph (Figure 70) showed a linear slope until 39 kip-ft, slightly stiffer than the two control beams (6-FI(1) and 6-FI(2)), with no lateral supports making contact. By 58.5 kip-ft, creaking noises were noted at the ends, and at 68.3 kip-ft, a 1" deflection occurred as the split on the end began to shift. A loud pop was heard at 74.8 kip-ft. At 107.3 kip-ft, slight noise emerged from the support. At 123.5 kip-ft, the beam started touching the middle top lateral support. When the moment reached 162.5 kip-ft, a screw sheared off from the channel, though no drop in load was observed. At 182.0 kip-ft and 3.51" deflection, there appeared to be some compression crack at the top, with creosote pushing out at the load cells, and loud popping was heard from mid-span as the moment held steady around 185.3 kip-ft. At 196.9 kip-ft and a 4.1" deflection, another pop was noted as the split shifted further, and a crack appeared on the east side string potentiometer (D3). With increased load, all east lateral supports were in contact with the beam, and slight eccentricity was observed on the load cells, leading to the decision to end the test. The failure propagation of the beam is shown in Figure 71. The ultimate moment carried by the beam was 200.9 kip-ft at a mid-span deflection of 4.27".

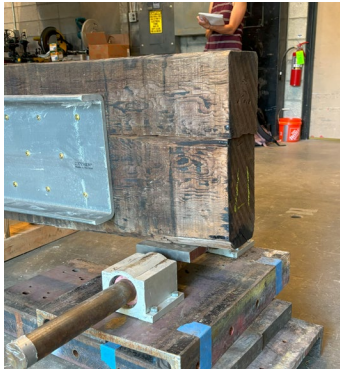
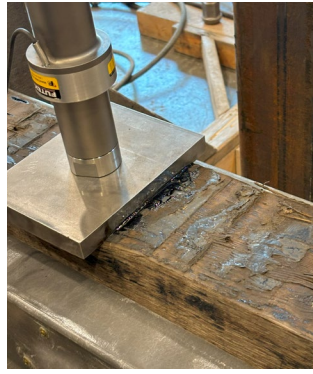
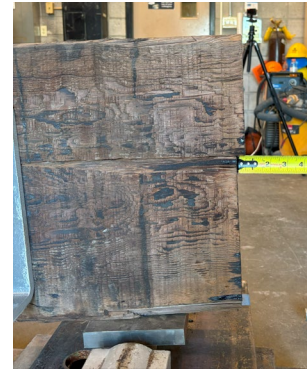
Figure 71: Failure propagation of 6-FI-SR(C-S)

(a) Split shifting

(b) Creosote coming out

(c) Split shifting further

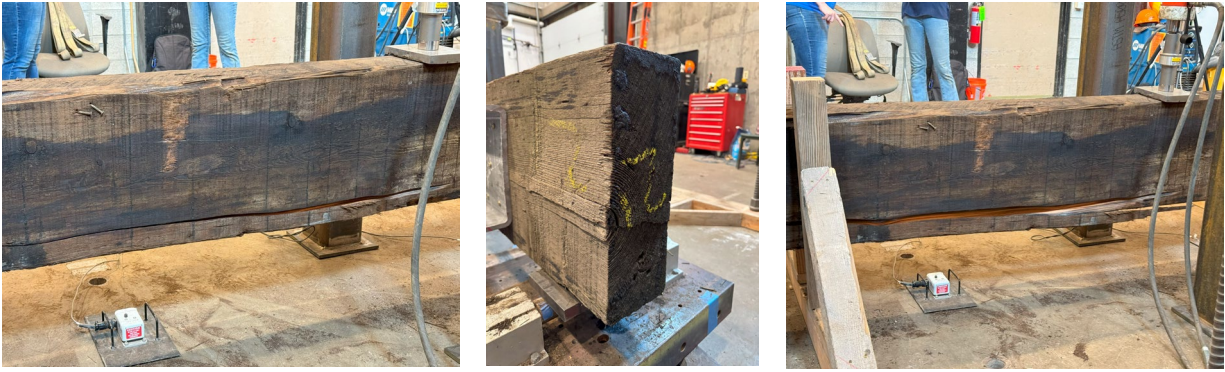
(a) Crack started at mid-span

(b) Split shifting

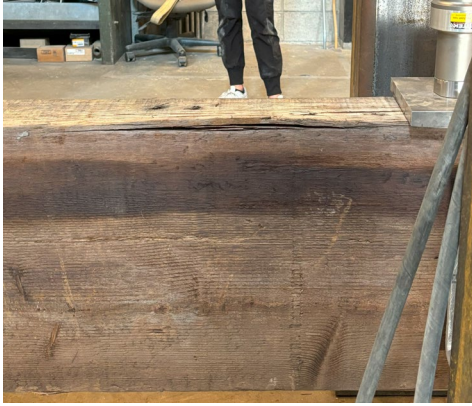
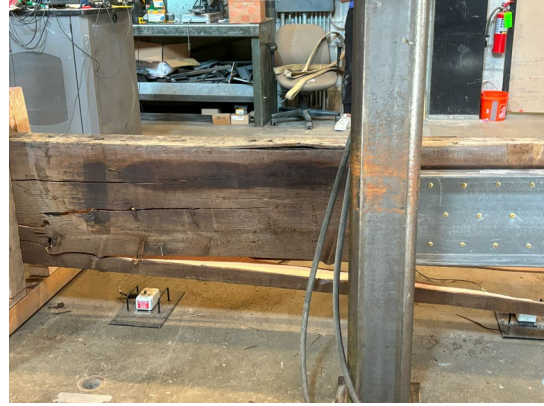
Figure 75: Failure propagation of 6-FI-SR(C6)

(a) Compression crack at top

(b) Flexure crack mid-span

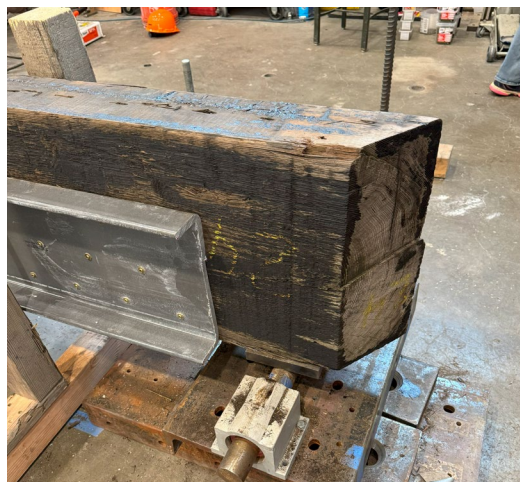
Figure 78: inclined cut on one end

This was a strengthened beam tested in a flexure setup. The strengthening was done by attaching two channels on the side and a strip at the bottom. It had dimensions of 5.75" x 17" and a length of 19' 10". There was an inclined cut on one end of the beam that added 3" to the total length of one side (Figure 78); however, the overall span length remained unaffected. A different size screw was mistakenly attached to the strip. The moment vs deflection graph is shown in Figure 79. During the load test, the first creaking was heard at around 58.5 kip-ft. At around 113.8 kip-ft, a small pop occurred on the end. At 136.5 kip-ft, a load pop occurred with no visible crack. When the moment was increased to 167.7 kip-ft, a crack emerged at the mid-span, accompanied by a distinct loud pop. At 176.2 kip-ft, creaking noises and a loud pop were heard as the crack in the mid-span expanded. The moment was then dropped to 170.9 kip-ft. At this point, one load cell was slightly eccentric, and creosote was oozing at the load cells (Figure 80-a). The crack propagated in the lower mid-span at around 182.0 kip-ft. The test was ultimately stopped at 189.2 kip-ft when the mid-span deflection was 2.77", due to bearing failure at the load cell.

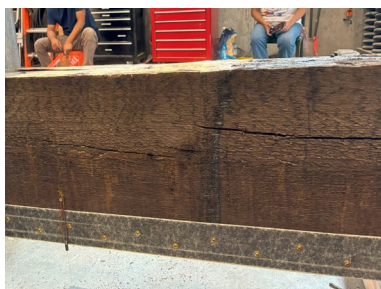
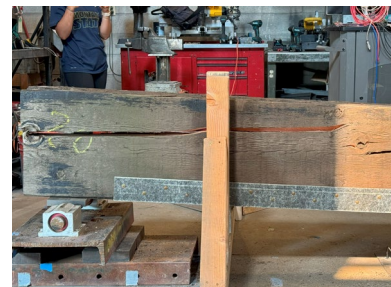
Figure 82: Failure propagation of 6-FI-St(S)

(a) Crack at the middle

(b) Compression failure
under load cell

(c) Split at the end

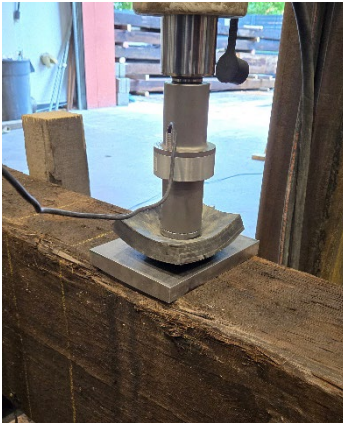
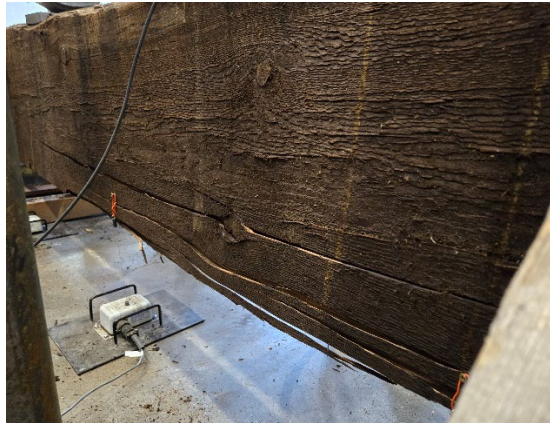
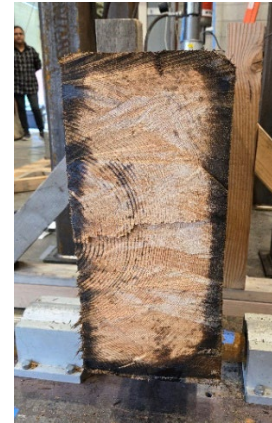
Figure 84: Failure propagation of 8-Sh(1)

The actual dimensions of the beam were 7.75" x 17.5" and 26' long with no noticeable damage. The beam was cut in 10' 1' for having a span length of 9' with a 6.5" overhang on each side. Figure 83 shows the shear vs deflection of the beam. Bearing failure started forming at around 25.0 kips at the load-bearing blocks. The flexural crack started at the middle of the beam at around 34.0 kips when the mid-span deflection was 0.67". The crack was opening up with increased loading. The beam failed by splitting at the end. The failure propagation of the beam is presented in Figure 84. The ultimate shear carried by the beam was 37.9 kips at a mid-span deflection of 0.98".

(a) Bearing failure started

(b) Flexure crack at the mid-span

(c) Split at the end

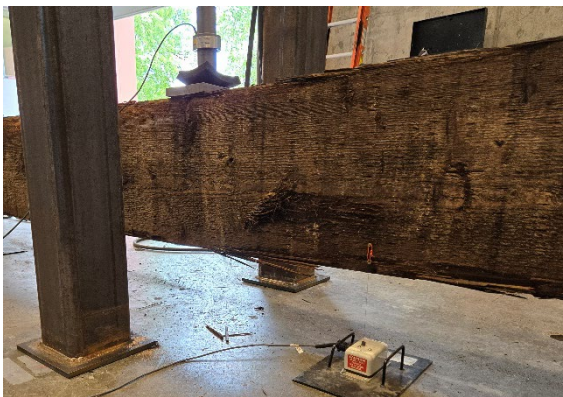
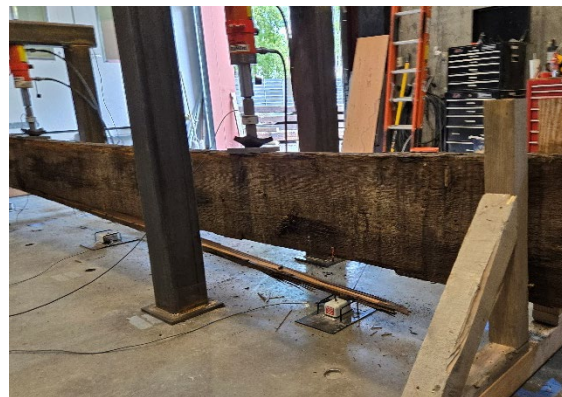
Figure 86: Failure propagation of 8-FI(1)

The beam's actual dimensions were 7.5" x 17" and 25' 9" long. Its span length was 25', with a 4.5" overhang on each side. The beam had no significant damage. Figure 85 presents the moment vs deflection of the beam. A flexural crack (Figure 86) started at around 132.0 kip-ft at the midspan of the beam and continued to open with higher load. The ultimate moment carried by the beam was 176.0 kip-ft at a midspan deflection of 3.28". The beam failed due to flexure, with the crack initiating 66" from the right end and extending to 84" from the left end. The crack was located approximately 4" from the bottom of the beam.

(a) Flexure crack starting at mid-span

(b) Cracked beam

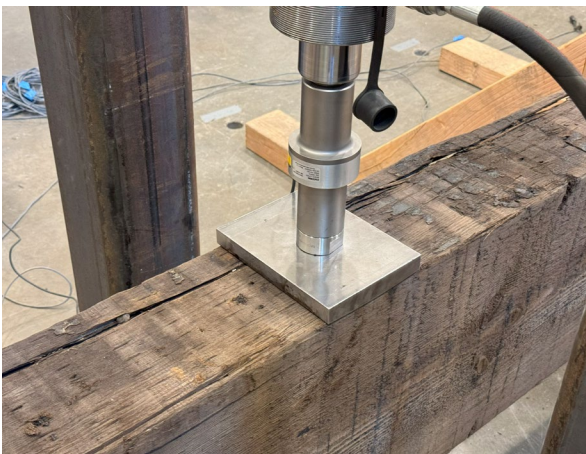
The beam had some minor checks and wane defects. Its actual dimensions were 7.75" x 17", and it was 26' long. The moment vs deflection graph is shown in Figure 87. The creaking sound at mid-span started at around 84.0 kip-ft. At 94.4 kip-ft, a split propagated, and compression failure (Figure 88-a) occurred, resulting in a moment drop to 78.4 kip-ft. The beam failed at cracking in mid-span (Figure 88-b). The ultimate moment carried by the beam was 96.0 kip-ft when the deflection was 2.56". Two holes were drilled to see the beam's core, and it was confirmed that there was no rot.

(a) Compression failure at top

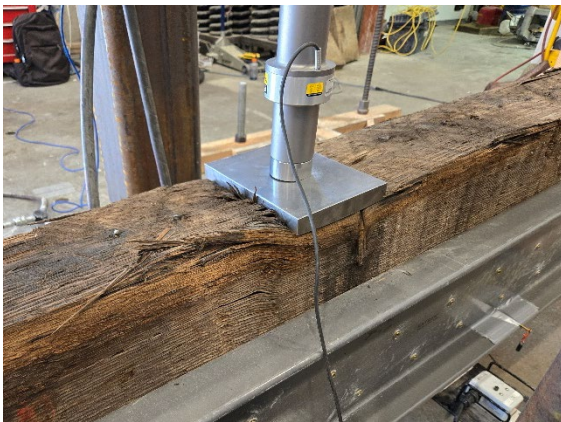
This was the crack-repair beam for flexural control 1 (8-FI(1)). The repair process involved attaching channels on the sides and a strip on the bottom, and the detailed repairing processes are discussed in section 4. The moment-deflection graph (Figure 89) showed a plateau at around 60 kip-ft, likely due to the screws engaging. There was a loud pop at around 242.4 kip-ft and a compression crack (Figure 90-a) near the load cell at 253.6 kip-ft. The test was stopped because the stroke limit was reached. The beam ultimately carried a moment of 264.8 kip-ft when the mid-span deflection was 5.28".

(a) Compression failure at top

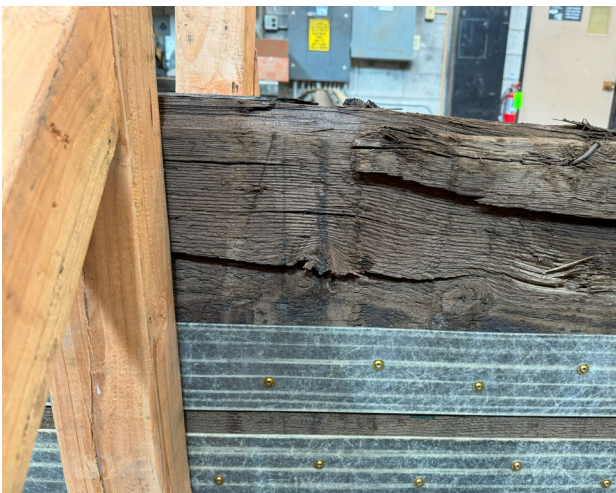
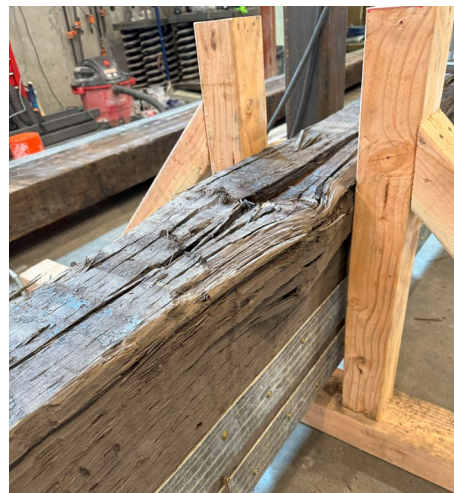
Figure 92: Failure propagation of 8-FI(2)-CR(S)

This was the Flexure Control 2 (8-FI(2)) beam with crack repairs. Four strips were attached to the sides, and one was attached to the bottom. The detailed repair method is discussed in section 4. The string potentiometers were anchored in the middle of two strips on the side. The moment vs deflection graph is shown in Figure 91. Creaking started in the midspan at around 104.0 kip-ft and continued with higher moment. At 160.0 kip-ft, a crack was opening up at the top middle through a knot (Figure 92-a), leading to a drop in the moment to 156.8 kip-ft. At 183.2 kip-ft, a poof of dust emerged from the top middle of the beam. When the moment reached 184.0 kip-ft, the beam started contacting the two lateral bracings. The loading was paused to take pictures at around 188 kip-ft. The beam cracked a lot while holding the load and eventually failed compression through a knot at the top face middle (Figure 92-b). The ultimate moment carried by the beam was 188.8 kip-ft when the mid-span deflection was 5.08”.

(a) Crack at mid-span through a knot

(b) Failure in compression

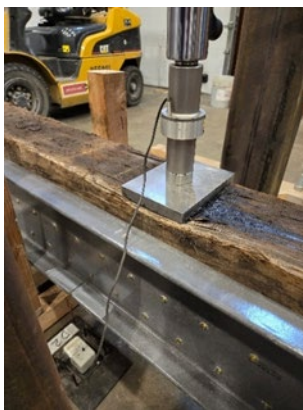
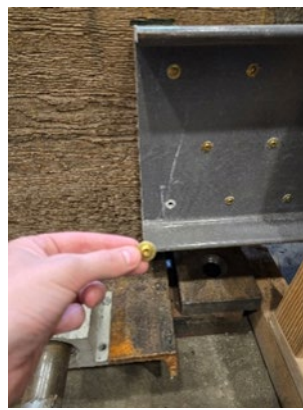
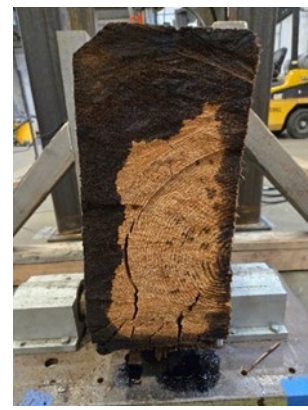
Figure 94: Failure propagation of 8-Sh(1)-SR(C)

(a) Bearing failure

(b) Screw sheared off

(c) Split at the end

This was the split-repair beam of shear control 1 (8-Sh(1)), which was repaired following the steps outlined in section 4, including attaching channels on the sides. There is an existing split on the end from the control test. The shear vs deflection graph is presented in Figure 93. Bearing failure began under the load block and support at approximately 26.0 kips. The beam started making contact with lateral bracings at around 36.0 kips. The existing split shifted at 36.8 kips. At 38.9 kips, a crack at the bottom midspan occurred, causing the shear to drop to 36.4 kips, with a screw on the channel shearing off. The load continued to increase, and shear failure was controlled on the end. The failure propagation of the beam is presented in Figure 94. The ultimate shear carried by the beam was 42.3 kips when the deflection was 1.58”.

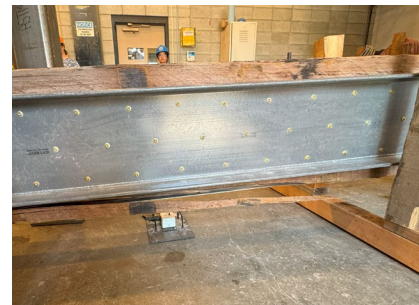
Figure 96: Failure propagation of 8-FI-SR(C-S)

(a) Compression crack at top (b) Beam buckled at top middle (c) Flexure crack at bottom middle

The beam's actual dimensions were 7.5" x 17" with a length of 26' 0.75". It had moderate checking along its length and was a split repaired beam with channels on the sides and a strip on the bottom. The beam had tapered ends and a through bolt was removed from one end. Figure 95 presents the moment vs deflection graphs. The first creaking occurred at around 94.4 kip-ft, and a small pop happened at around 112.0 kip-ft. A crack started forming in the bottom middle at around 133.6 kip-ft. Creaking continued with higher loading, and at a moment of 163.2 kip-ft, a crack formed under the channel, approximately 2" from the bottom on the east side, with a loud pop. As the moment increased to 175.2 kip-ft, a compression crack began to form near the top in the center of the beam. At 184.8 kip-ft, another loud pop was heard as the top middle of the beam buckled at the compression crack, causing the moment to drop to 143.2 kip-ft and then rebuild. At 167.2 kip-ft, a crack formation started near the D2 string potentiometer, about 12" from the load frame, followed by another crack at the bottom-mid, causing a slight load drop. As the moment reached 184.8 kip-ft, the beginning of a compression crack was observed near the center. At 187.2 kip-ft with 4.4" of deflection, a crack near the center began to open up. Finally, at 188.8 kip-ft with 4.7" of deflection, the bottom crack between the D1 and D2 string potentiometers started to widen, and a large crack formed near the D3 string potentiometer with a loud pop. The test was stopped after reaching the maximum stroke of the load cell. Figure 96 shows the failure propagation of the beam. The ultimate moment carried by the beam was 198.4 kip-ft at a mid-span deflection of 5.22".

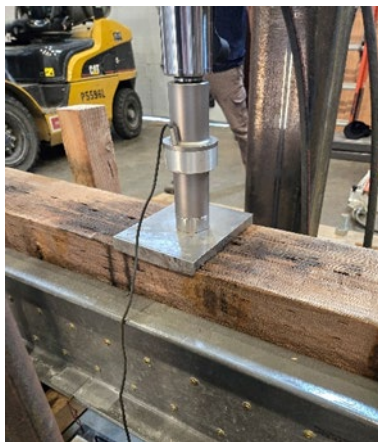
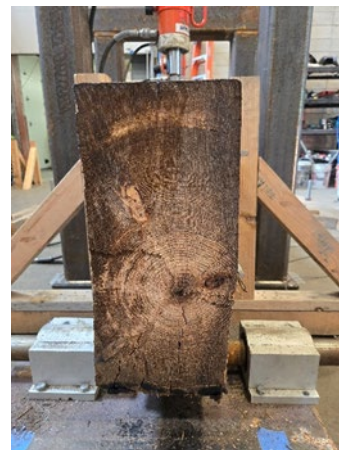
Figure 98: Failure propagation of 8-Sh-St(C)

(a) Bearing failure at load block

(b) Split at the end

The actual dimensions of the beam were 7.5" x 17.5" with a length of 10'. It was a shear-strengthened beam cut into 10' section for the shear test setup. The strengthening process involved attaching channels on the sides, and more detailed information on the strengthening can be found in section 4. String potentiometers were attached to the bottom flange of the channel. The bottom surface of the beam was not flat, so it was necessary to hold the beam in place before starting the loading. Figure 97 shows the shear vs deflection graph of the beam. The first creaking noise was heard at around 35.0 kips, and bearing failure occurred at both supports at around 43.0 kips (Figure 98-a). Creaking continued with higher loading, and a tension crack occurred at the bottom midspan at 52.5 kips, causing a slight load drop. The beam was continuously loaded and ultimately failed due to shear at one end, which caused split propagation and a shift (Figure 98-b). The ultimate shear carried by the beam was 56.3 kips at a mid-span deflection of 1.45".

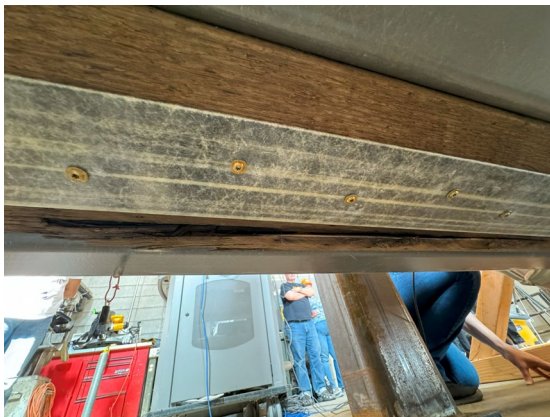
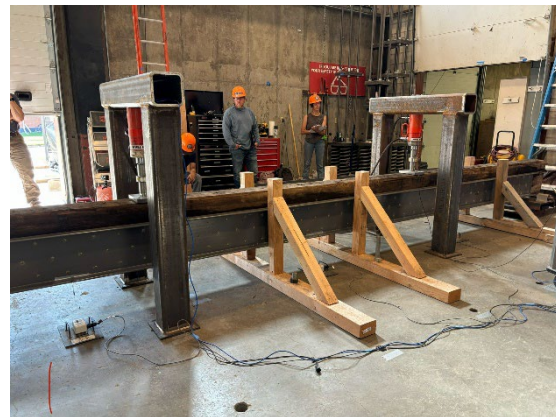
Figure 100: Failure propagation of 8-FI-St(C-S)

(a) Crack at the bottom

(b) Fully loaded beam

The beam was a strengthened beam with channels on the sides and a strip on the bottom. Its dimensions were 7.5" x 17" with a length of 26' 1.5". The moment vs deflection graph is shown in Figure 99. The first creaking noise was heard at around 128.0 kip-ft. At 144.0 kip-ft, there was a creak and a small pop from one end. As the moment increased to 172 kip-ft, crackling sounds accompanied by a small pop were heard from the end. When the moment reached 228.0 kip-ft, a loud pop was heard as a large compression crack began to form, causing a change in slope. At around 232.0 kip-ft, with a 4" mid-span deflection, the beam cracked just below the D2 string potentiometer with a loud pop (Figure 100-a), although the strip remained intact. At 252 kip-ft, with 5" of deflection, flange buckling was observed. Finally, at 255.2 kip-ft and 5.36" of deflection, a loud pop was heard as a small fragment flew off. The beam ultimately carried a moment of 255.2 kip-ft at a mid-span deflection of 5.32".

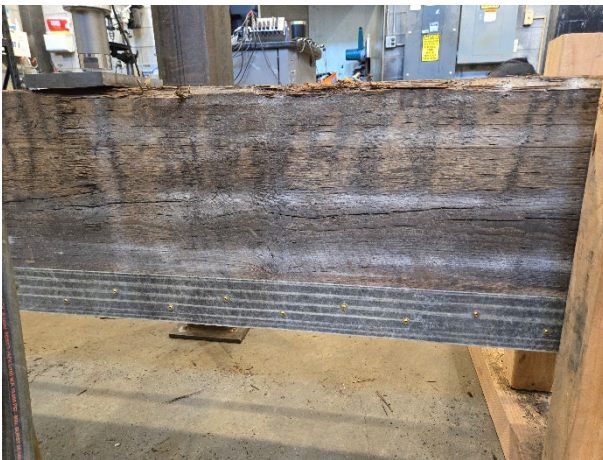
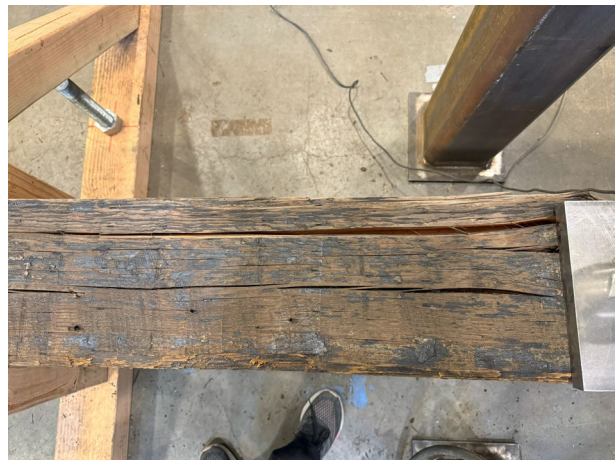
Figure 102: Failure propagation of 8-FI-St(S)

(a) Crack starting

(b) Compression at top

This was a beam reinforced with strips, with three strips attached to the sides and bottom. The beam's actual dimensions were 7.75" x 17.5" with a length of 26' 6.75". There was some significant checking and a large notch on one end, causing the strips to hang over. The string potentiometers were anchored above the strip on the side. The moment vs deflection is shown in Figure 101. Creaking began at around 112.0 kip-ft throughout the beam and continued with higher loading. Loud pops were heard at 168.0 kip-ft and 181.6 kip-ft with no significant drop in load. A crack (Figure 102-a) began propagating at 230.4 kip-ft on the bottom through a knot with a loud pop, causing the moment to drop to 214.4 kip-ft. The beam started touching the middle lateral bracing. Ultimately, the beam failed with a crack propagating to the midspan and compression failure under the load block (Figure 102-b) at around 200.0 kip-ft with a loud pop. The ultimate moment carried by the beam was 230.4 kip-ft when the deflection was 3.76".

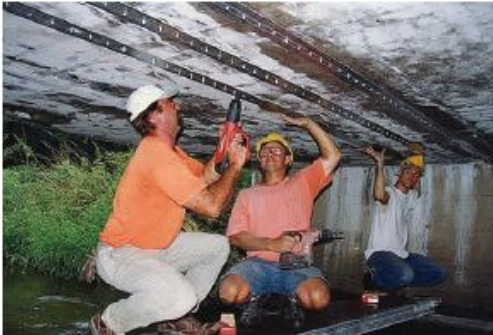
Workers installed SAFSTRIP® on this bridge in Edgerton, Wisconsin, using the MF-FRP system. The load rating for the bridge increased from HS-17 to HS-25 as a result.

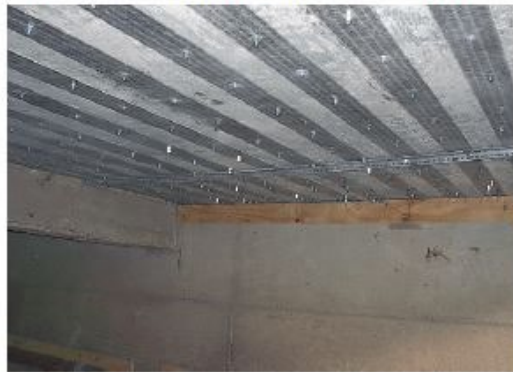
This bridge, located in St. James, Missouri, was load posted at the time of strengthening. After mechanically attaching SAFSTRIP® with concrete wedge bolts and anchors, the bridge load limit was raised to 20 tons.

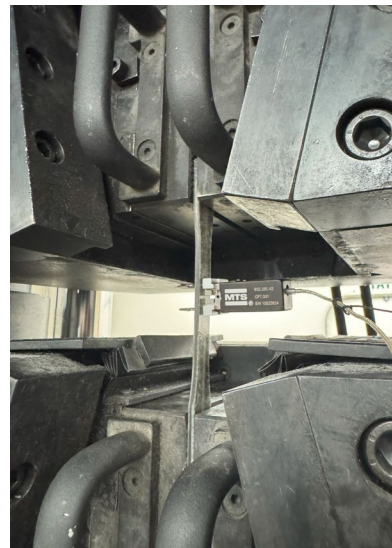
Figure 112: Tensile test setup for FRP coupons

(b) Hybrid FRP strip coupon

All tensile tests were conducted at the Materials Testing Lab, Montana State University, using an MTS Testing Machine. The tests followed the guidelines of ASTM D638-14, and the loading rate was maintained at 0.0033 in/sec for all specimens. Proper alignment of the coupons in the grips was ensured to avoid eccentric loading. Specimens were instrumented with an MTS extensometer to capture accurate strain responses and stress was calculated using the measured loads and cross-sectional areas. Photographs of the test setup and mounted coupons are provided in Figure 112.
