## US 2 - SWAMP CREEK MITIGATION SITE

Montana Department of Transportation Stream Mitigation Monitoring Report

**MDT Project:** Libby Creek-South; NH-F 1-1(29)45 F, CN 1027004

**Monitoring Year:** 2024

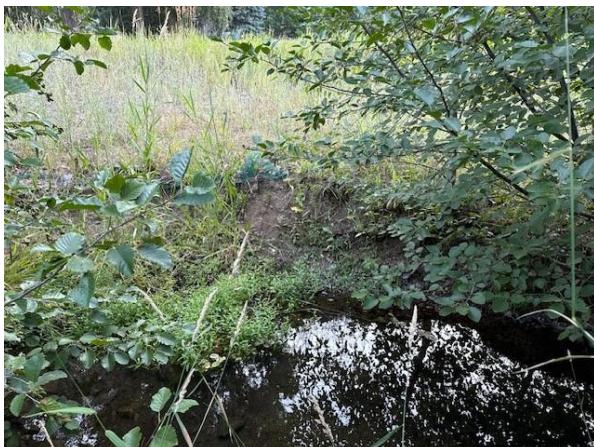
Reach 3.2 contained four eroding banks in 2023, however three of those banks were removed from the inventory in 2024. The single eroding bank that was retained is due to bare ground and active bank material loss from erosion. The three banks that were removed from Reach 3.2 exhibited dense vegetation, stability at the toe, and appeared in a natural condition. Photos 3 and 4 below depict the single remaining eroding bank and an example of an eroding bank that was removed from the erosion inventory in 2024.

*Photo 3. Photo of eroding bank within reach 3.2 (STA 26+25) that was retained in the 2024 inventory.*

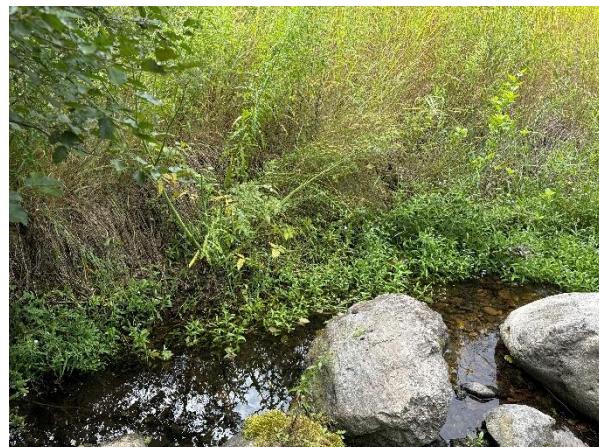
*Photo 4. Photo of eroding bank within reach 3.2 (STA 29+00) that was removed from the 2024 inventory.*

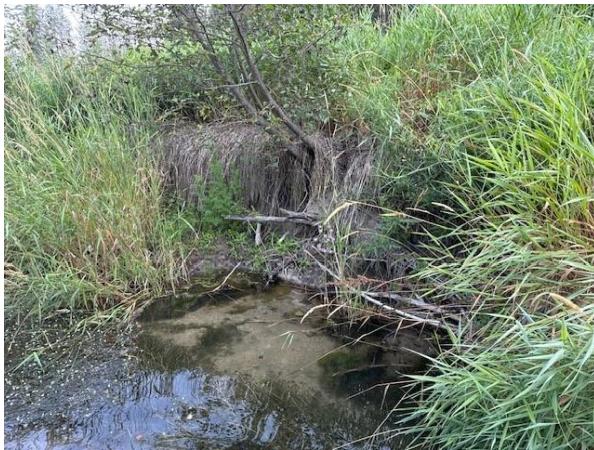
Reach 3.4 exhibited five eroding banks in 2023, however four of those banks were removed from the inventory in 2024. Photos 5 and 6 below depict typical eroding banks within reach 3.4 that were either retained for the 2024 inventory or removed.

*Photo 5. Photo of eroding bank within reach 3.4 (STA 13+50) that was retained in the 2024 inventory.*

3.3	0	900	0.0	No erosion observed in Reach 3.3
3.4	20	3,250	0.6	Bank erosion in Reach 3.4 was limited to one actively eroding bank downstream of the stabilized headcut from 2019. The observed eroding bank had a vertical wall and was failing at its toe. Evidence of fine sediment deposition at the toe of the slope was observed.
5	9	750	1.2	Bank erosion was limited to a single outside meander bend. The recorded bank erosion appeared to be at a more stable slope, but was sparsely vegetated and actively contributing sediment to the system.

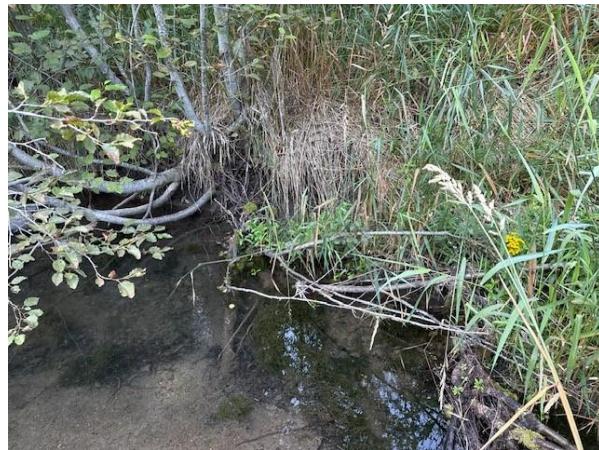
*Photo 6. Photo of eroding bank within reach 3.4 (STA 12+00) that was removed from the 2024 inventory.*

The banks in Reach 3.4 that were removed from the inventory exhibited low bank height, a prevalence of woody root material, and a high percentage of established vegetation. The banks that were removed also exhibit natural, undercut characteristics, these conditions justify their removal from the eroding bank inventory.

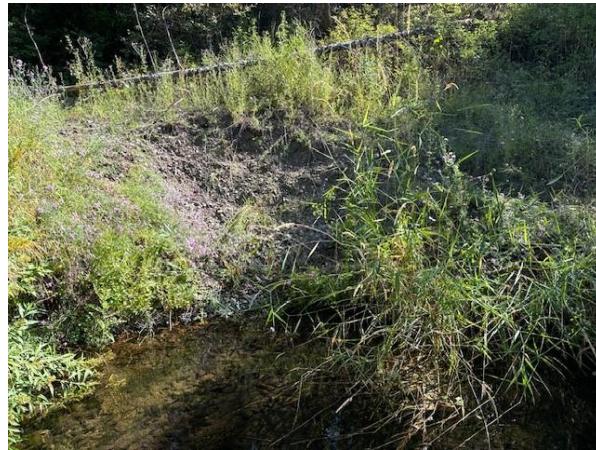
*Photo 7. Photo of eroding bank within reach 5 (STA 1+75) that was retained during the 2024 inventory.*

The single eroding bank in Reach 5 was retained due to the degree of exposed soil and lack of stabilizing vegetation. While this bank was retained during the 2024 inventory, the bank erosion is natural and has signs of wildlife using this area as a ramp to access and cross Swamp Creek. These conditions are considered natural, and no corrective action is recommended.

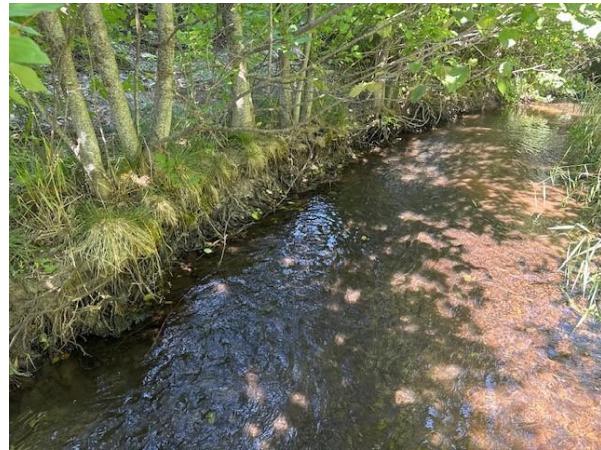
*Photo 9. Photo of eroding bank within reach 7.1 (STA 14+25) that was removed from the 2024 inventory.*

These banks were removed from the inventory due to low bank height and establishment of mature woody vegetation. While the eroding bank at STA 14+25 does have an unvegetated toe, the presence of large woody root masses appears to be stabilizing the bank. Both locations exhibit natural and stable conditions justifying their removal from the erosion inventory.

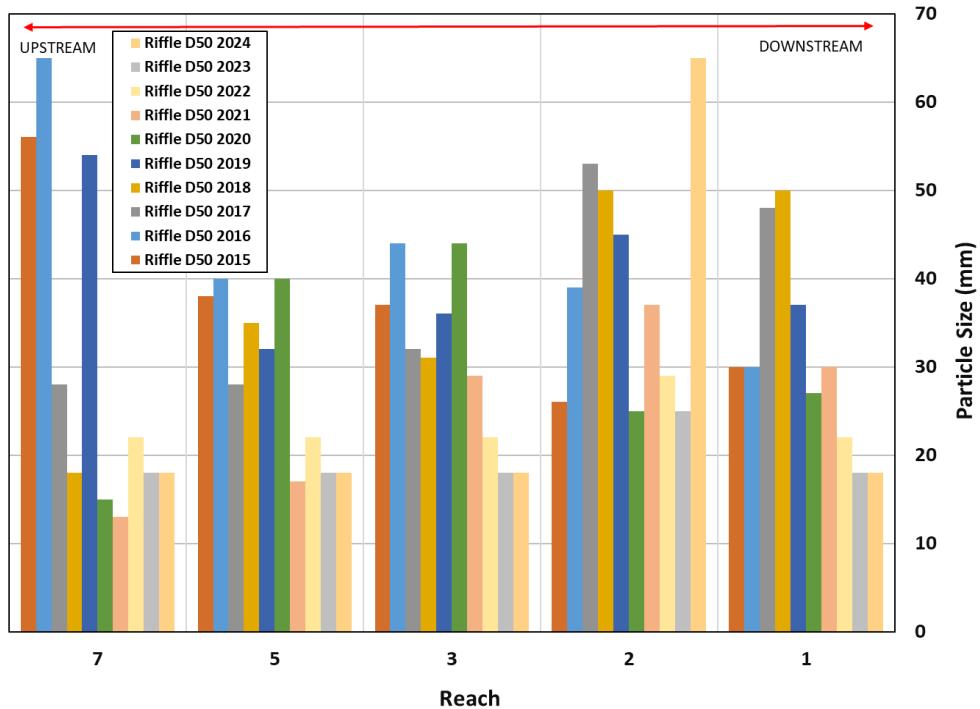
### Riffle D50 Particle Sizes, Swamp Creek

Wolman pebble count data collected in Swamp Creek in 2024 are presented in the cumulative distribution curves in Appendix F. Continued monitoring of bed material composition indicates the mean substrate size (D50) found in both pools and riffles is coarse gravel ranging from 13-27 mm. D50 values in riffles were identical to the material sizes sampled in 2023 for all reaches except for Reach 2. D50 values for pools were approximately 4mm smaller at all sampled locations, which is indicative of continued bed fining in pools as previously noted in 2023.

**Figure 1.** Mean particle sizes in one riffle sampled within each reconstructed reach within the Swamp Creek mitigation area.

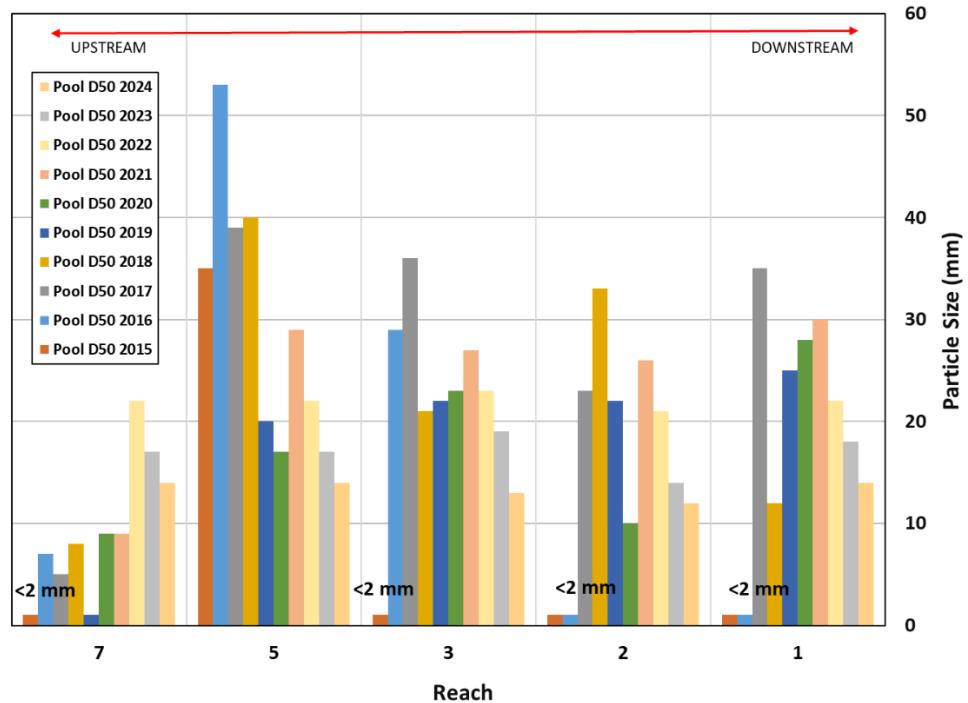
### Pool D50 Particle Sizes, Swamp Creek

While pebble count data indicates spawning sized gravels are present within each of the monitoring reaches, and median particle sizes values in riffles and pools consists of coarse gravels, Reaches 1, 2 and 3 exhibit fine bed materials <2mm in excess of 20%. The abundance of fine-grained particles may somewhat compromise successful spawning by salmonids.

**Figure 2.** Mean particle sizes in one pool sampled within each reconstructed reach within the Swamp Creek mitigation area.

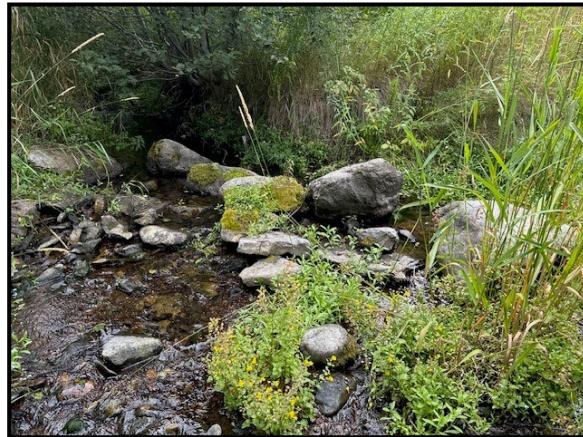
2024

Although the bed elevation has remained consistent in the vicinity of the armored head cut in Reach 3.4, the rock weir installed to prevent further incision is continuing to show signs of deterioration as noted in 2023. The channel has not continued to incise and the head cut has not migrated further upstream; therefore no immediate action is warranted. Continued deterioration of the stabilization treatment may result in future maintenance needs.

**Additional Photo 2:** Failed rock weir flanked by channel at upstream end of Reach 3.1.
