HWY 567/Pipe Creek Road Libby North Corridor Planning Study

December 2007

Montana Department of Transportation

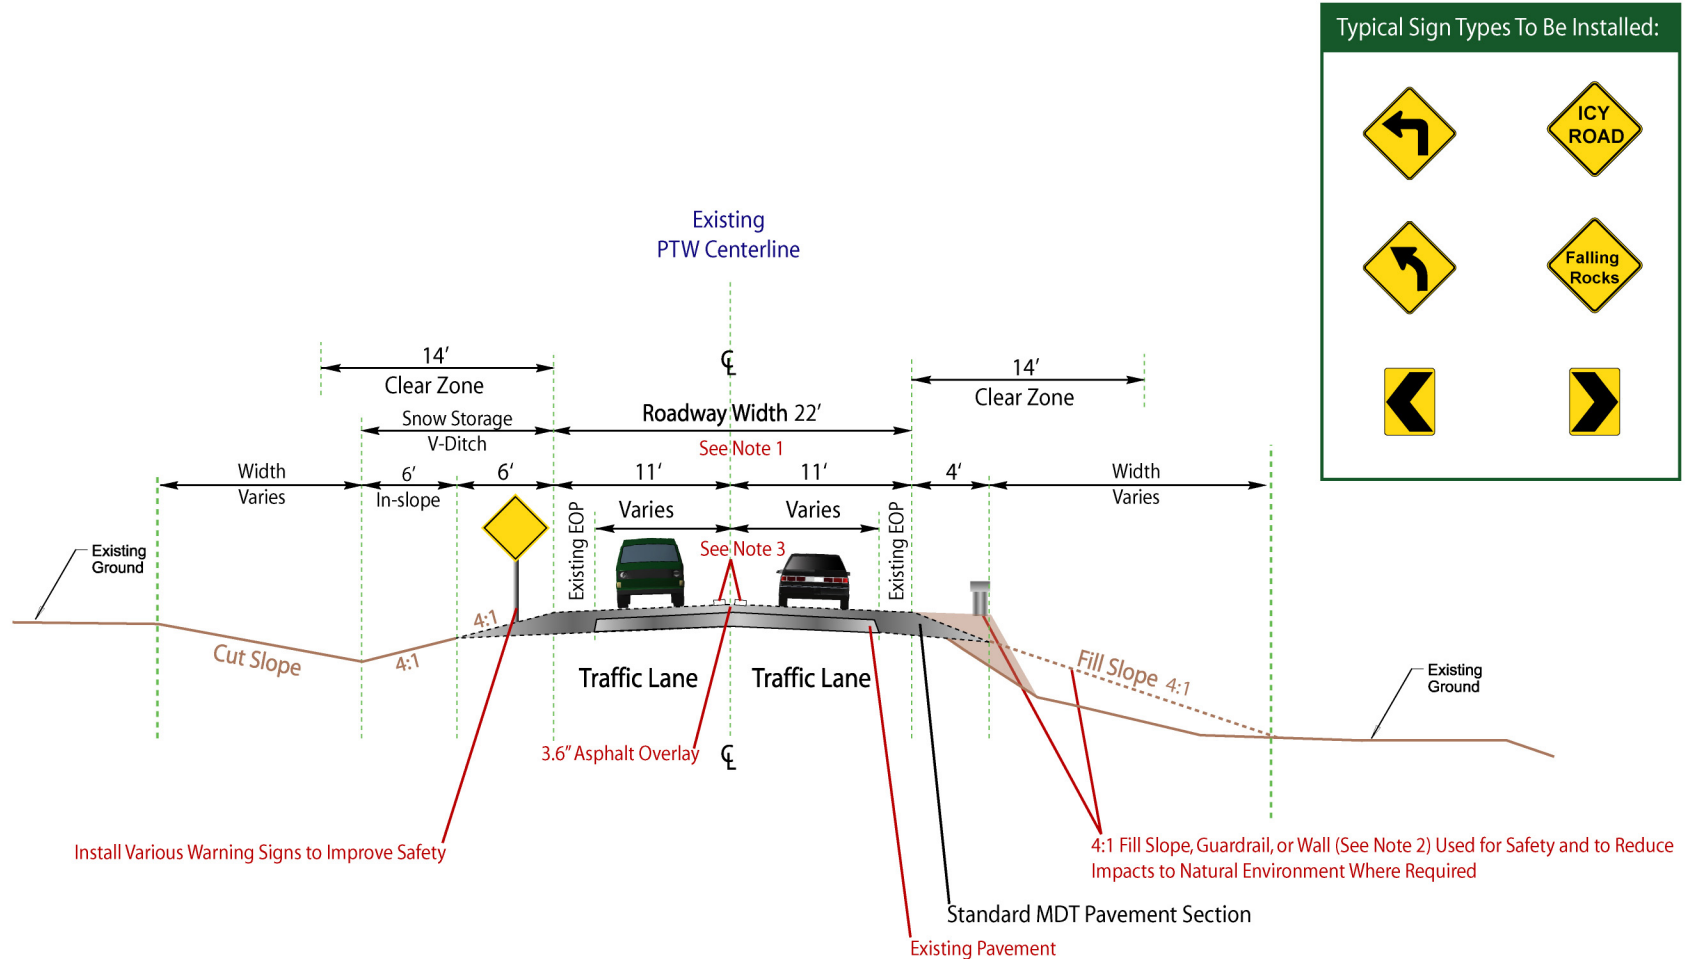
Figure 17
Improvement Option 6: Rehabilitation From RP 19 to RP 20.1 Typical Cross-Section

- Notes:
1. Design Option 2 is to use a 20' Roadway Width from RP 19 to RP 20.1 to Decrease Impacts.
 2. Use Guardrail with a Long Post to Reduce Deflection Distance Required Behind Guardrail.
 3. Use 6" Wide Paint Stripes to help reduce Speed.
 4. Use Design Speed of 25 MPH, Which is Appropriate for Existing Geometry to Reduce Impacts to Natural environment, with Appropriate Signing to Warn of Reduced Speed and Sharp Curvature.
