MT-1 WEST OF ANACONDA
TO GEORGETOWN LAKE

CORRIDOR PLANNING STUDY

FINAL

December 2011

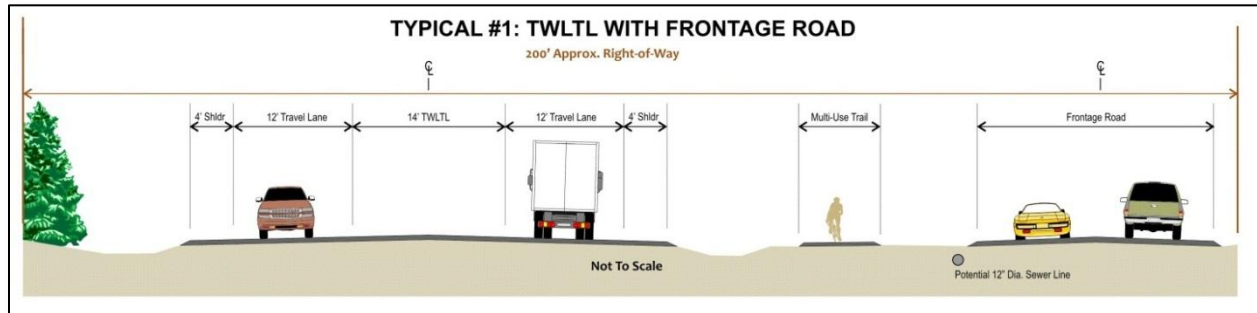
Figure 5.1: Typical Section #1 - TWLTL with Frontage Road

It is recommended that the roadway between RP 10.06 and RP 13.8 be modified to incorporate Typical Section #1 – Two-Way Left-Turn Lane (TWLTL) with Frontage Road as shown in **Figure 5.1**. This typical section will provide a center TWLTL to accommodate westbound and eastbound left turning traffic from MT-1. The development of a frontage road on the north side of MT-1 will allow the consolidation and/or closure of numerous private approaches. The typical section

can accommodate local infrastructure plans for wastewater facility extension and a multi-use trail. It is recommended that the multiuse trail be placed between the edge of MT-1 and the proposed frontage road. The potential also exists for adding right-turn lanes at appropriate major access points on the north side of MT-1. The need and location of right-turn lanes would be explored during project development activities. Pedestrian signage should be incorporated into future project implementation as appropriate.

After the development of the TWLTL, it is recommended that the speed limit in the 35 mph posted speed limit area be increased to 45 mph with appropriate transitions. The speed limit can only be raised to 45 mph by petition of the ADLC Commissioners to the Montana Transportation Commission. Representatives of ADLC state that raising the speed limit in this segment will be supported if future improvements are implemented along the roadway as described under this improvement option.
