# EXISTING AND PROJECTED CONDITIONS REPORT

**July 2012**

## MT 16 / MT 200 Glendive to Fairview Corridor Planning Study

### Existing and Projected Conditions Report

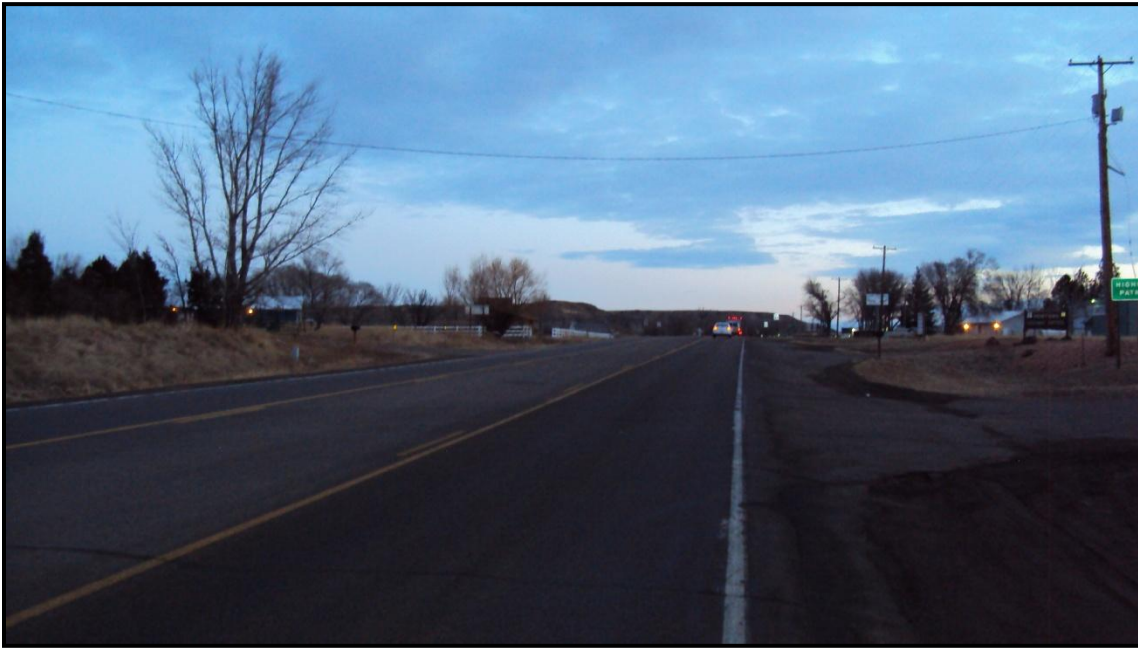
**Photo 1.** Looking north on MT 16 at a two-way left-turn lane north of Glendive. RP 0.7.

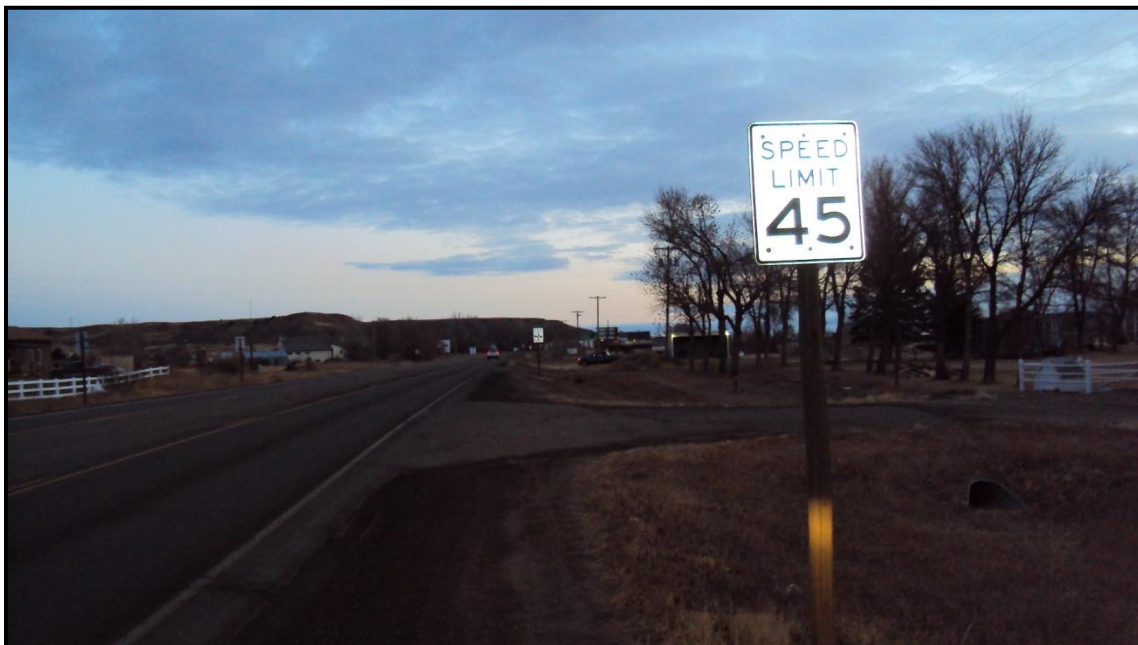
**Photo 2.** Looking north on MT 16 at 45 mile per hour (mph) sign north of Glendive. RP 0.7.

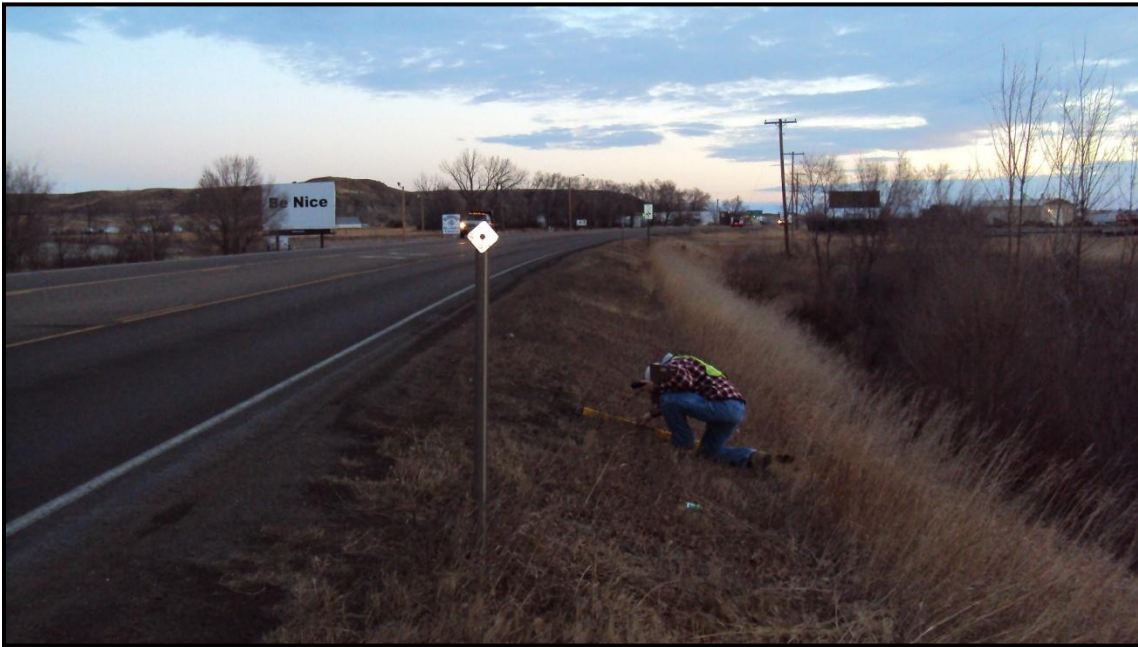
**Photo 3.** Looking north on MT 16. East side slope transitions from 3:1 to 2:1 approximately 13 feet from northbound travel lane. RP 1.1.

- East side slope transitions from 3:1 to 2:1 approximately 13 feet from northbound travel lane at RP 1.1. Photo 3.
- West side slope transitions from 4:1 to 2:1 approximately 20 feet from southbound travel lane at RP 1.8. Photo 7.

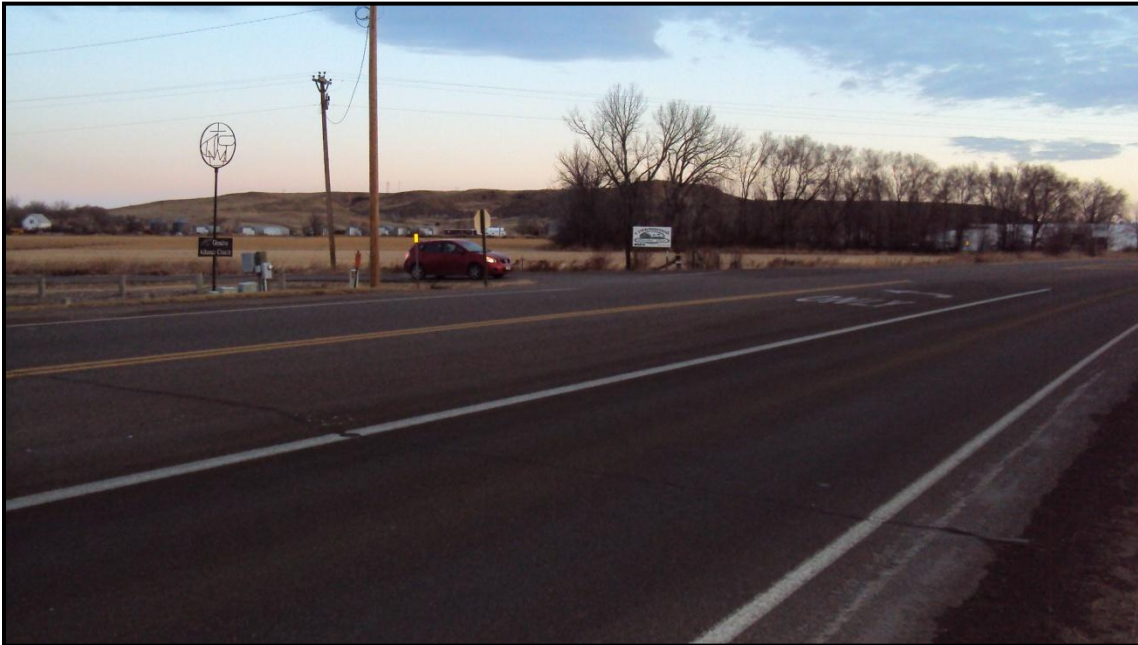
**Photo 4.** Looking northwest at intersection of Highland Park Road and MT 16 northbound left-turn lane. RP 1.2.

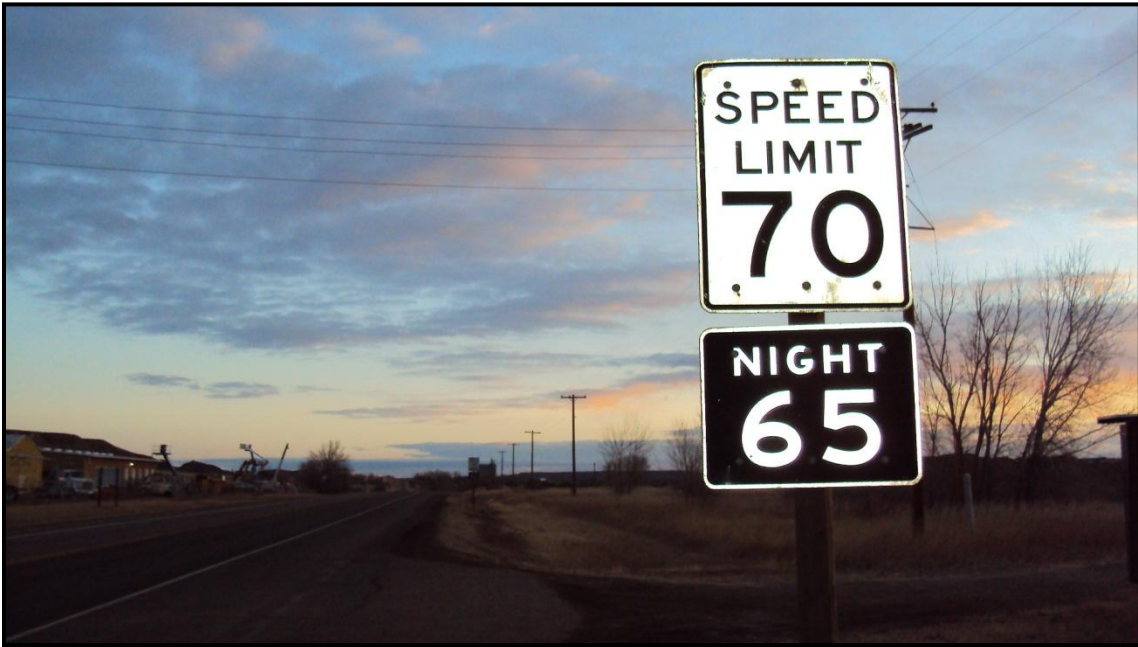
**Photo 5.** Looking north on MT 16 at the beginning of a 70 mph zone. RP 1.3.

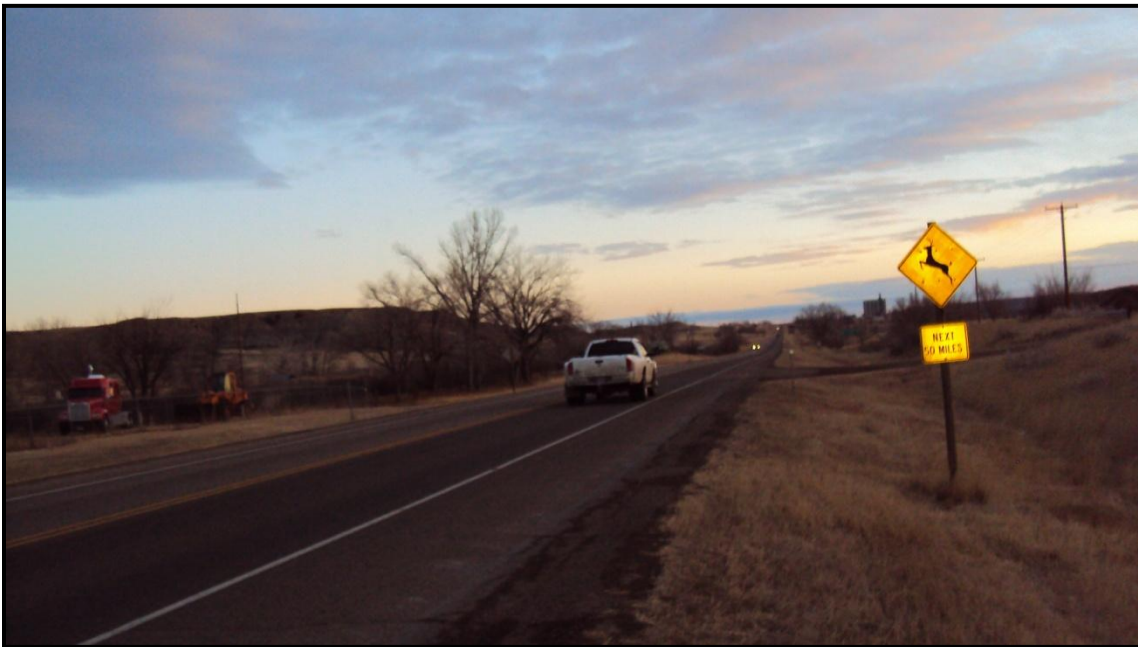
**Photo 6.** Looking north on MT 16 at deer crossing sign. RP 1.4.

- Deer carcass observed at RP 1.0.
- Wildlife crossing sign at RP 1.4. Photo 6.
- Box culvert/wildlife undercrossing at RP 2.4. Photo 8.
- Wildlife crossing sign at RP 10.9. Photo 22.
- Owl carcass observed at RP 12.9.
- Deer carcass observed at RP 14.4.
- Bird carcasses observed at RP 17.4.
- Wildlife crossing sign at RP 20.9.
- Deer carcass observed at RP 21.7.
- Wildlife crossing sign at RP 30.9.

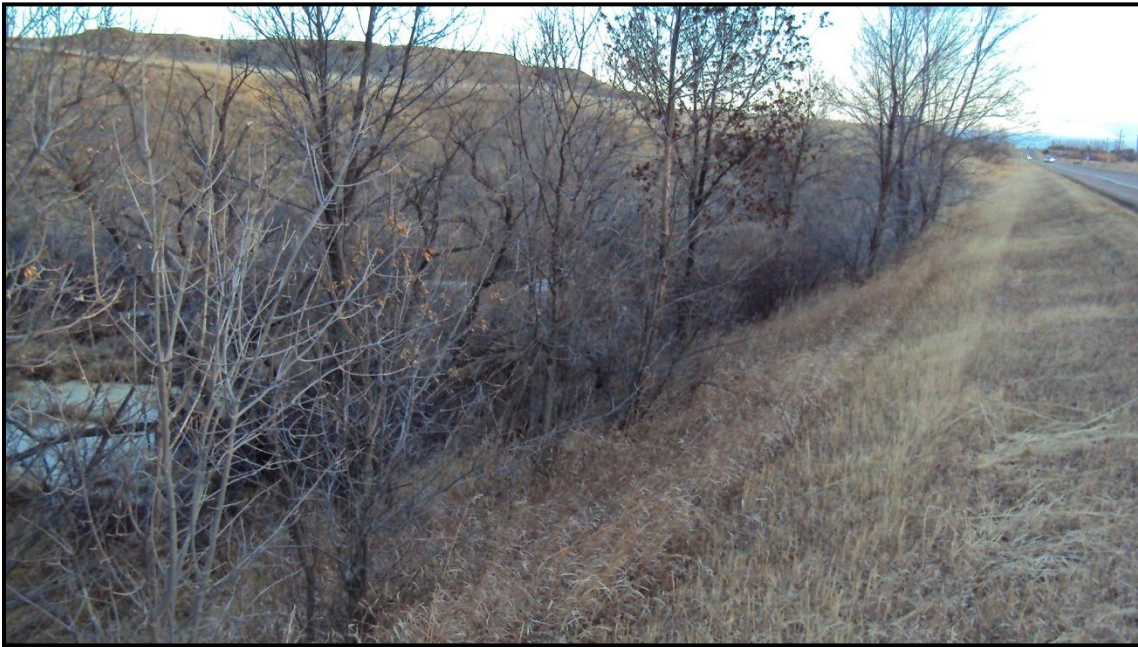
**Photo 7.** Looking north on the west side slope of MT 16. West side slope transitions from 4:1 to 2:1 approximately 20 feet from southbound travel lane. Areas exhibiting wetland characteristics observed west of MT 16. RP 1.7.

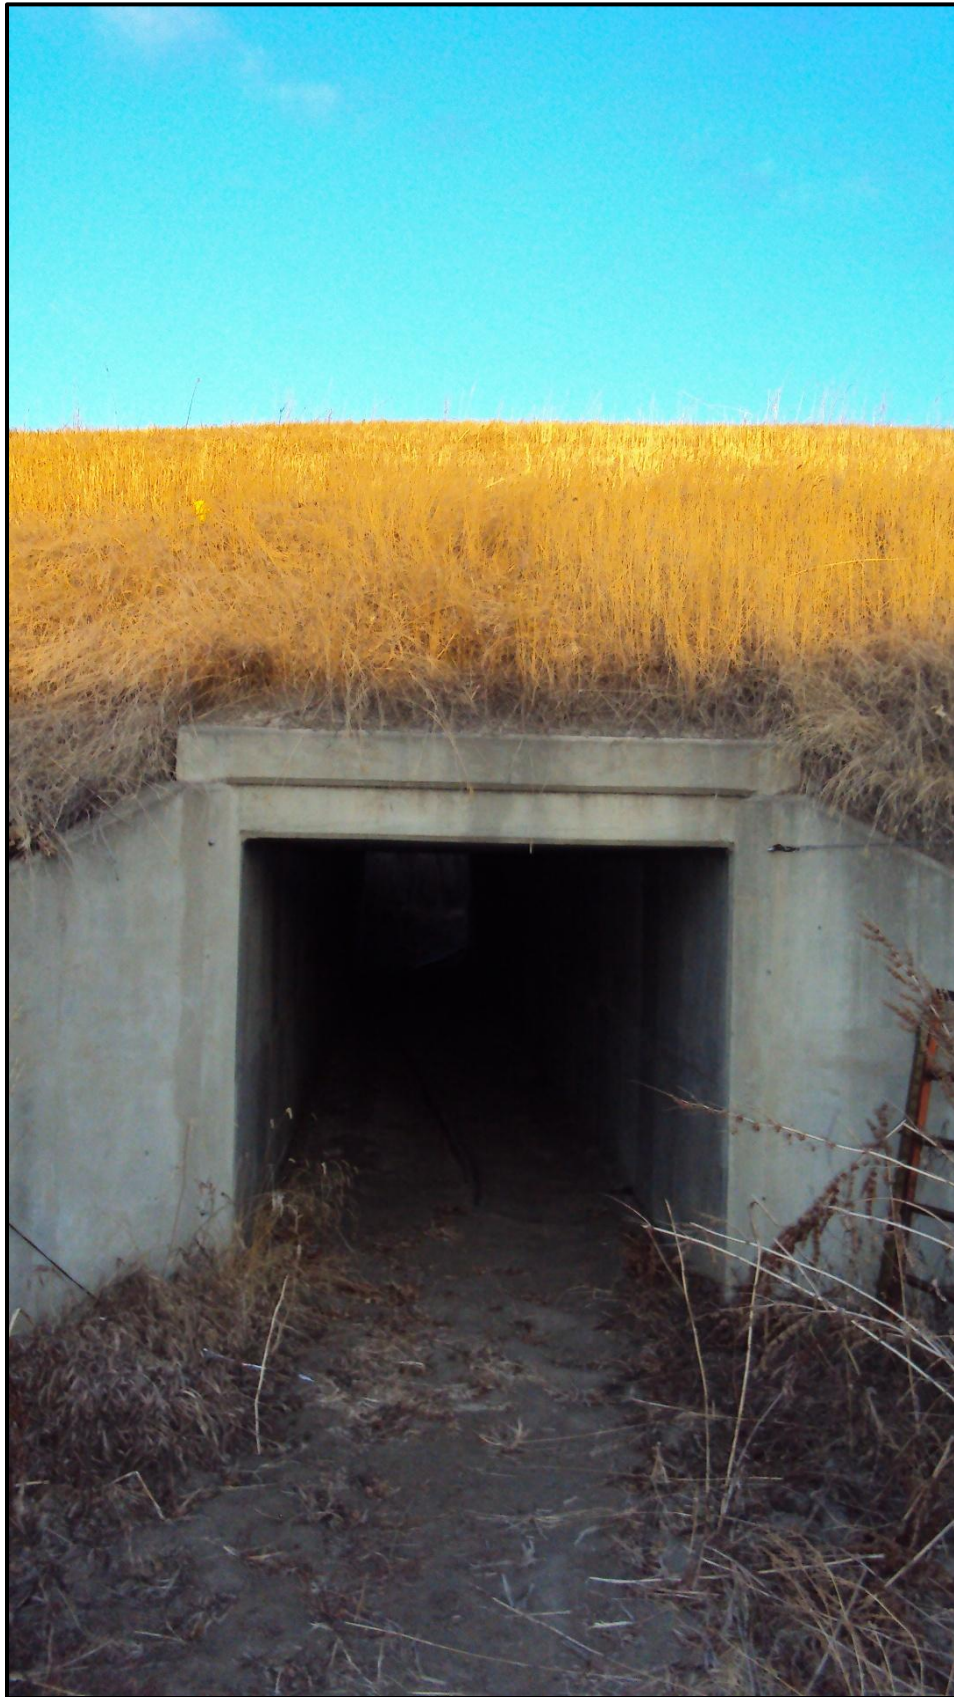
**Photo 8.** Looking west at a box culvert/wildlife underpass under MT 16. East side slope transitions from 4:1 to 2:1 approximately 18 feet from northbound travel lane. RP 2.4.

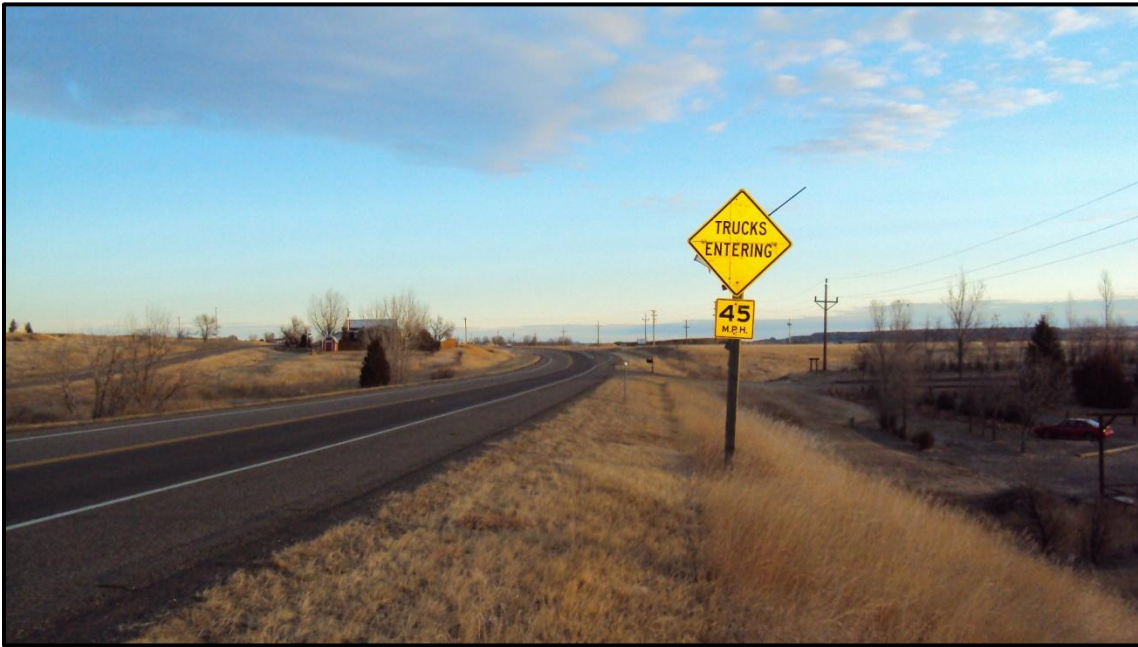
**Photo 9.** Looking north on MT 16 at trucks entering 45 mph advisory sign. East side slope transitions from 5:1 to 2:1 approximately 18 feet from northbound travel lane. RP 2.8.

- East side slope transitions from 4:1 to 2:1 approximately 18 feet from northbound travel lane at RP 2.4. Photo 8.
- East side slope transitions from 5:1 to 2:1 approximately 18 feet from northbound travel lane at RP 3.0. Photo 9.

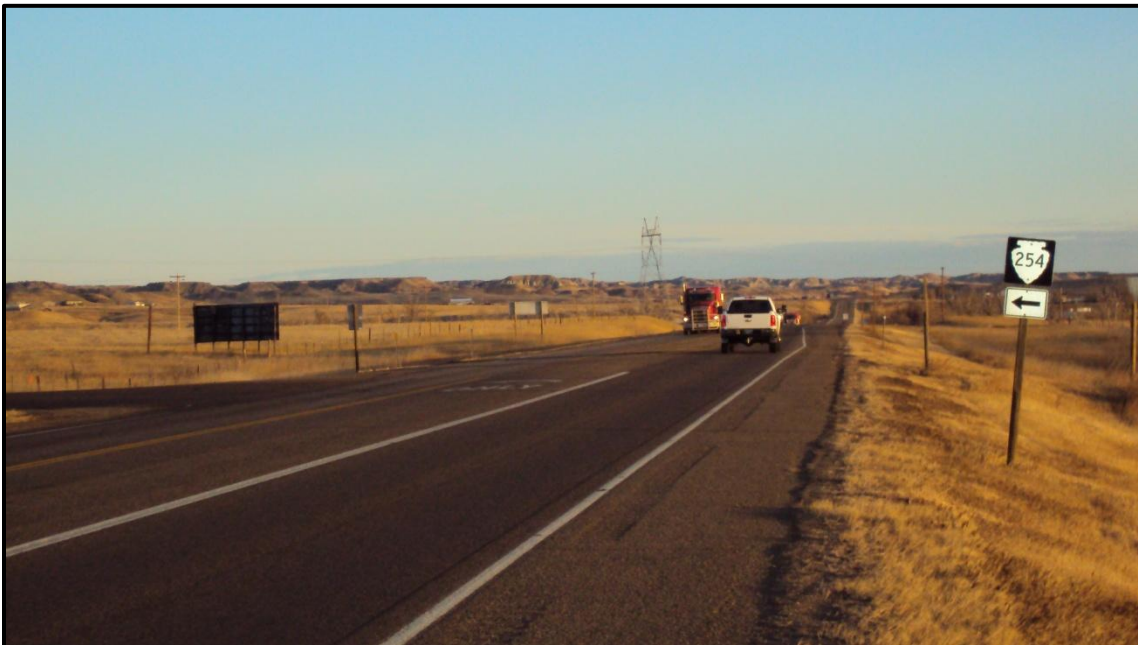
**Photo 12.** Looking north on MT 16 at intersection of MT 16 and County Road 254 northbound left-turn lane. RP 3.7.

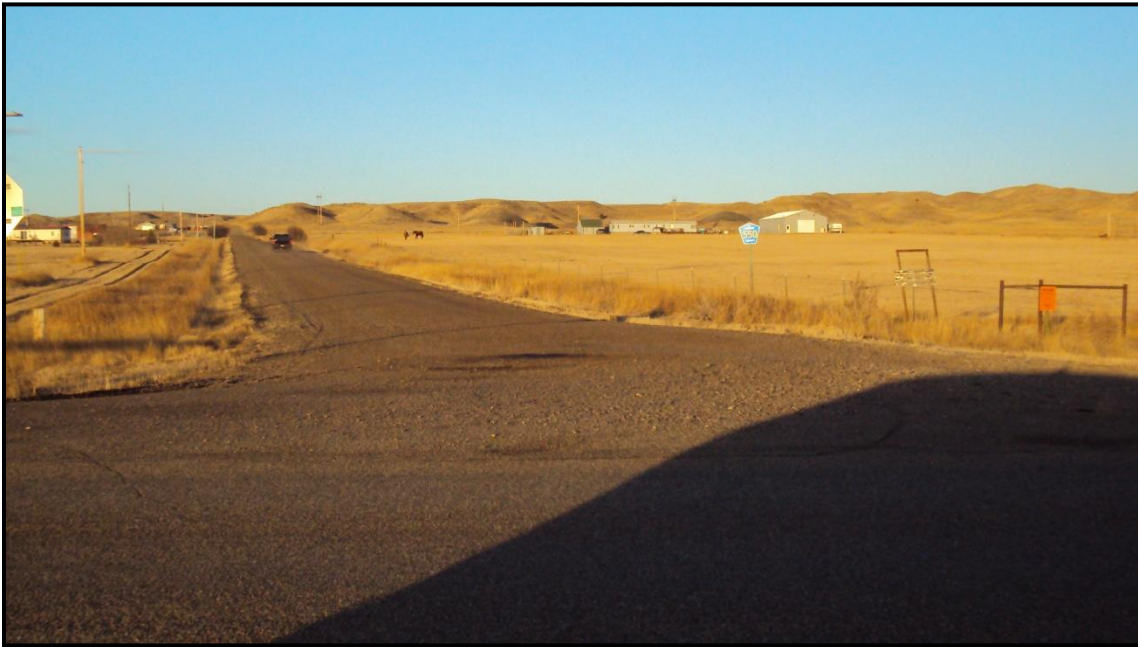
**Photo 14.** Looking west at the intersection of MT 16 and County Road 550. County Road 550 is unpaved. RP 5.6.

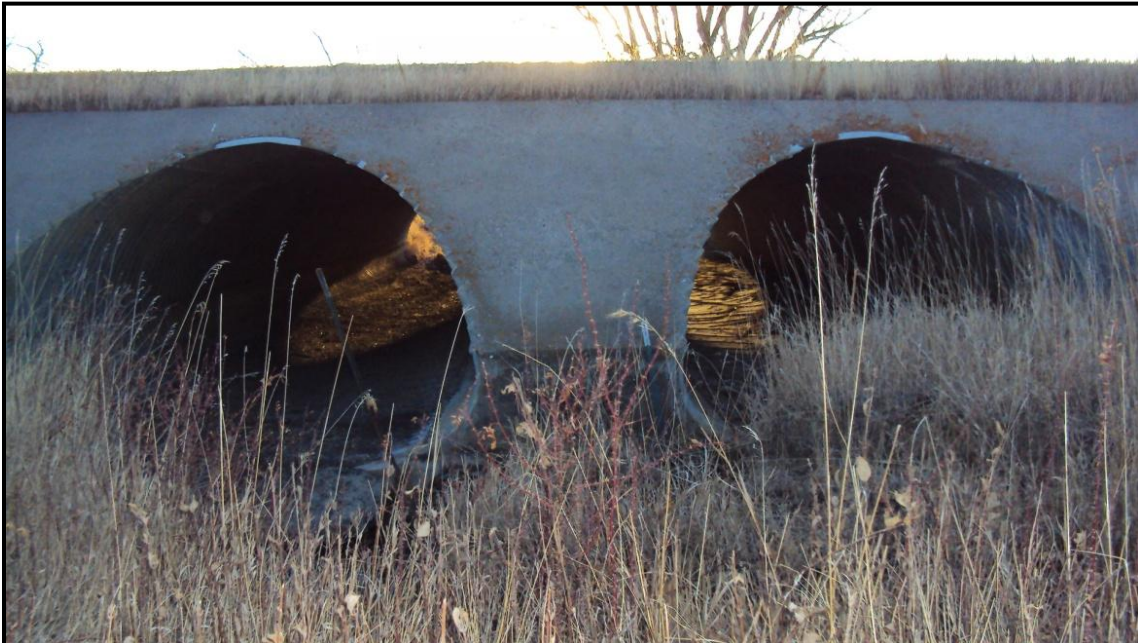
**Photo 15.** Looking east at 96-inch double arch culverts under MT 16. West side slope was measured at 4:1 to approximately 21 feet from northbound travel lane. RP 7.0.

- 96-inch double arch culverts under MT 16 at RP 7.0. Photo 15.
- Lower Seven Mile Creek at RP 10.1. Photos 20 and 21.
- Morgan Creek at RP 12.5. Photos 25 and 26.
- Thirteen Mile Creek at RP 15.5. Photo 32.

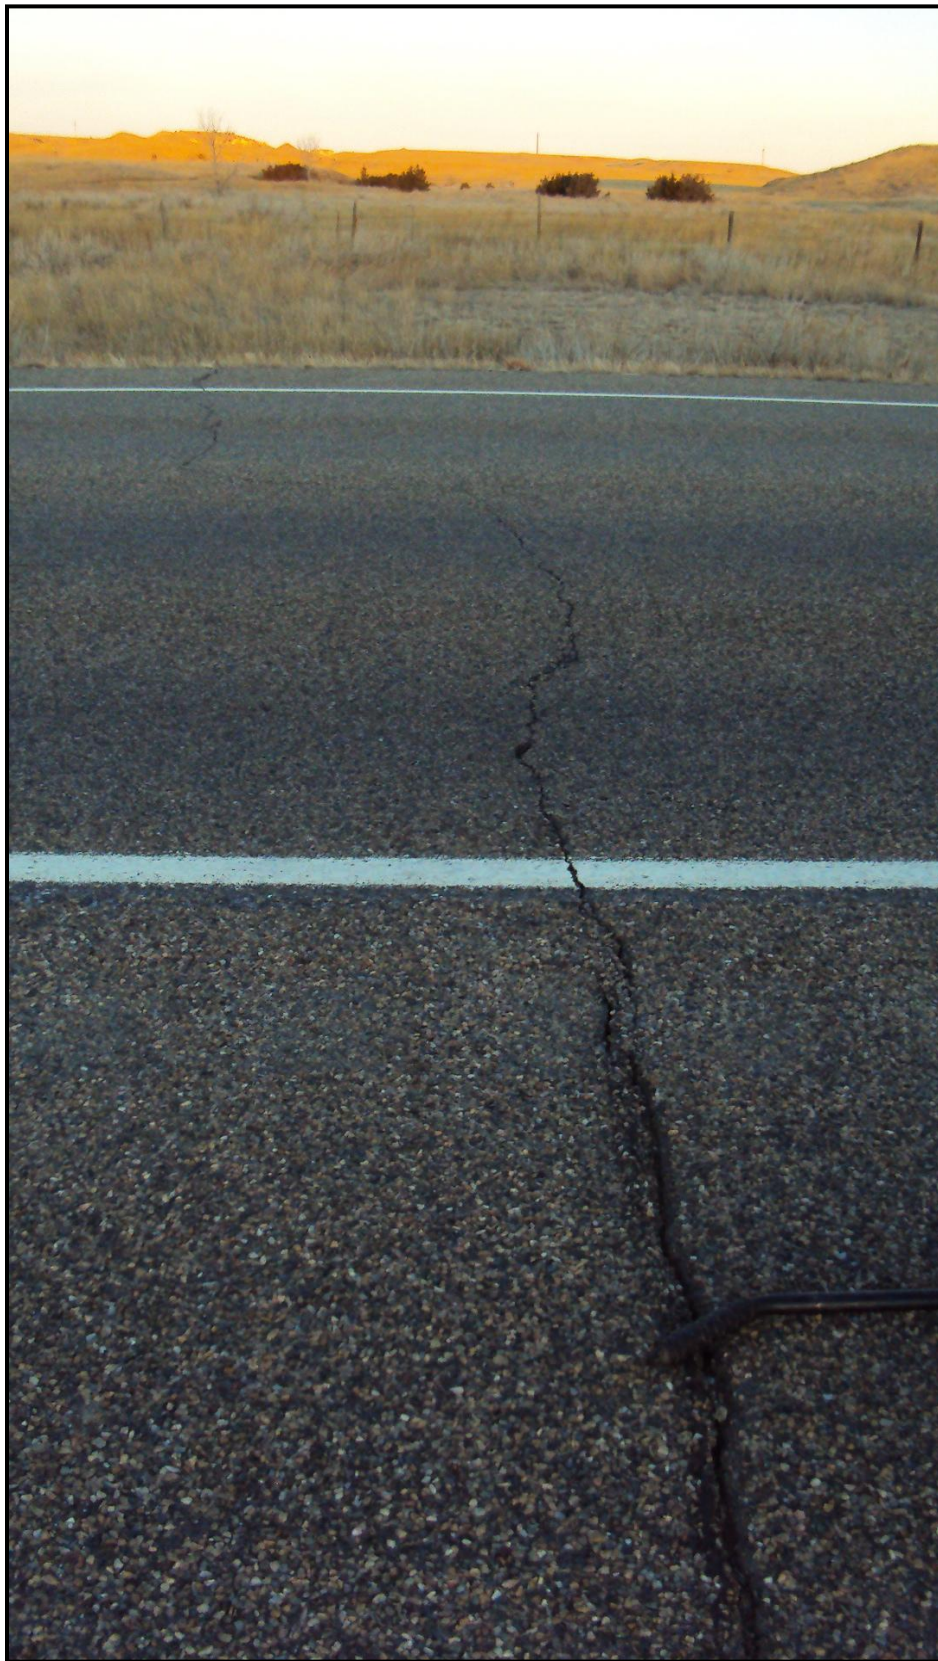
**Photo 16.** Looking across MT 16 at transverse pavement cracking. Pavement cracking within the travel way measured approximately 0.125 inches, approximately every 50 feet. Pavement rutting measured at approximately 0.5 centimeters. RP 8.3.

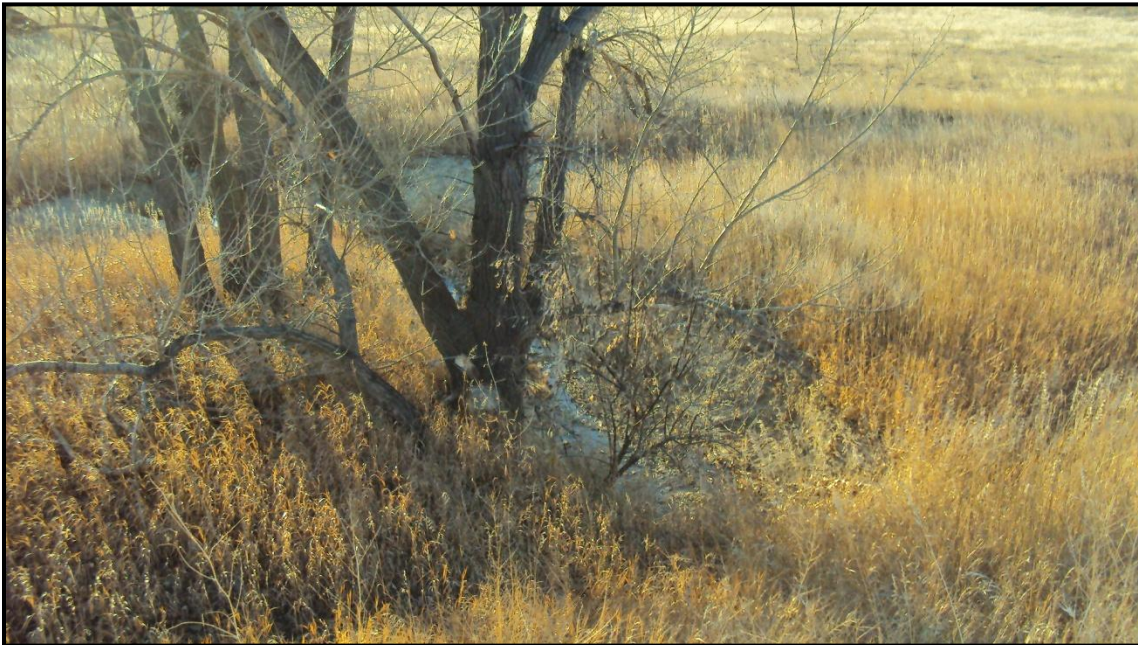
**Photo 17.** Looking at areas exhibiting wetland characteristics observed east of MT 16. East side slope transitions from 4:1 to 2:1 approximately 18 feet from northbound travel lane. RP 8.4.

- West of MT 16 at RP 1.7. Photo 7.
- East of MT 16 at RP 8.4. Photo 17.
- East of MT 16 at RP 29.2. Photo 47.

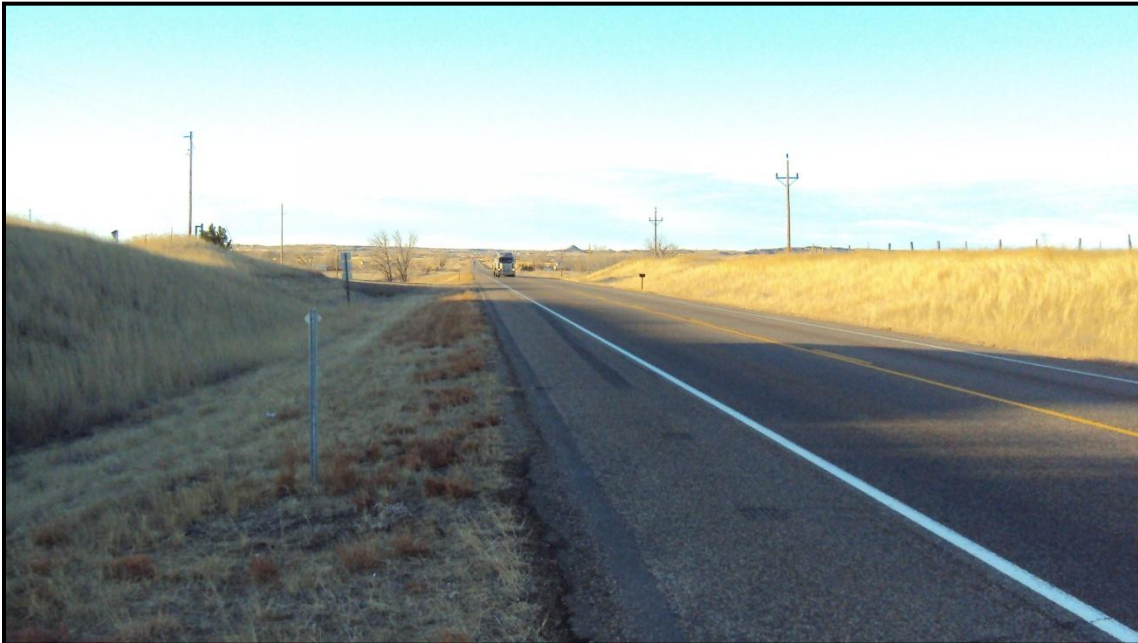
**Photo 18.** Looking south on MT 16 at tire skid marks. RP 8.7.

- RP 8.7. Photo 18.

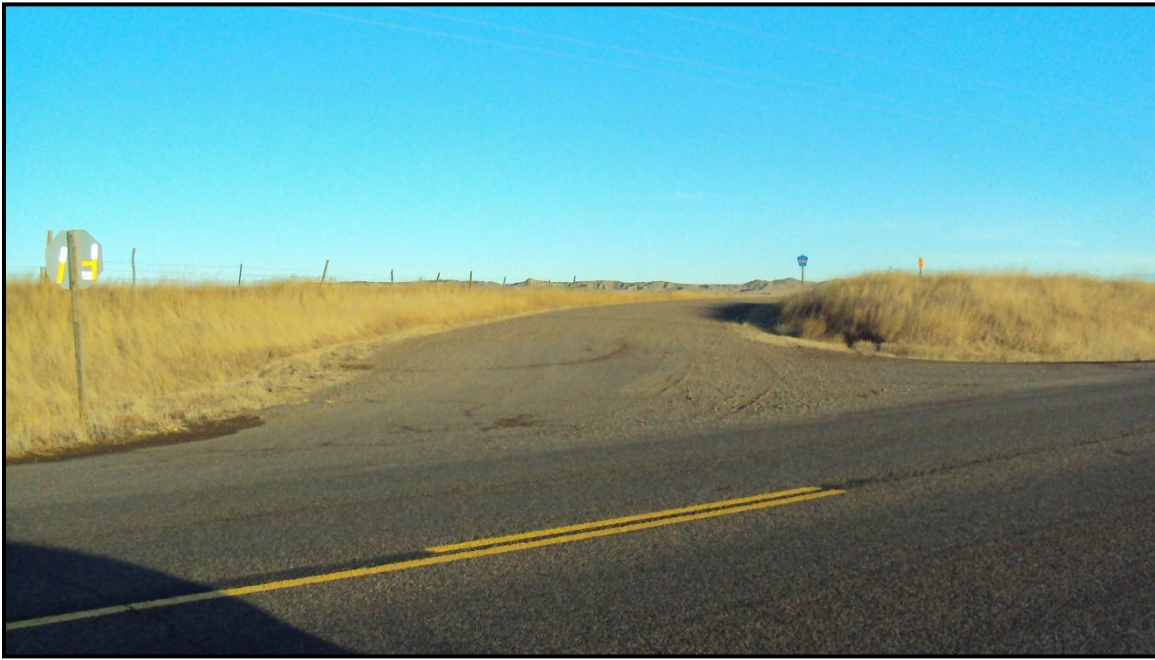
**Photo 19.** Looking west at intersection of MT 16 and County Road 544. County Road 544 is unpaved. RP 8.7.

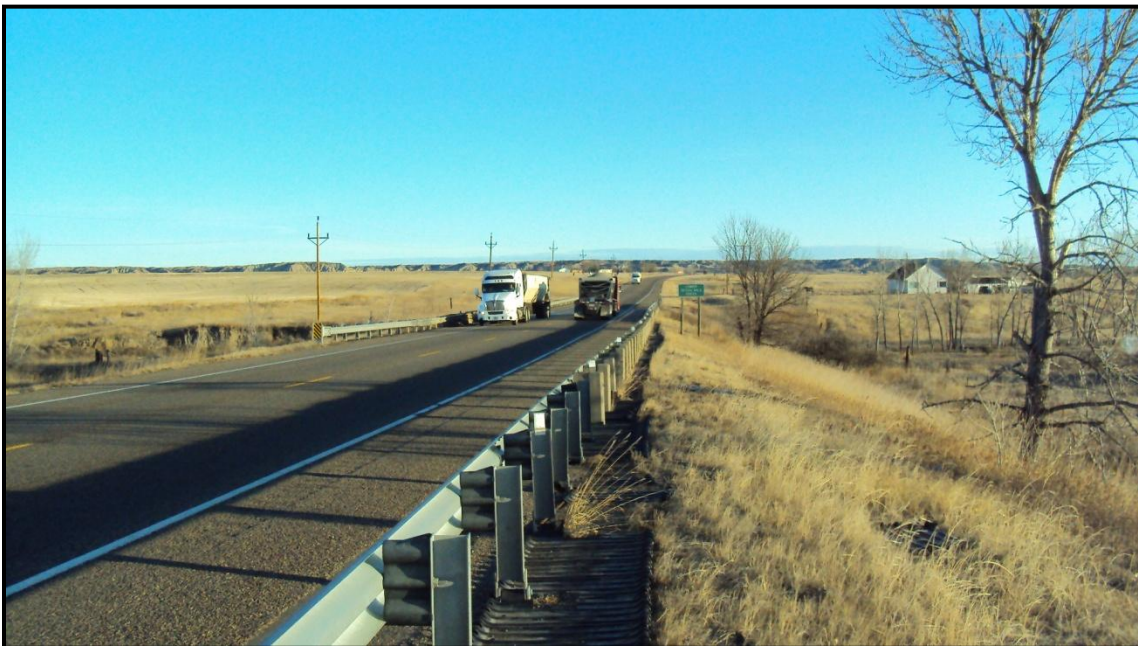
**Photo 20.** Looking south on MT 16 at Lower Seven Mile Creek. East side slope transitions from 4:1 to 2:1 approximately 15 feet from the northbound travel lane. RP 10.1.

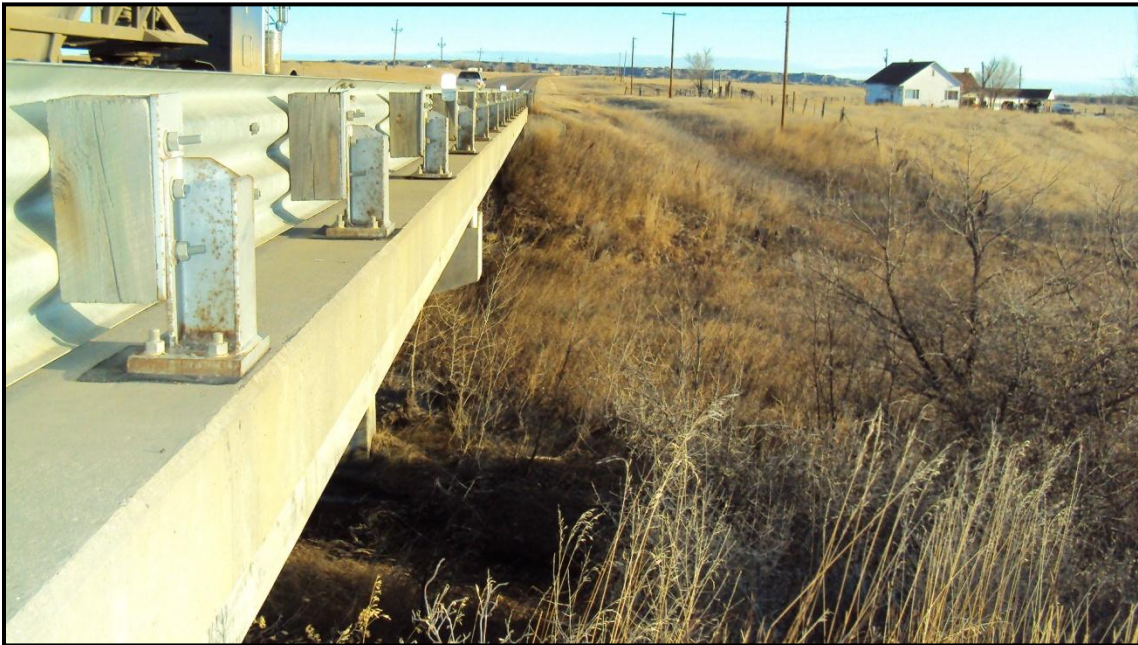
**Photo 21.** Looking north on MT 16 at Lower Seven Mile Creek bridge undercrossing. RP 10.1.

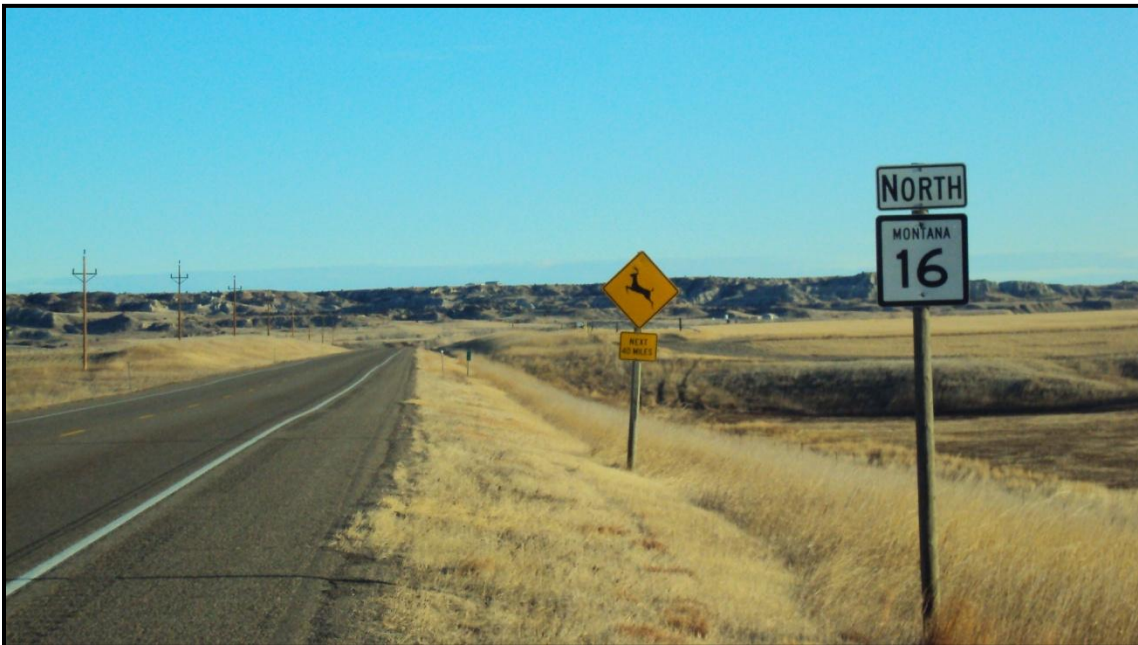
**Photo 22.** Looking north on MT 16 at deer crossing sign. RP 10.9.

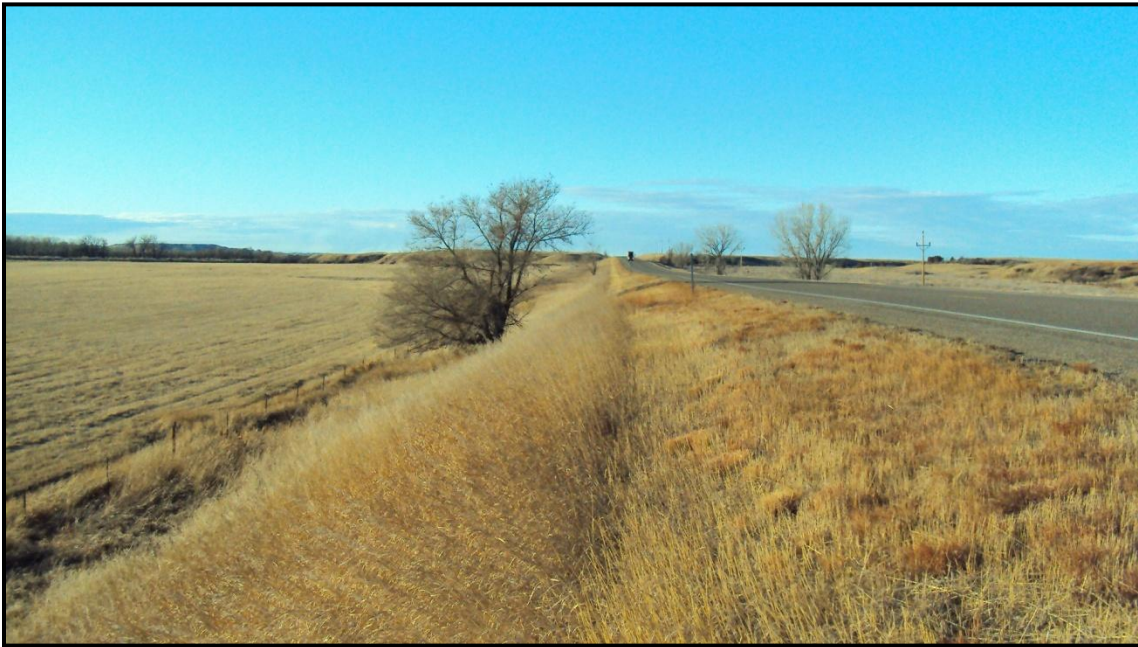
**Photo 23.** Looking south on MT 16. West side slope transitions from 4:1 to 2:1 approximately 17 feet from southbound travel lane. RP 12.0.

- West side slope transitions from 4:1 to 2:1 approximately 17 feet from southbound travel lane at RP 11.8. Photo 23.
- East side slope transitions from 4:1 to 2:1 approximately 17 feet from northbound travel lane at RP 11.8. Photo 24.

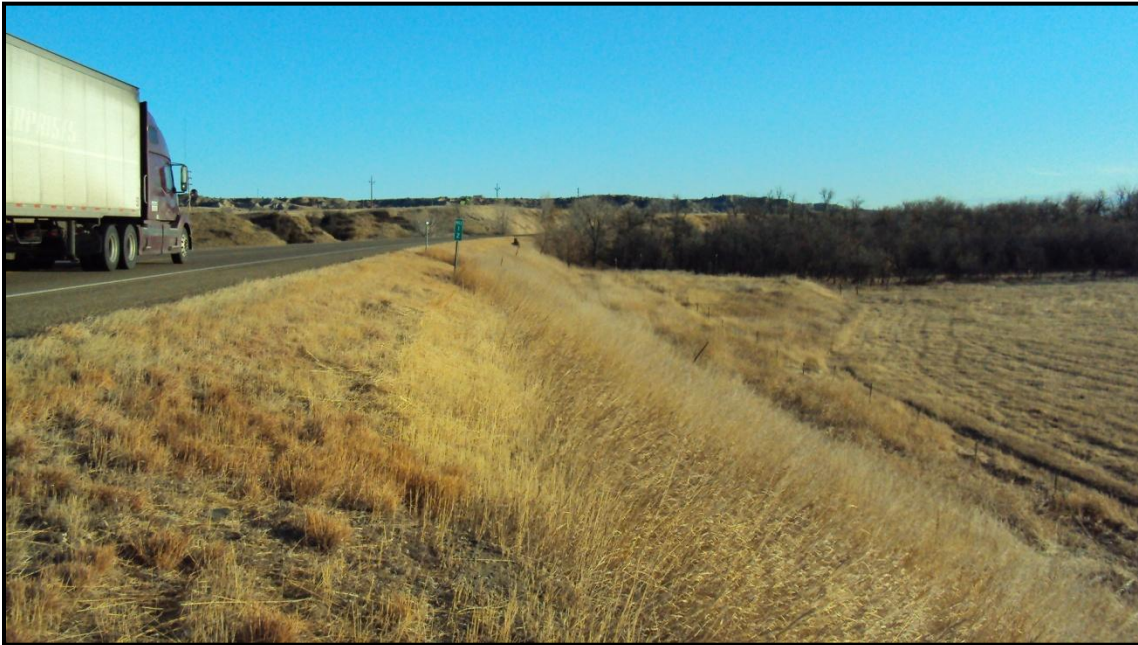
**Photo 24.** Looking north on MT 16. East side slope transitions from 4:1 to 2:1 approximately 17 feet from northbound travel lane. RP 12.0.

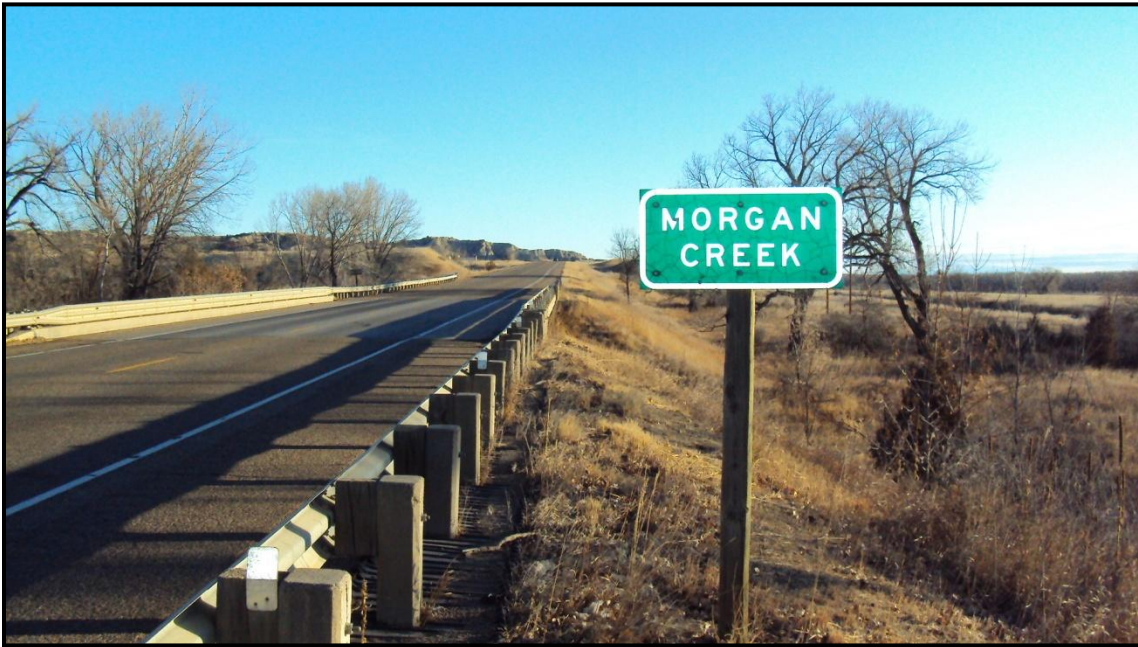
**Photo 25.** Looking north on MT 16 at Morgan Creek. RP 12.5.

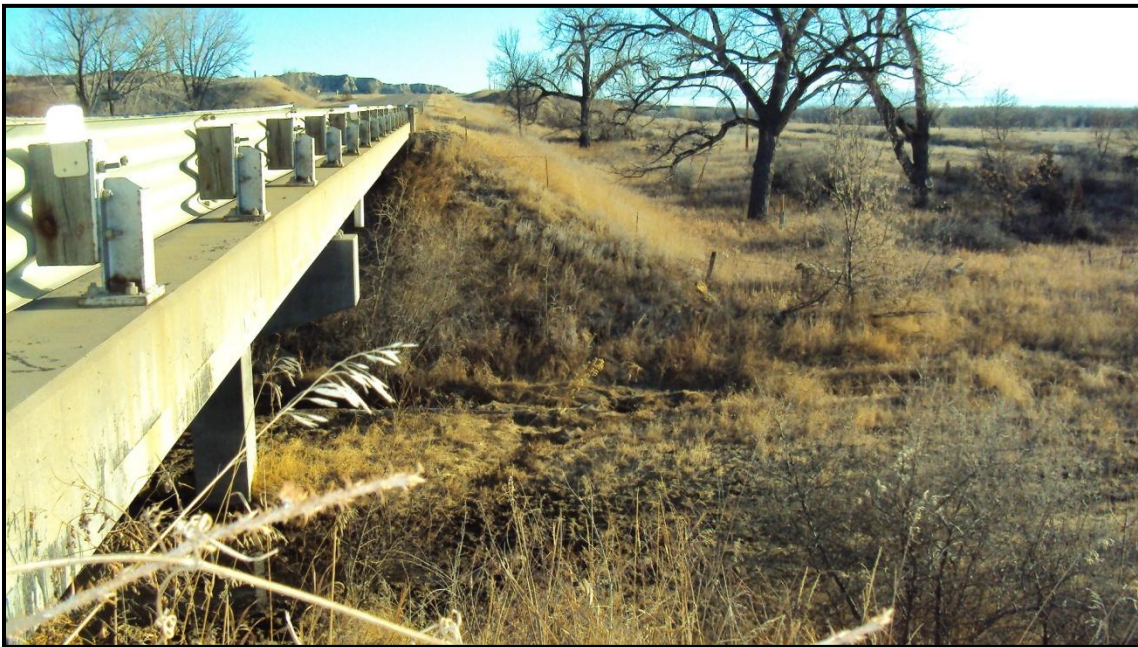
**Photo 26.** Looking north on MT 16 at Morgan Creek bridge undercrossing. RP 12.5.

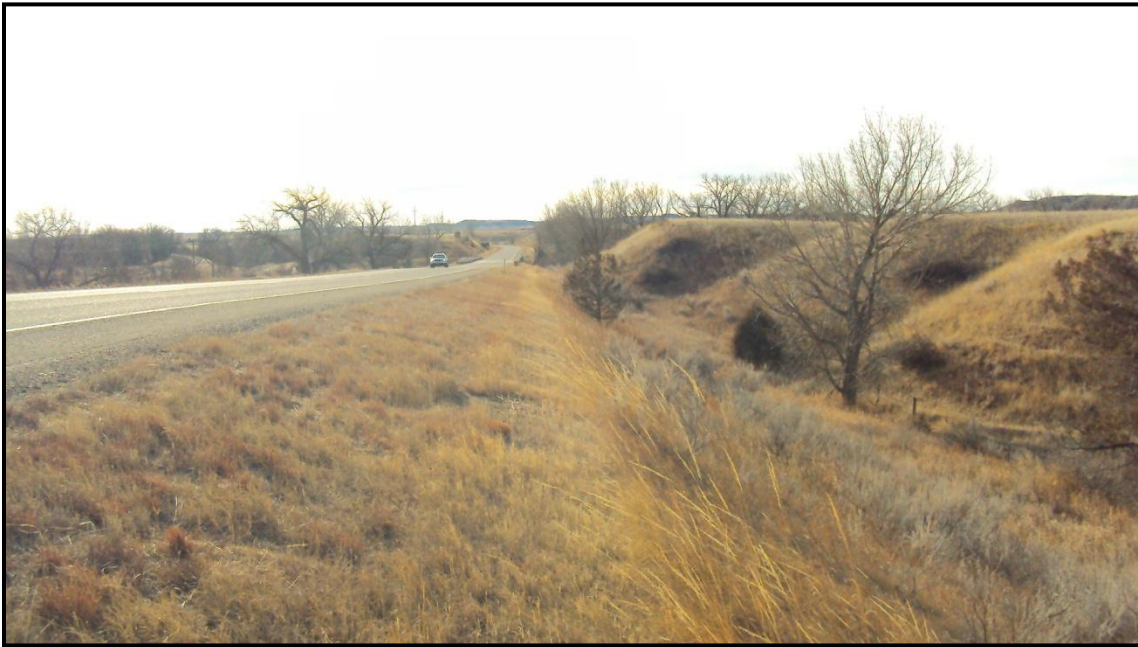
**Photo 27.** Looking north on MT 16. East side slope transitions from 4:1 to 2:1 approximately 20 feet from northbound travel lane. RP 12.7.

- East side slope transitions from 4:1 to 2:1 approximately 20 feet from northbound travel lane at RP 12.7. Photo 27.
- West side slope transitions from 4:1 to 1.5:1 23 feet from southbound travel lane RP 14.2.

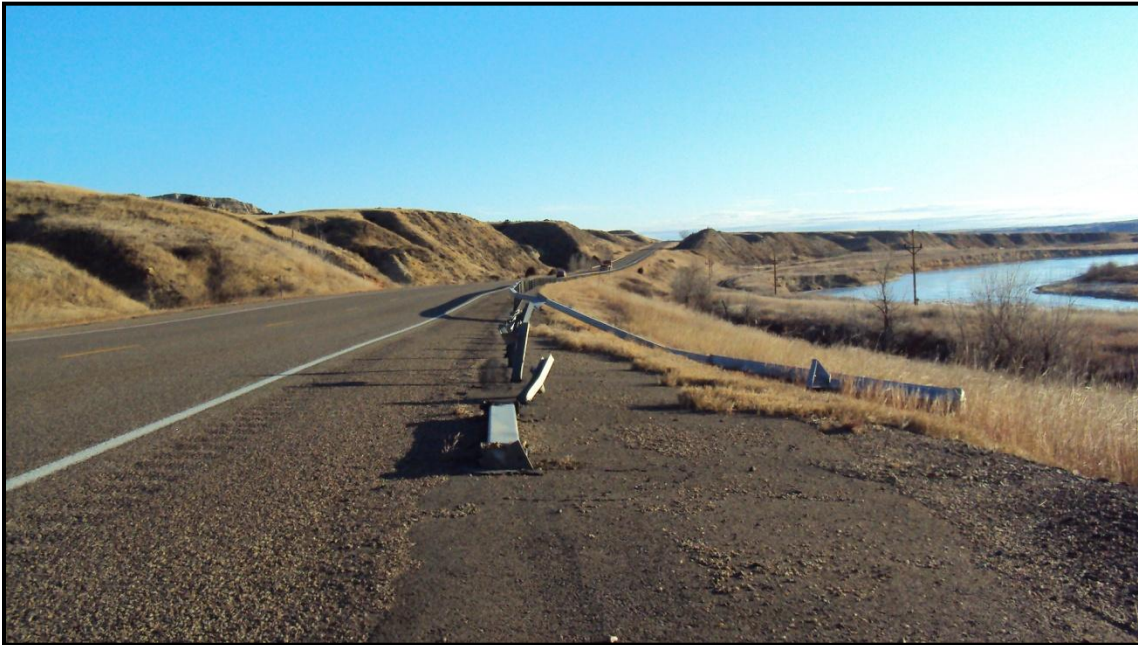
**Photo 28.** Looking north on MT 16 at damaged guardrail. East side slope transitions from 4:1 to 5:1 approximately 23 feet from northbound travel lane. RP 13.6.

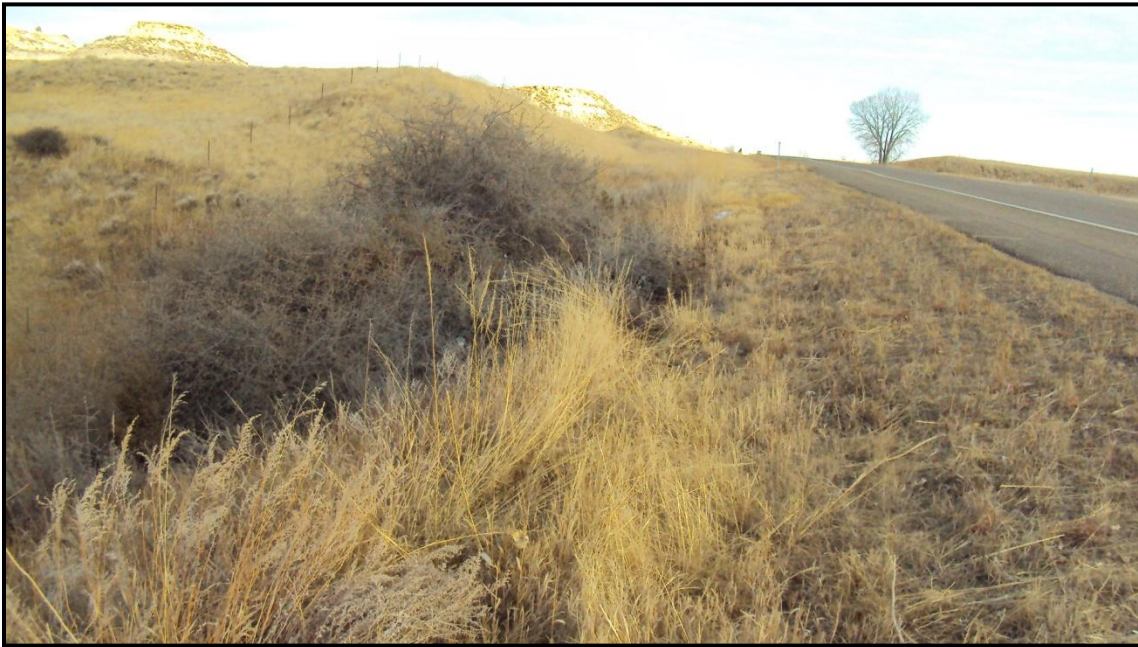
**Photo 30.** Looking south on MT 16. West side slope transitions from 4:1 to 2:1 approximately 20 feet from northbound travel lane. RP 14.4.

- West side slope transitions from 4:1 to 2:1 approximately 20 feet from southbound travel lane at RP 14.2. Photo 30.

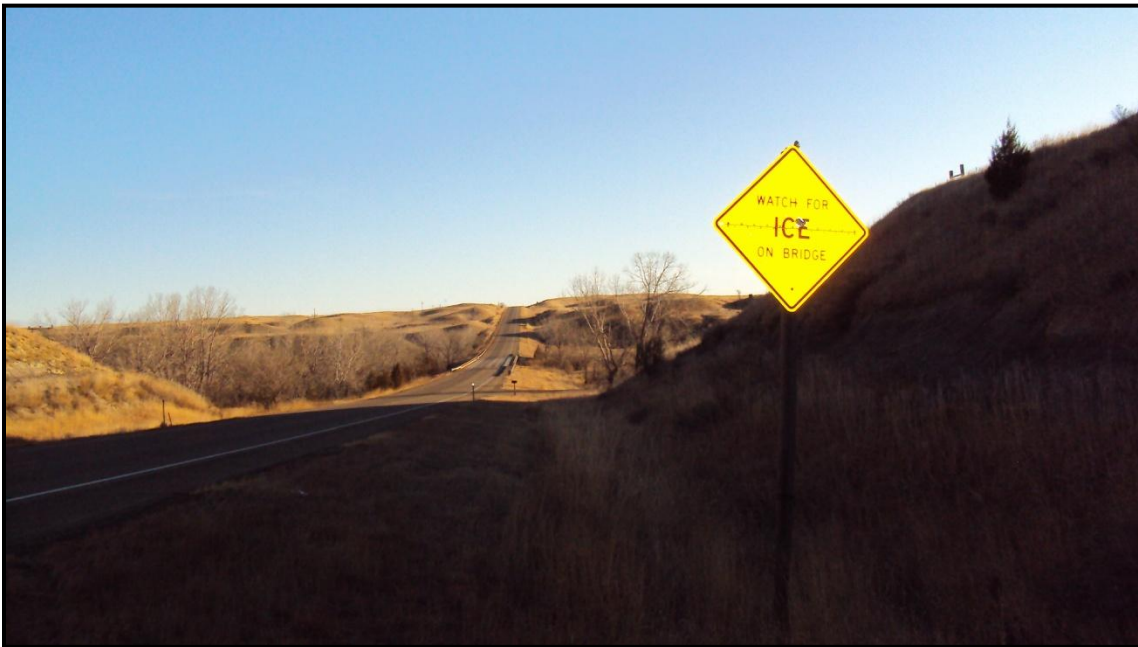
**Photo 31.** Looking south on MT 16 at watch for ice on bridge sign. RP 14.7.
