# EXISTING AND PROJECTED CONDITIONS REPORT

**July 2012**

## MT 16 / MT 200 Glendive to Fairview Corridor Planning Study

### Existing and Projected Conditions Report

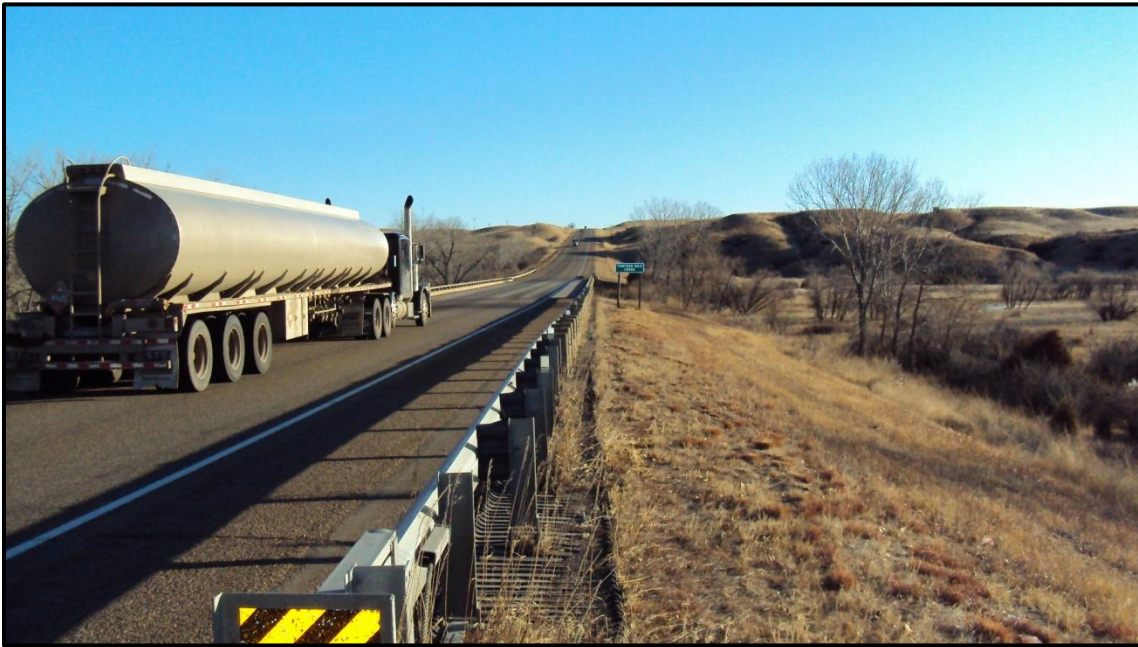
**Photo 32.** Looking north on MT 16 at Thirteen Mile Creek. RP 15.5.

- 96-inch double arch culverts under MT 16 at RP 7.0. Photo 15.
- Lower Seven Mile Creek at RP 10.1. Photos 20 and 21.
- Morgan Creek at RP 12.5. Photos 25 and 26.
- Thirteen Mile Creek at RP 15.5. Photo 32.

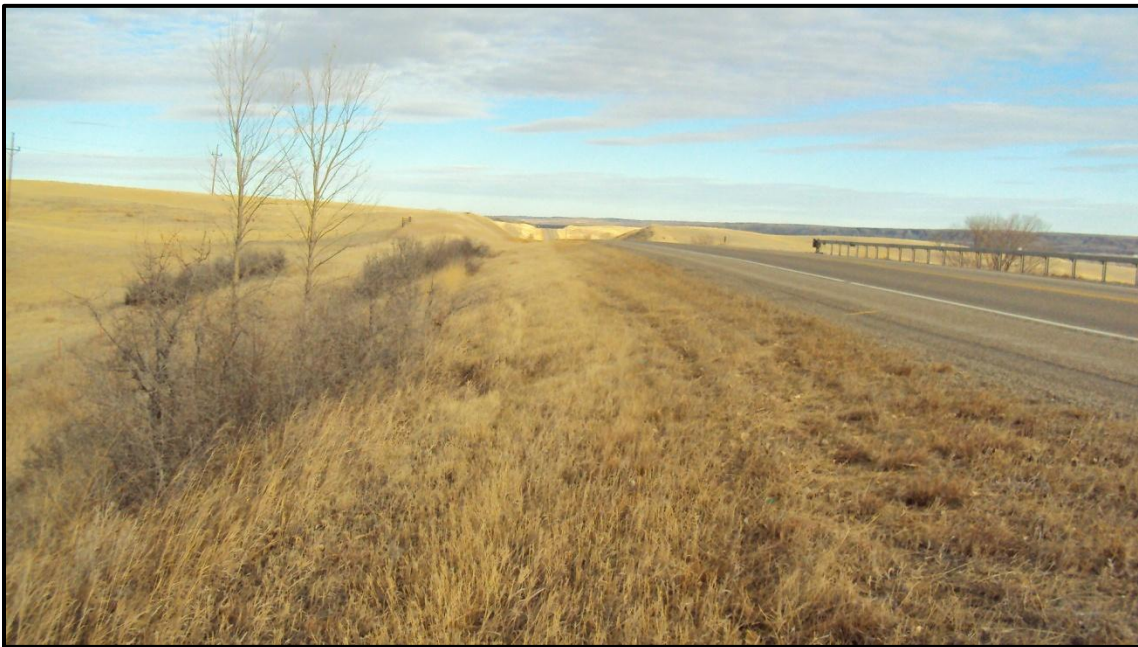
**Photo 33.** Looking north on MT 16. West side slope transitions from 5:1 to 3:1 approximately 17 feet from southbound travel lane. RP 16.4.

- West side slope transitions from 5:1 to 3:1 approximately 17 feet from southbound travel lane at RP 16.3. Photo 33.
- East side slope transitions from 4:1 to 2:1 approximately 20 feet from northbound travel lane at RP 17.4.
- Reconstructed pavement section ends at RP 24.7. Photo 43.
- Unvegetated side slopes at RP 27.5. Photo 45.
- East side slope transitions from 5:1 to 3:1 approximately 28 feet from northbound travel lane at RP 29.7.
- West side slope transitions from 5:1 to 3:1 approximately 28 feet from southbound travel lane at RP 29.7.

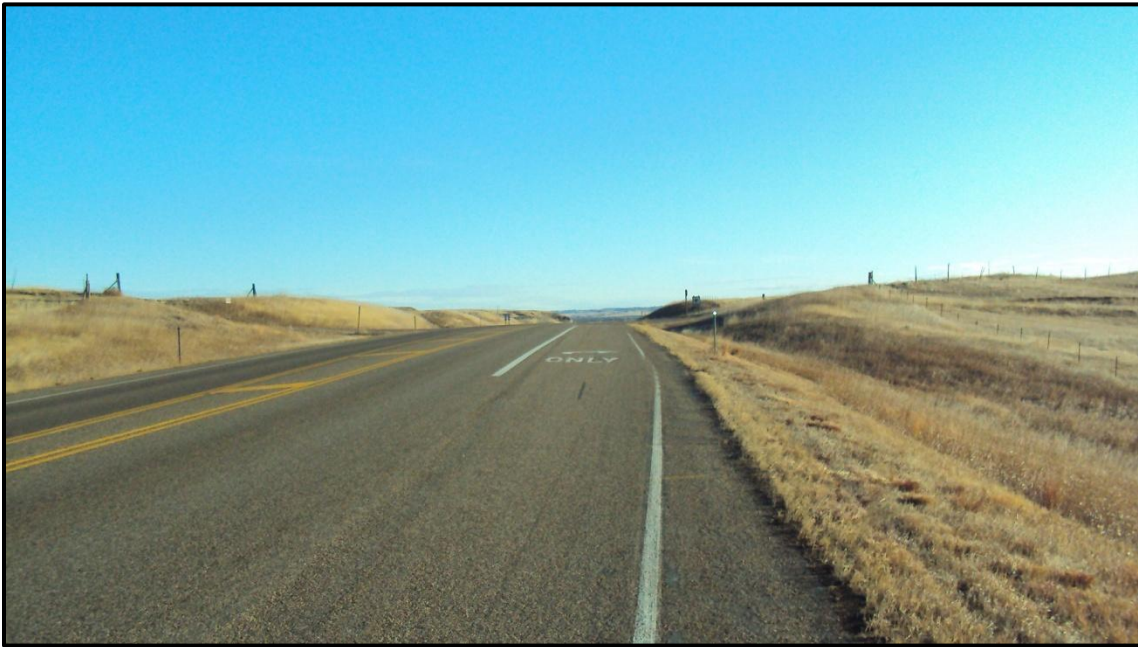
**Photo 34.** Looking north on MT 16 at northbound right-turn lane at Intake fishing access. RP 17.1.

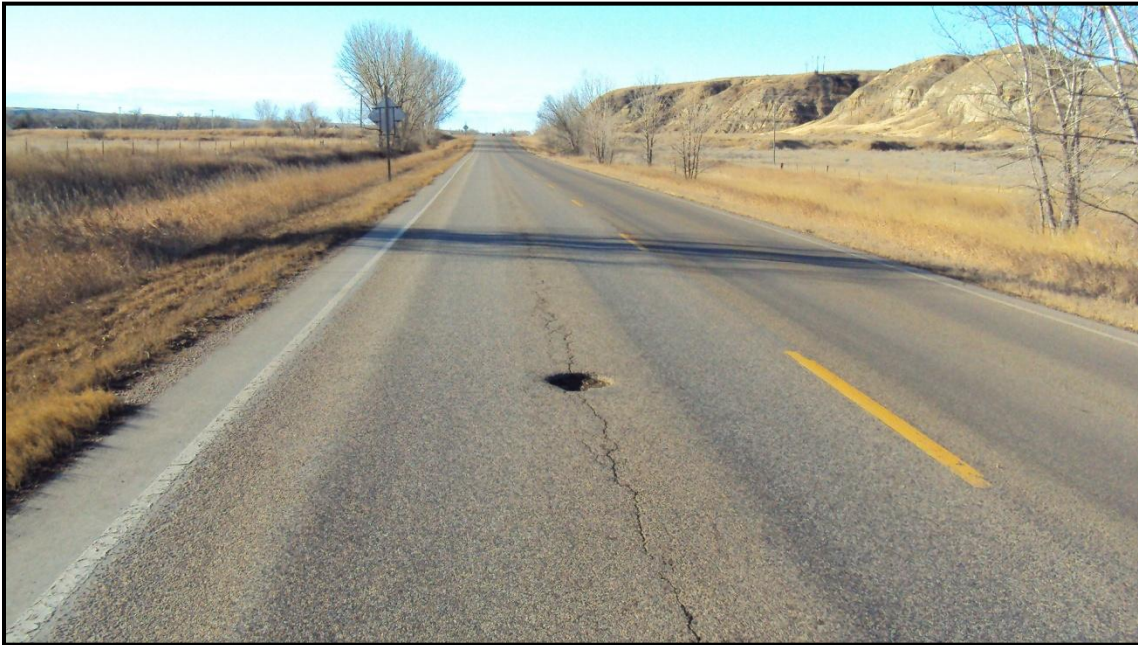
**Photo 35.** Looking south on MT 16 at longitudinal pavement cracking and pothole. RP 19.3.

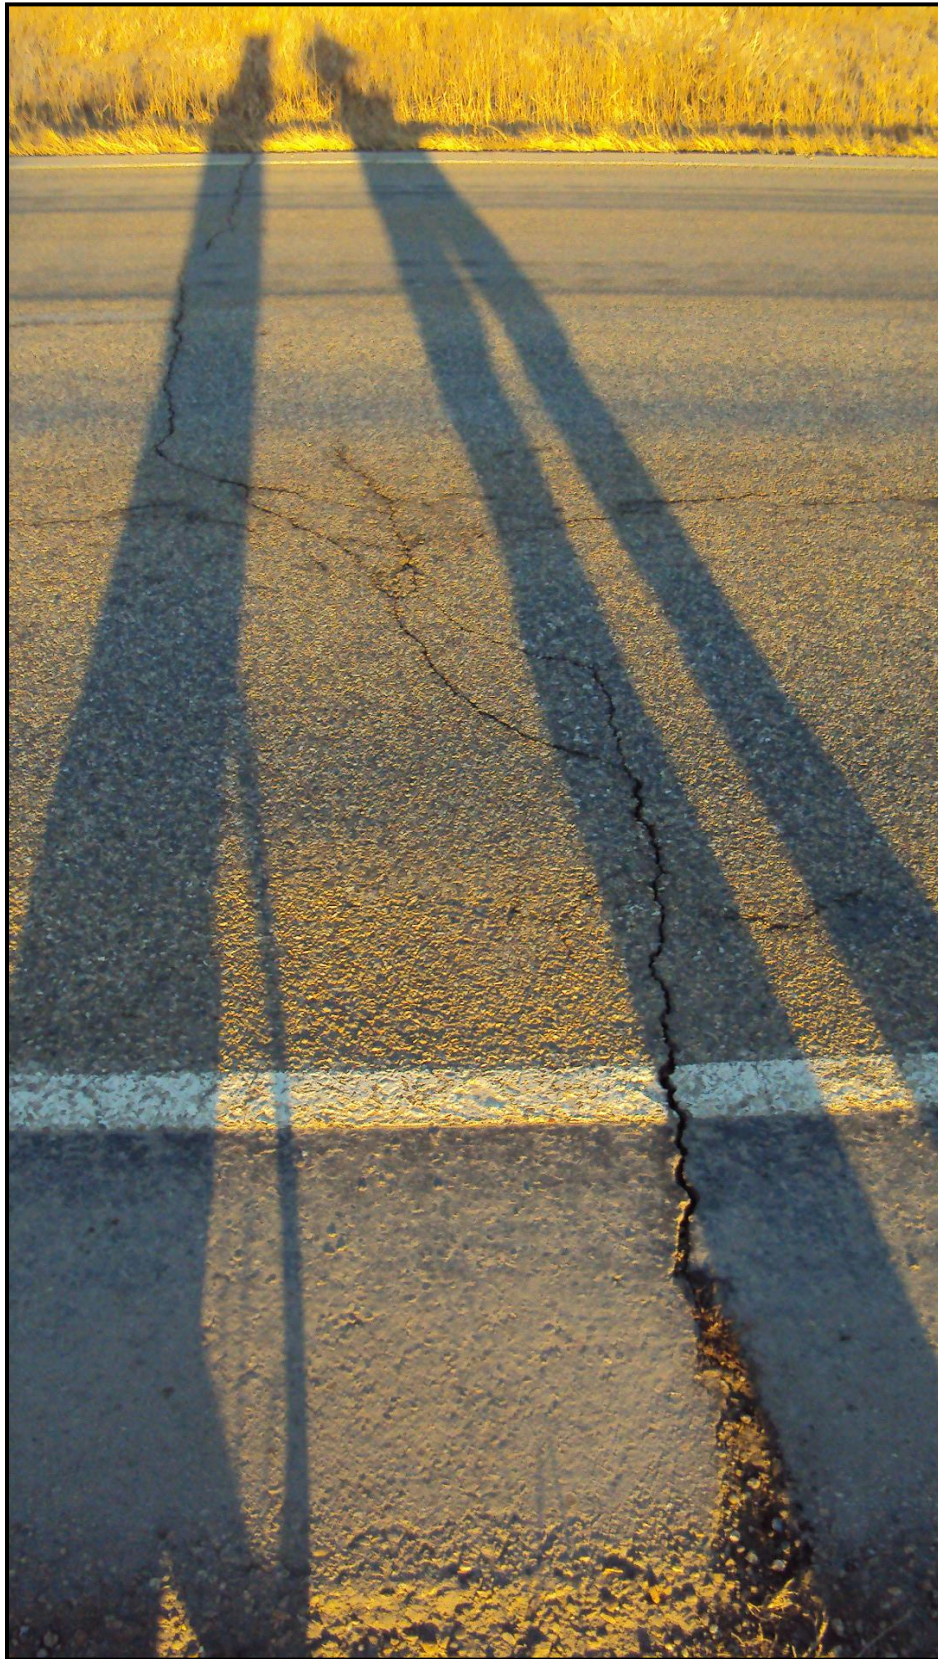
**Photo 36.** Looking across MT 16 at transverse pavement cracking. Pavement cracking within the travel way measured approximately 0.5 inches in width, approximately every 30 feet. Pavement rutting measured approximately 0.5 inches in depth. RP 19.3.

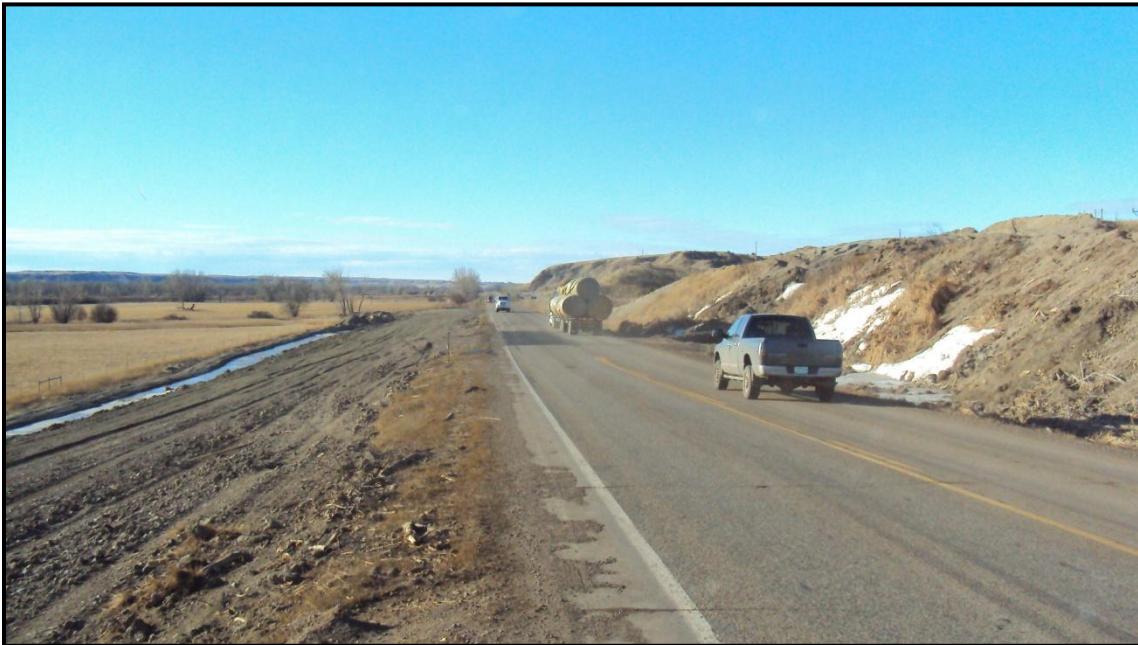
**Photo 37.** Looking south on MT 16 at narrow shoulder widths, longitudinal pavement cracking, and spot resurfacing. RP 19.6.

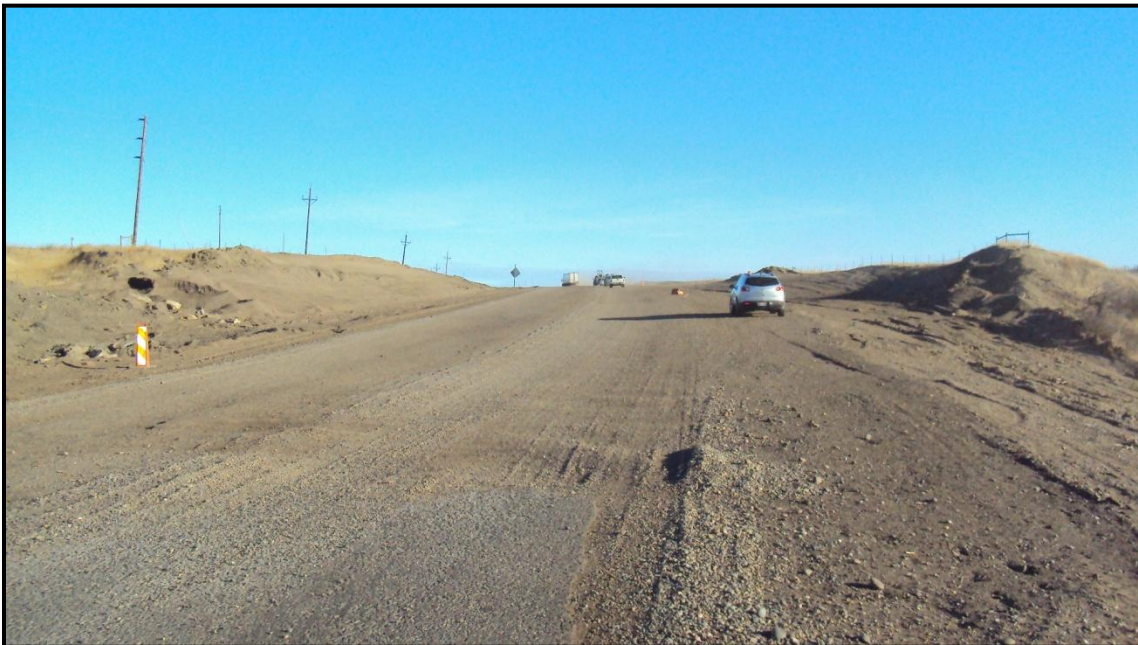
**Photo 38.** Looking north on MT 16 at roadway reconstruction and re-graded side slopes. RP 19.7.

- Transverse pavement cracking within the travel way was observed. Narrow shoulder widths and spot resurfacing was observed at RP 19.6. Photo 37.
- Roadway reconstruction with re-graded side slopes at RP 19.7. Photo 38.

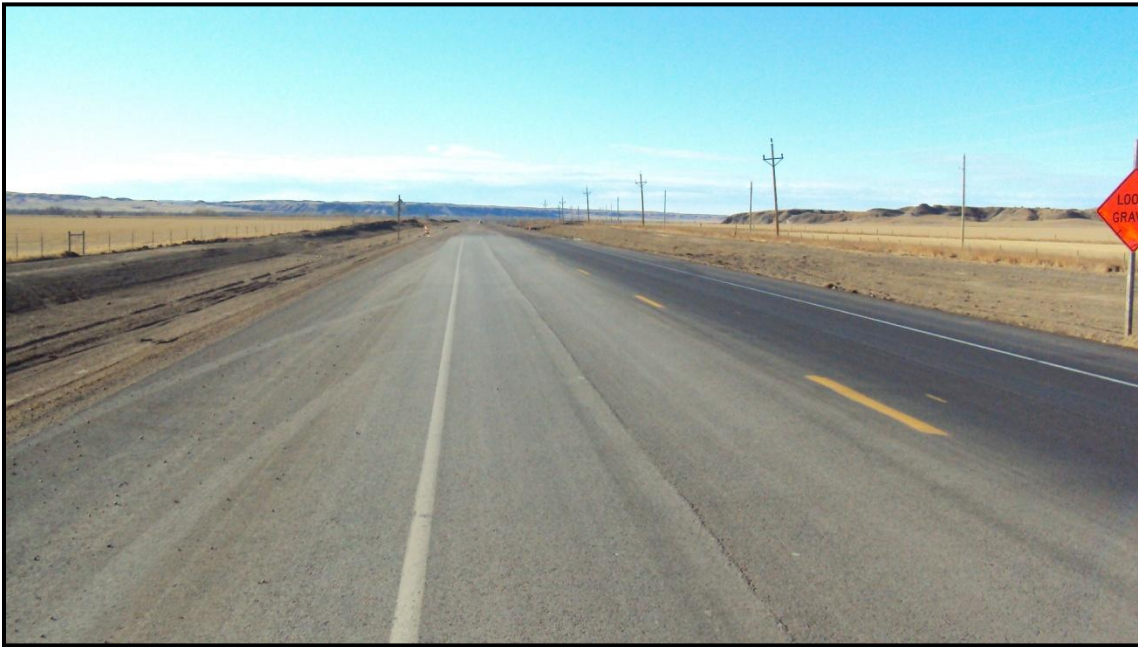
**Photo 39.** Looking south at reconstructed portion of MT 16. RP 20.4.

- Reconstructed pavement at RP 20.4. Photos 39 and 40.
- Transverse pavement cracking within the travel way measured approximately 0.5 inches in width, approximately every 35 feet. Longitudinal pavement cracking was observed within the travel way. No measurable pavement rutting was observed within the travel way at RP 29.0. Photo 46.

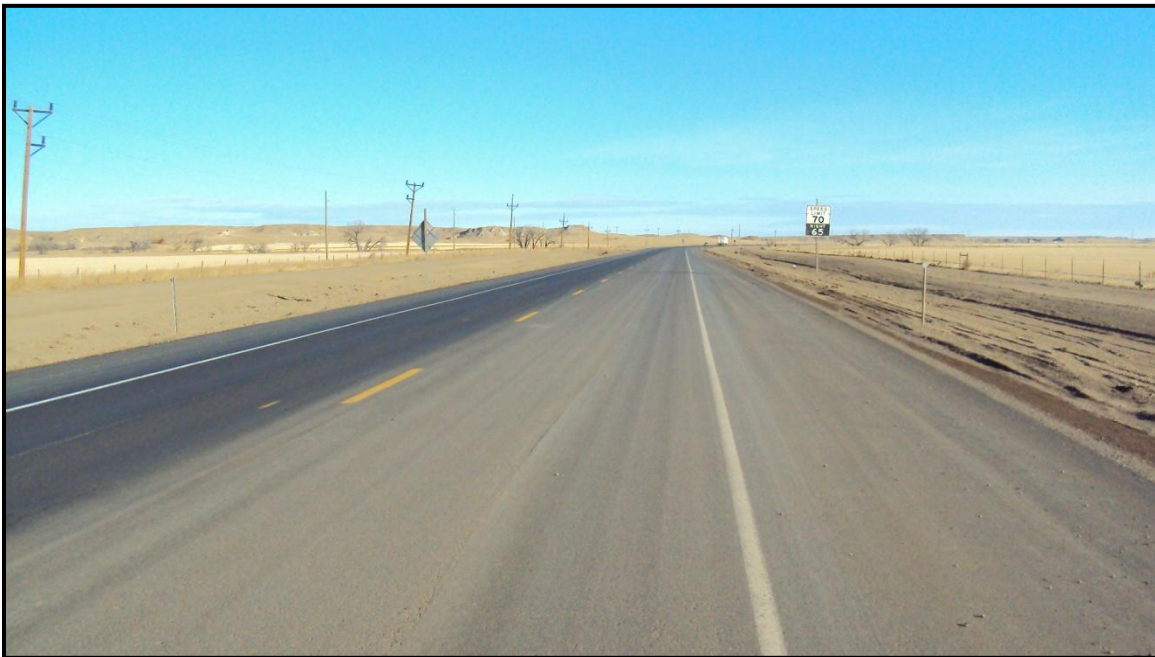
**Photo 40.** Looking south at reconstructed portion of MT 16. RP 20.4.

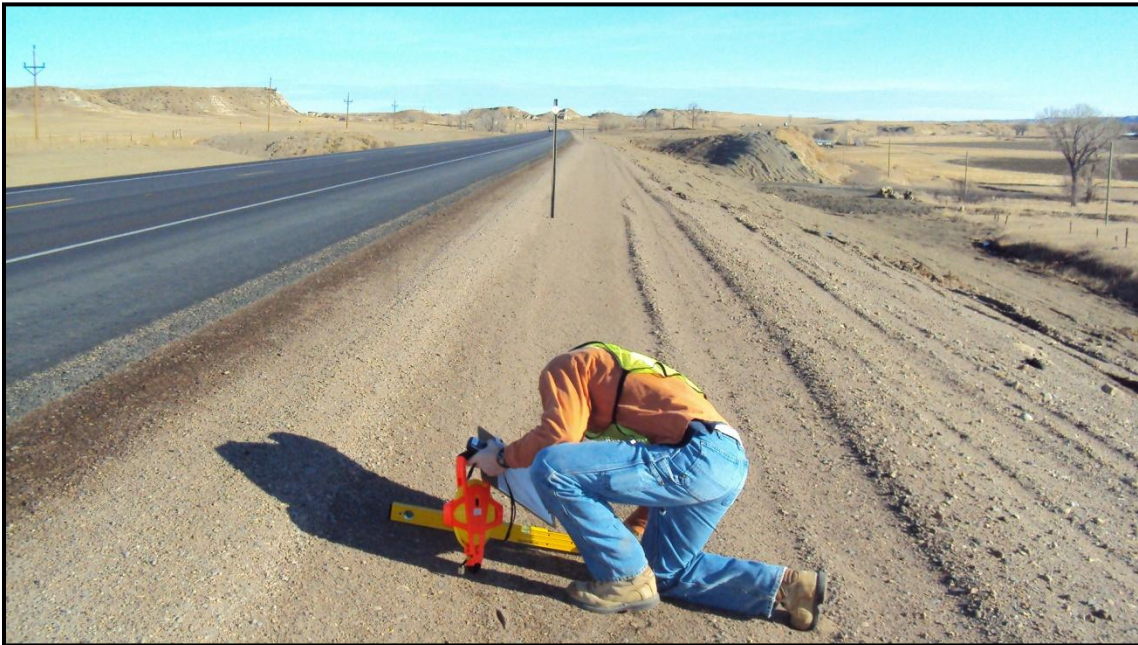
**Photo 41.** Looking north on MT 16. East side slope transitions from 5:1 to 3:1 approximately 28 feet from northbound travel lane. RP 22.5.

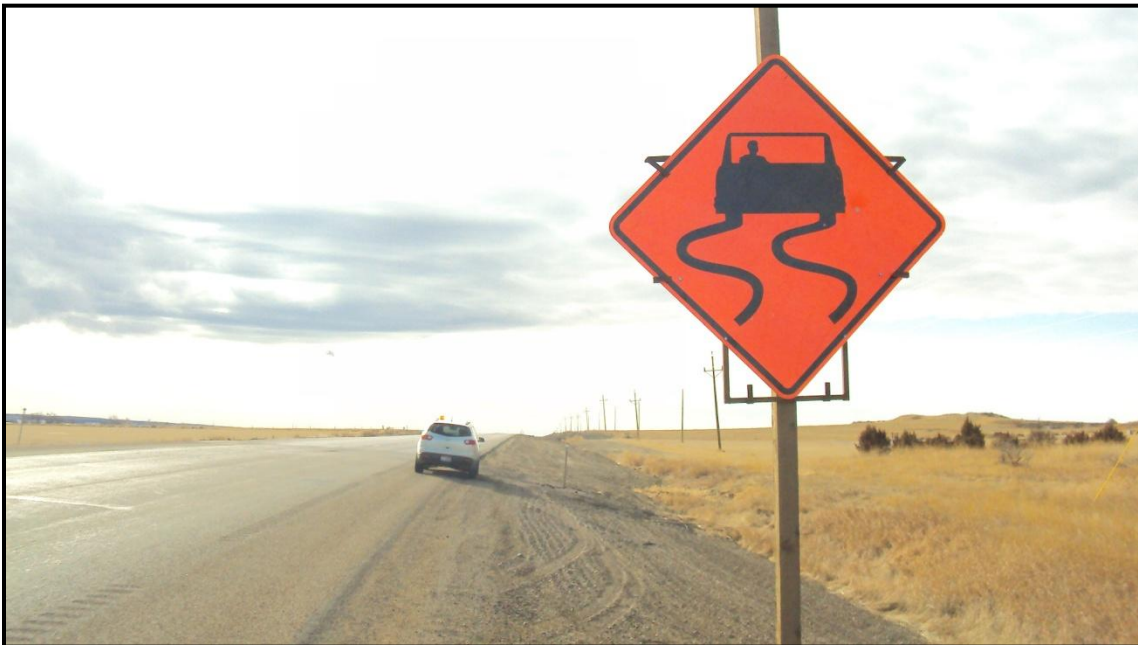
**Photo 42.** Looking south on MT 16 at slippery when wet sign. RP 24.6.

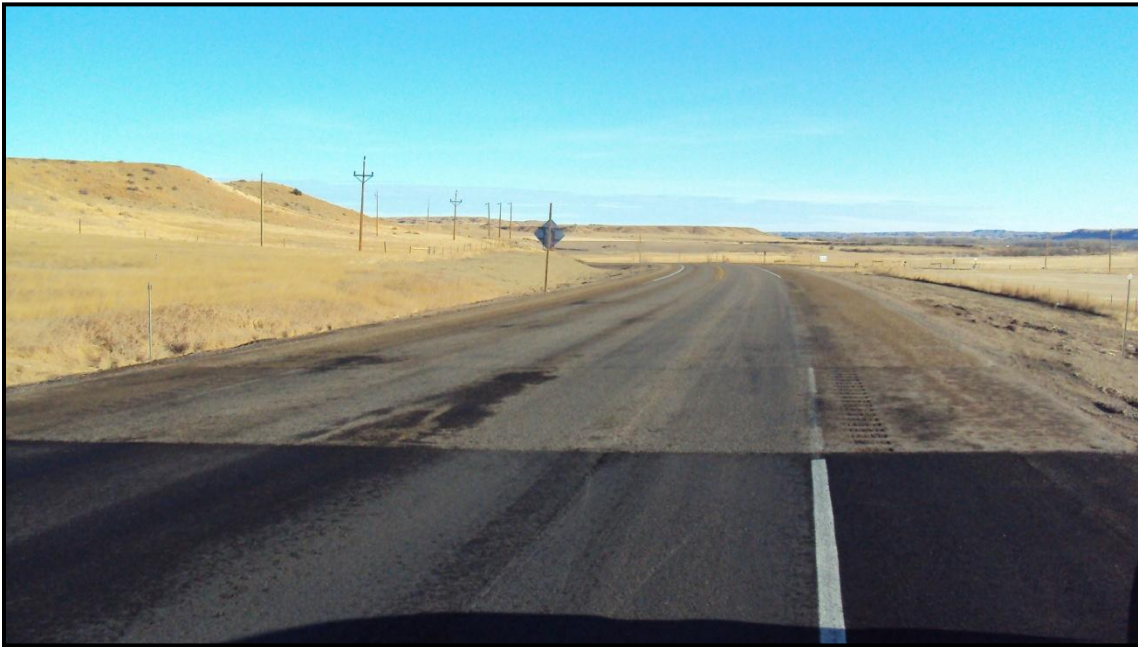
**Photo 43.** Looking north on MT 16 at end of reconstructed section. RP 24.7.

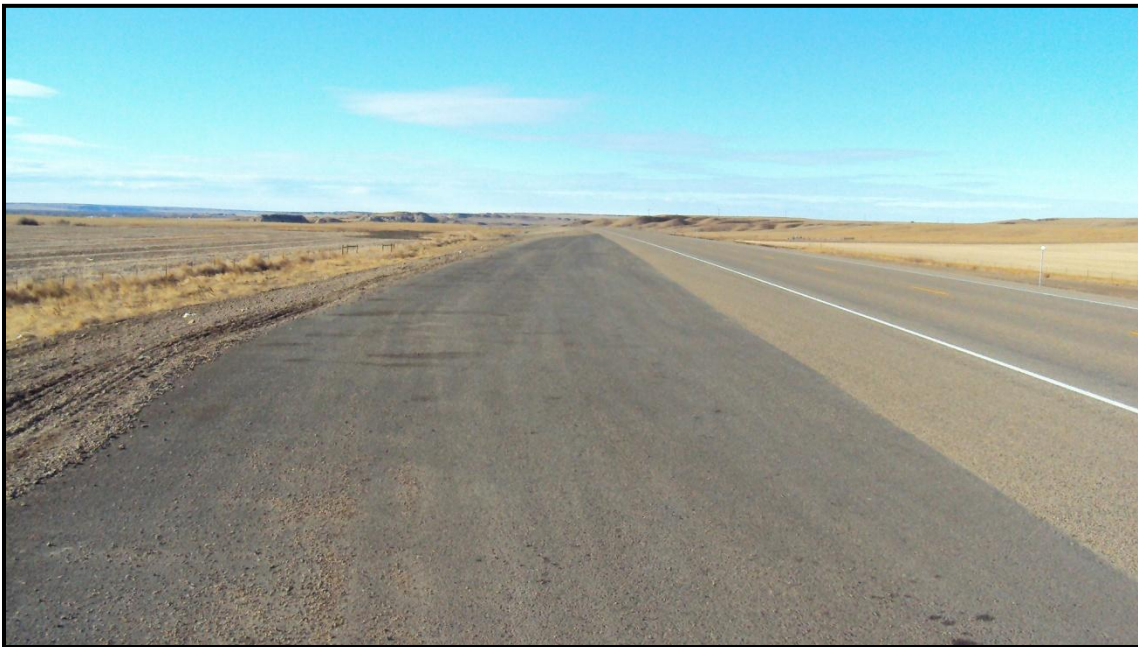
**Photo 44.** Looking south on MT 16 at a paved vehicle pullout. RP 26.4.

- Damaged guardrail at RP 13.6. Photo 28.
- Paved vehicle pullout at RP 26.4. Photo 44.
- Paved vehicle pullout at RP 30.4. Photo 49.

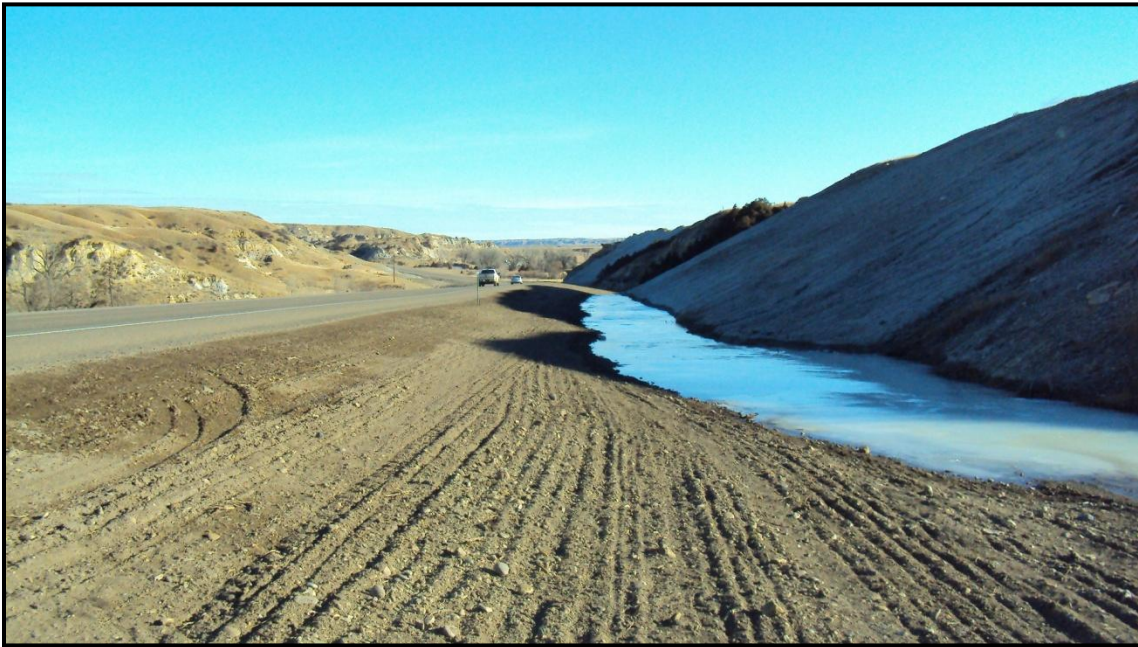
**Photo 45.** Looking north on MT 16 at unvegetated side slope. RP 27.5.

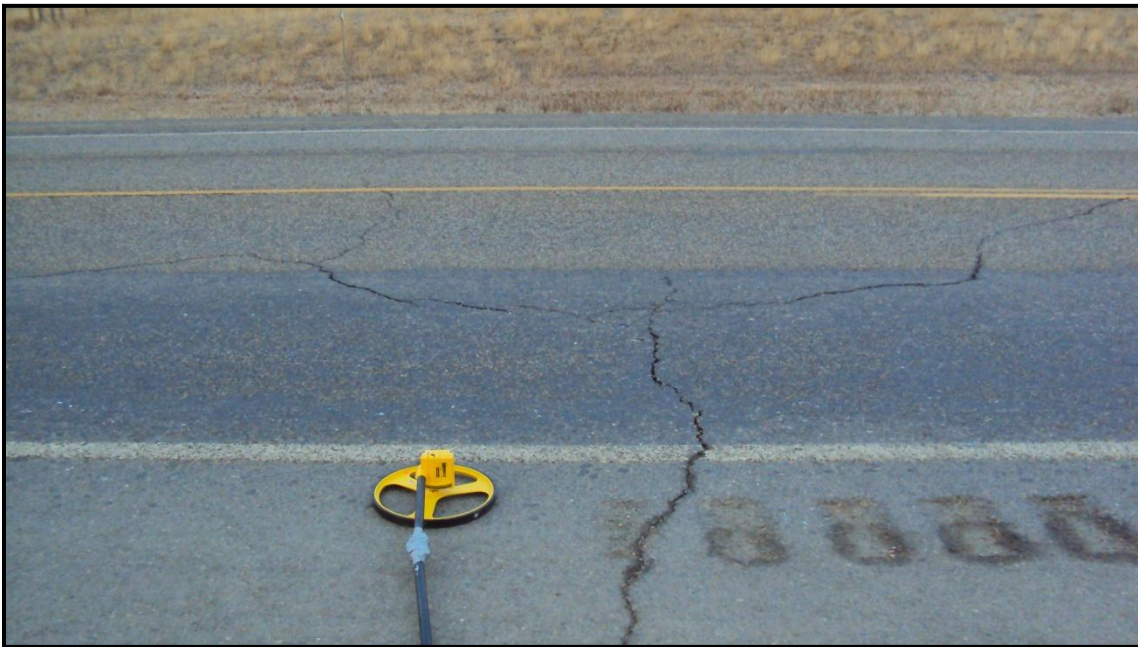
**Photo 46.** Looking across MT 16 at continuous transverse pavement cracking. Pavement cracking within the travel way measured approximately 0.5 inches in width, approximately every 35 feet. RP 29.0.

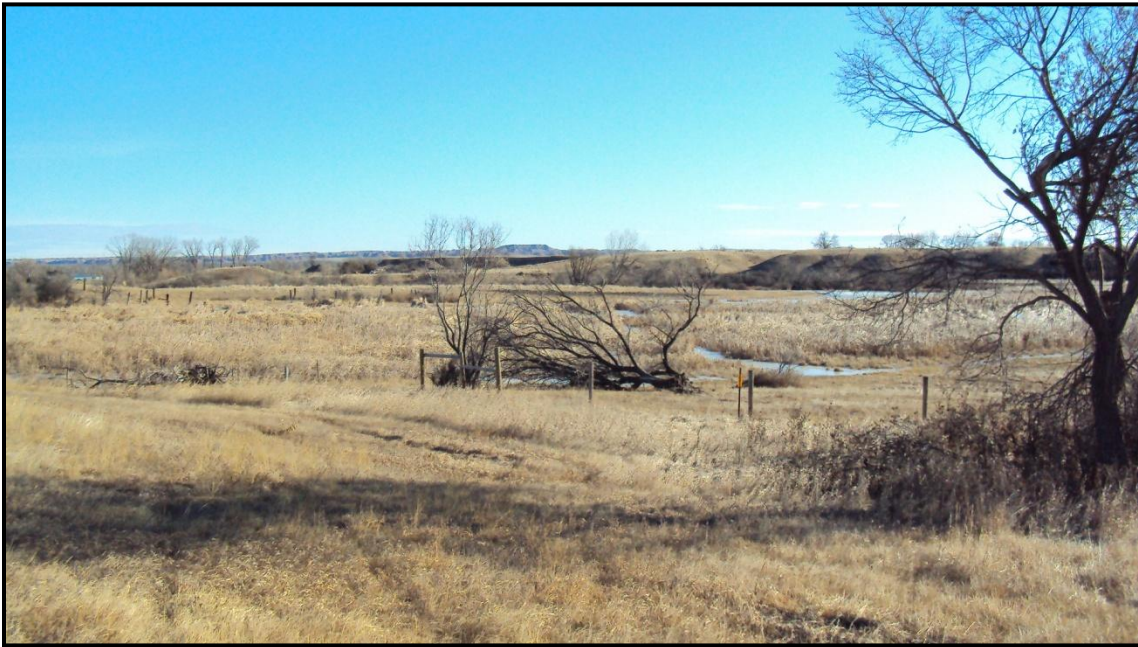
**Photo 47.** Looking east of MT 16 at areas exhibiting wetland characteristics. RP 29.2.

- West of MT 16 at RP 1.7. Photo 7.
- East of MT 16 at RP 8.4. Photo 17.
- East of MT 16 at RP 29.2. Photo 47.

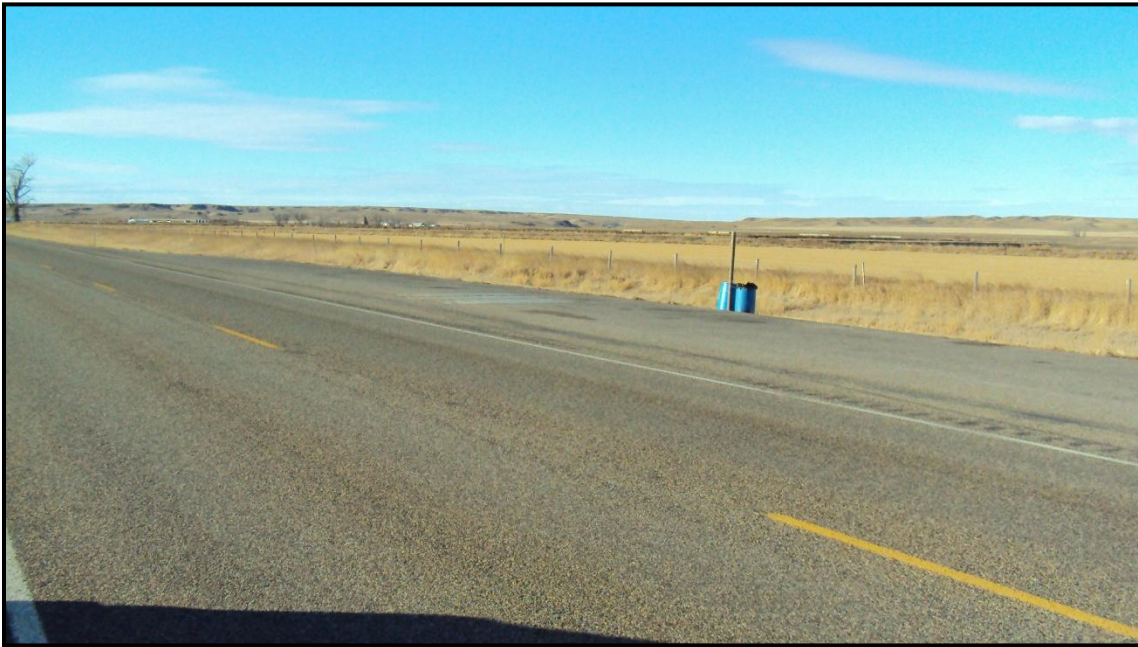
**Photo 49.** Looking south on MT 16 at a paved vehicle pullout. RP 30.4.

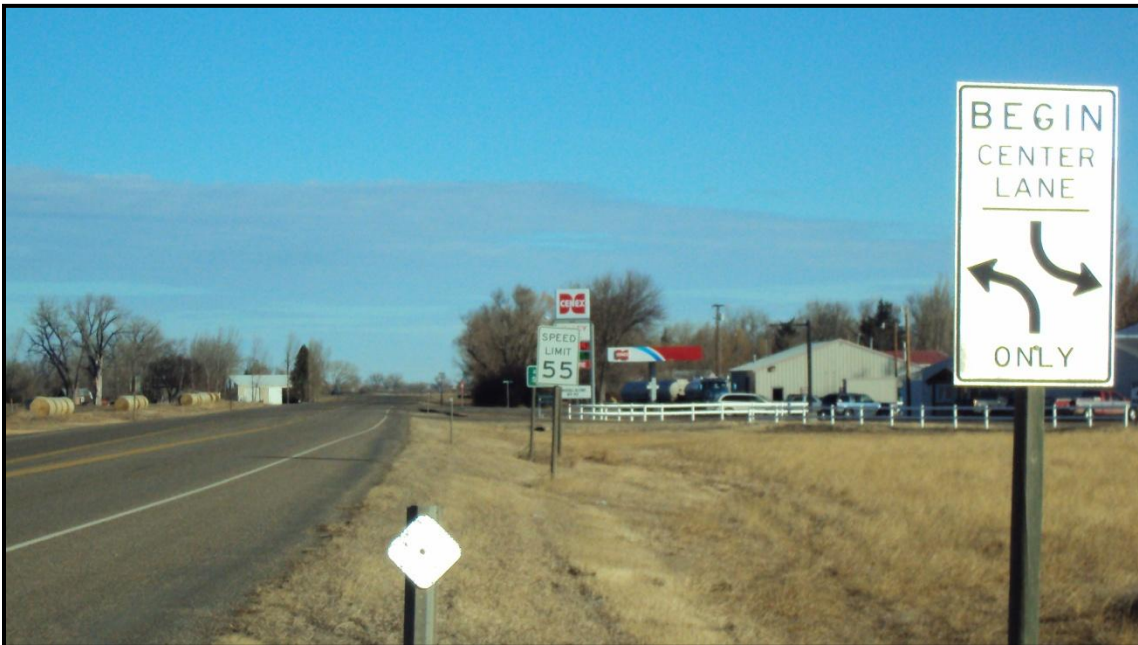
**Photo 50.** Looking north on MT 16 at beginning of two-way left-turn lane and reduced posted speed limit (55 mph for all vehicles) through Savage, MT. RP 31.5.

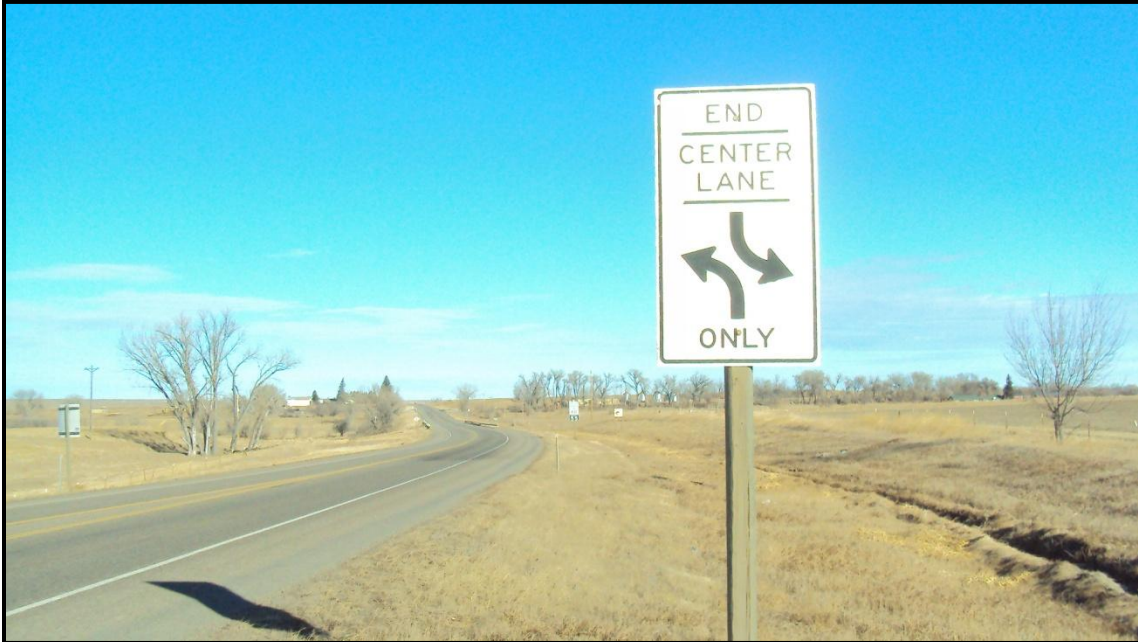
**Photo 51.** Looking north on MT 16 at end of two-way left-turn lane and restored posted speed limits (60 mph for trucks, 70 mph for vehicles). RP 32.3.

- End of turning left-turn lane at RP 32.3. Photo 51.

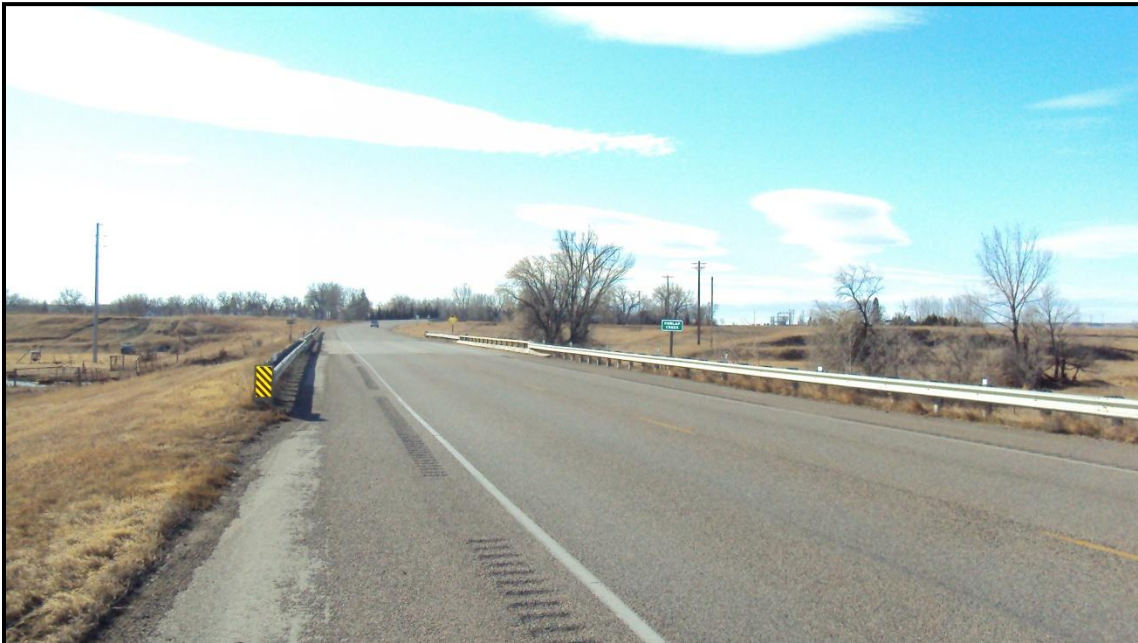
**Photo 52.** Looking south on MT 16 at Dunlap Creek. RP 32.6.

- Dunlap Creek at RP 32.6. Photo 52.
- Irrigation Canal at RP 37.5. Photo 53.

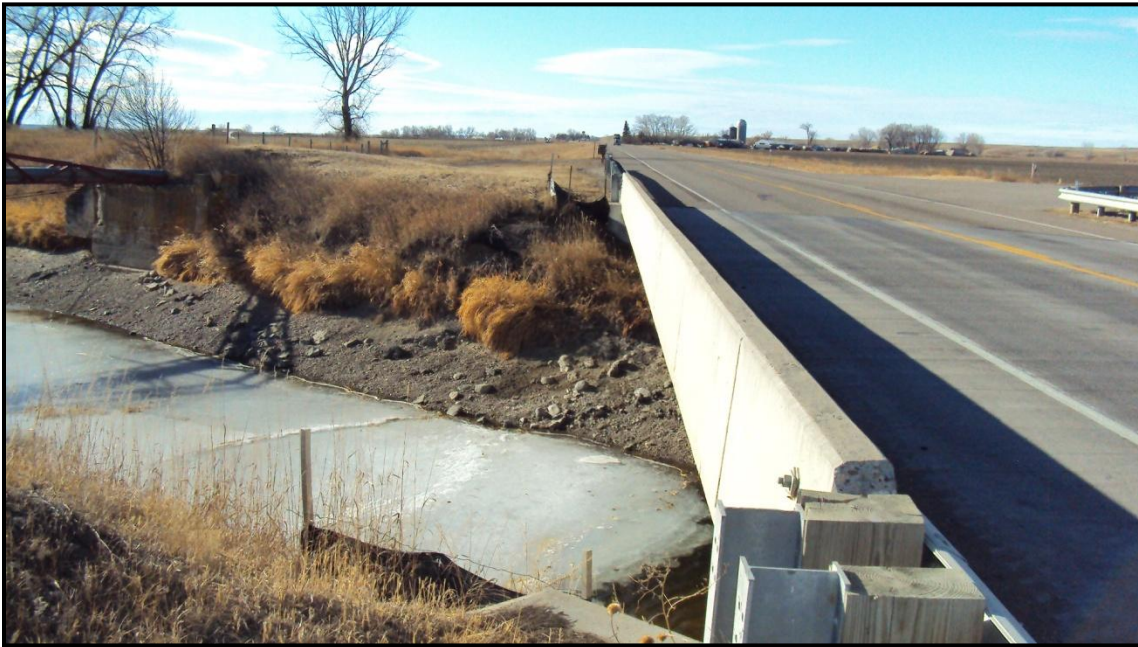
**Photo 53.** Looking south on MT 16 at Irrigation Canal. RP 37.5.

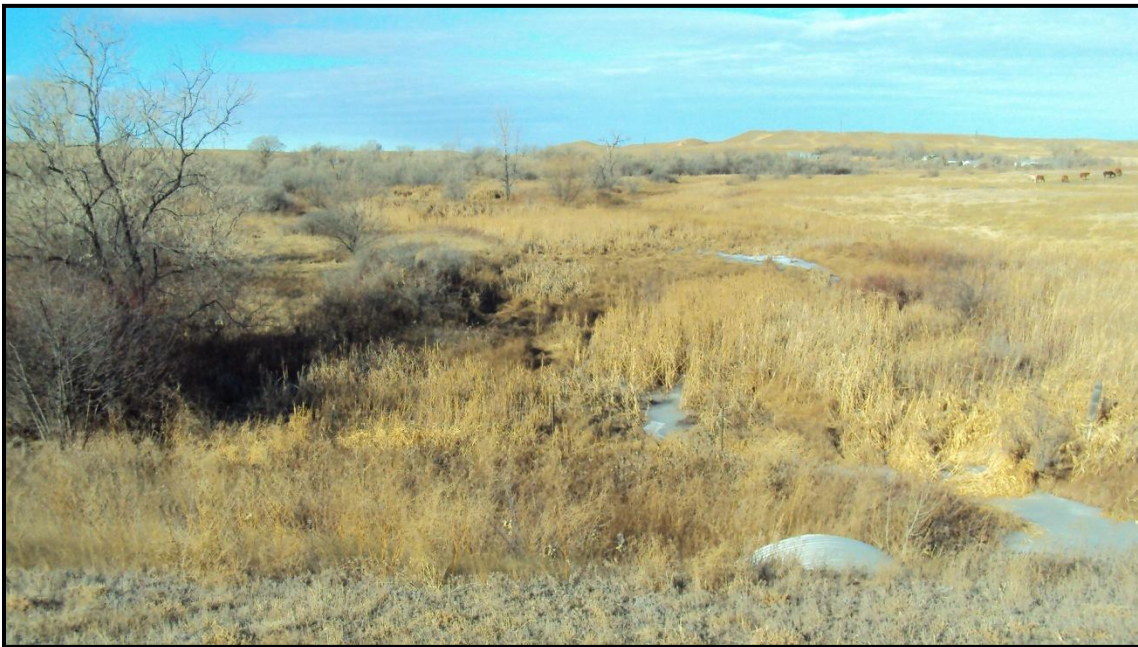
- Areas exhibiting wetland characteristics were observed east and west of MT 16 at RP 37.7. Photo 54.

**Photo 54.** Looking east of MT 16 at areas exhibiting wetland characteristics. RP 37.7.

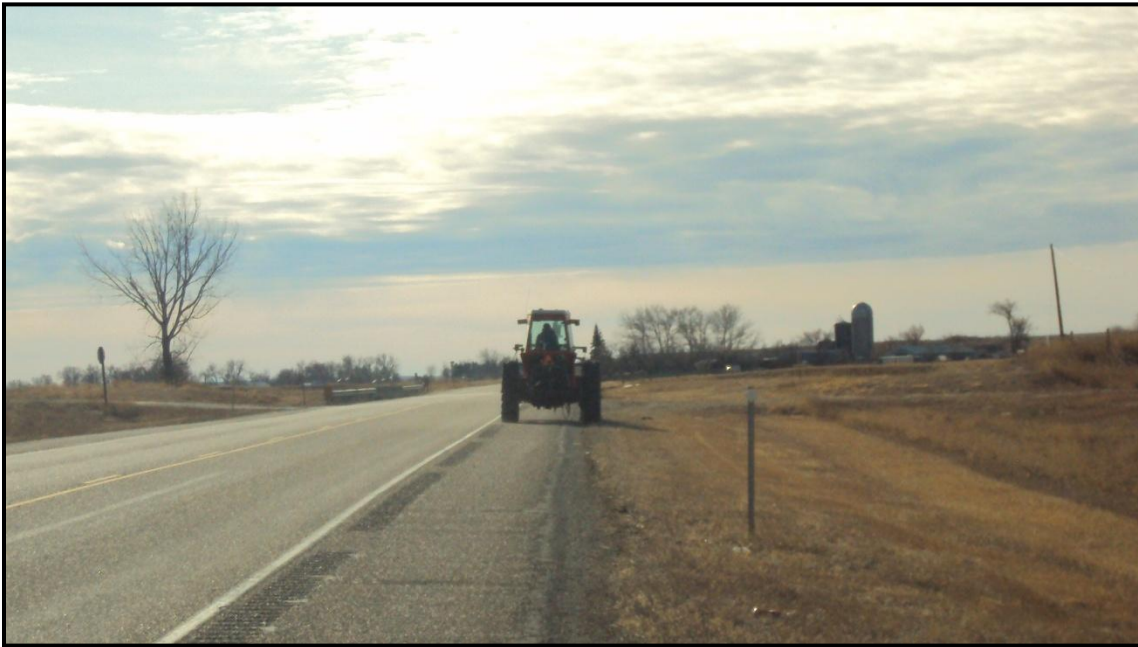
- Slow moving tractor was observed at RP 38.4. Photo 55.

**Photo 55.** Looking south on MT 16 at slow moving tractor. RP 38.4.

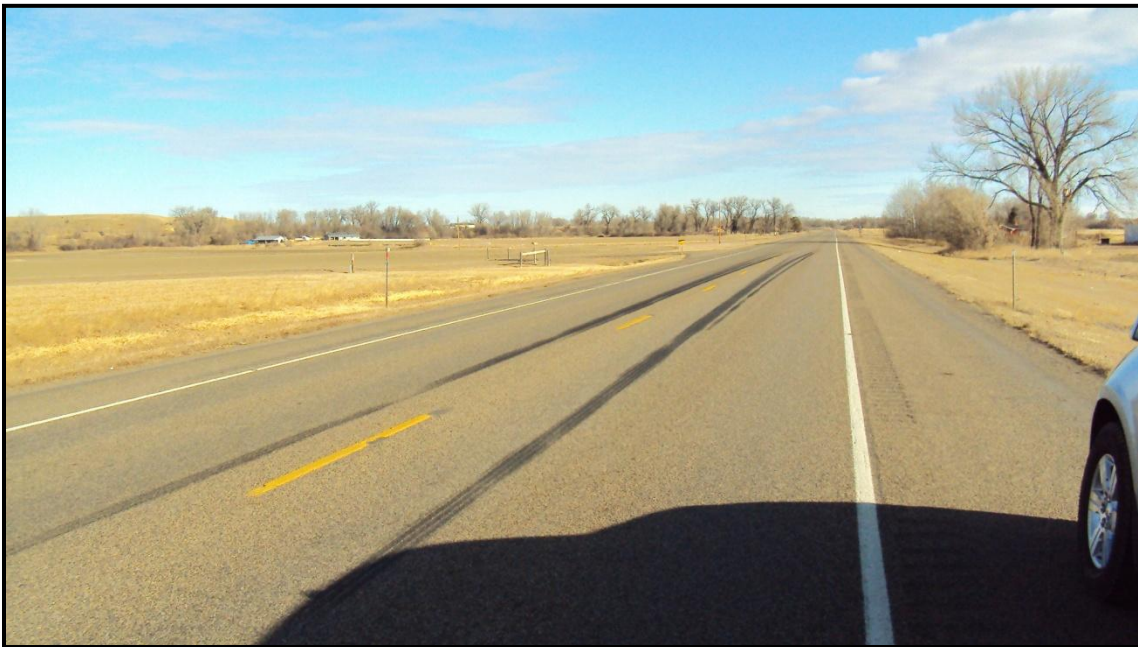
- RP 40.4. Photo 56.
- Entrance to Crane at RP 41.4. Photo 57.

**Photo 56.** Looking north on MT 16 at tire skid marks. RP 40.4.

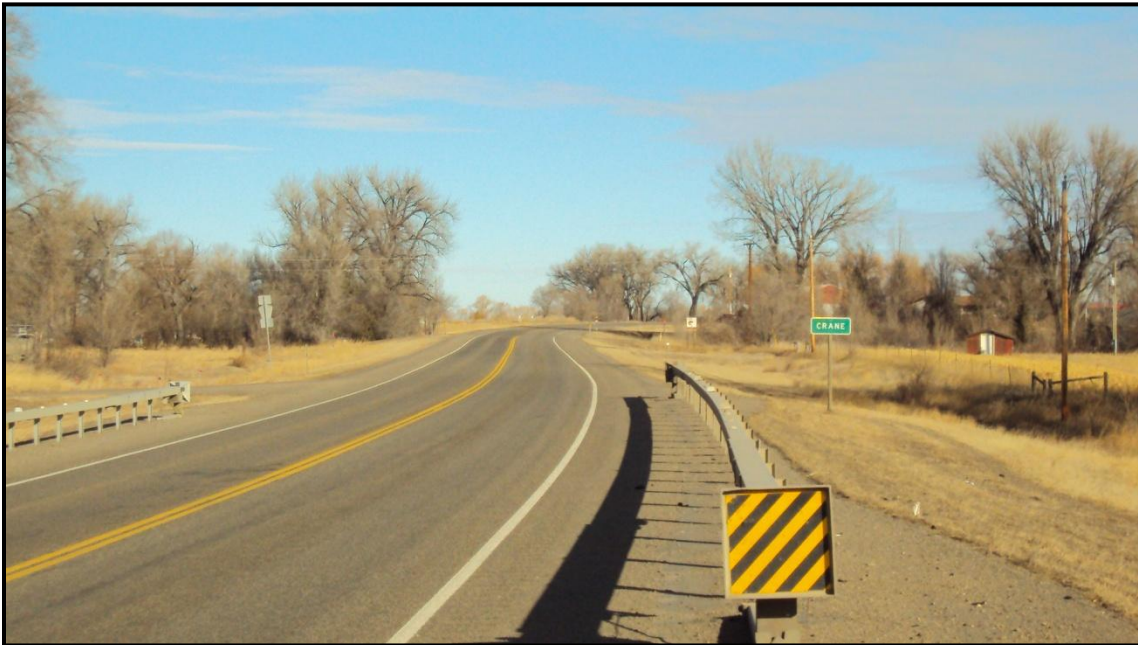
**Photo 57.** Looking north on MT 16 at entrance to Crane, MT. Speed limits are not reduced through Crane, MT. RP 41.4.

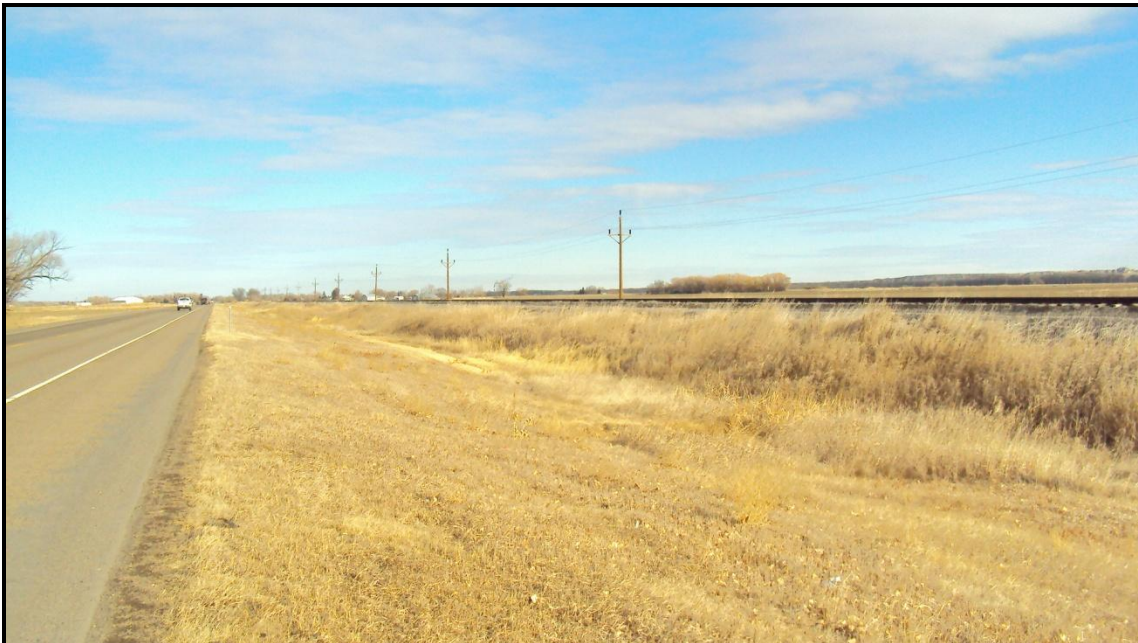
- Railway paralleling MT 16 at RP 45.0. Photo 58.
- Damaged guardrail at RP 46.7. Photo 60.

**Photo 58.** Looking north at railway paralleling MT 16. RP 45.0.

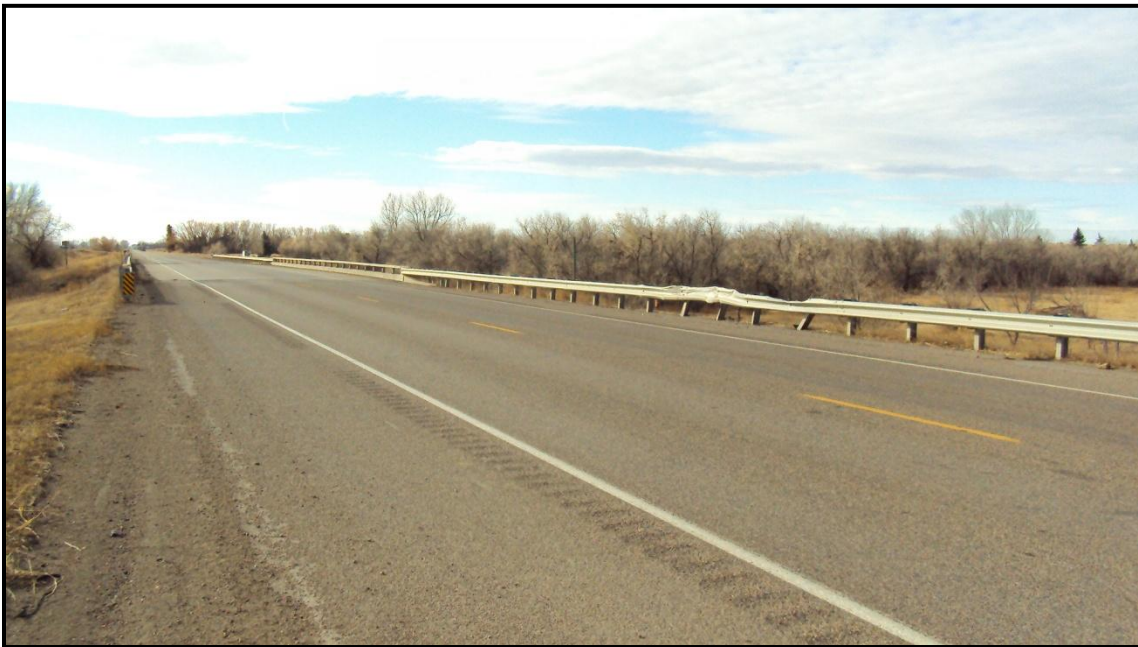
**Photo 60.** Looking south on MT 16 at damaged guardrail. RP 46.7.

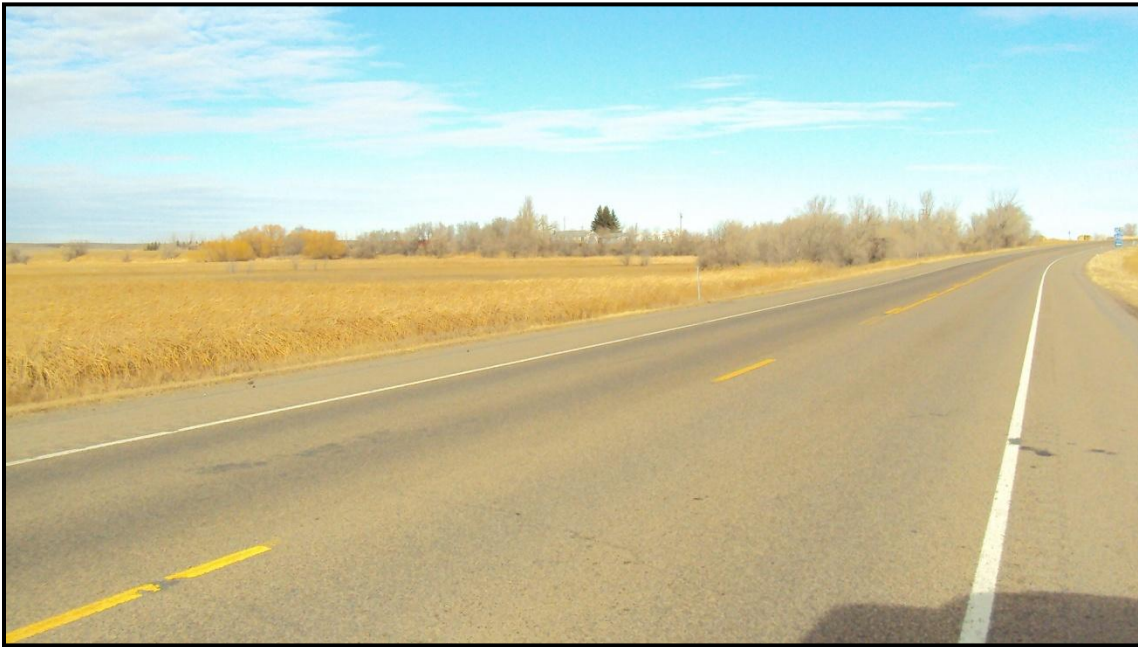
- Areas exhibiting wetland characteristics were observed east and west of MT 16 at RP 47.8. Photos 61 and 62.

**Photo 61.** Looking northwest of MT 16 at areas exhibiting wetland characteristics observed approximately 32 feet from southbound travel lane. RP 47.8.
