# EXISTING AND PROJECTED CONDITIONS REPORT

**July 2012**

## MT 16 / MT 200 Glendive to Fairview Corridor Planning Study

### Existing and Projected Conditions Report

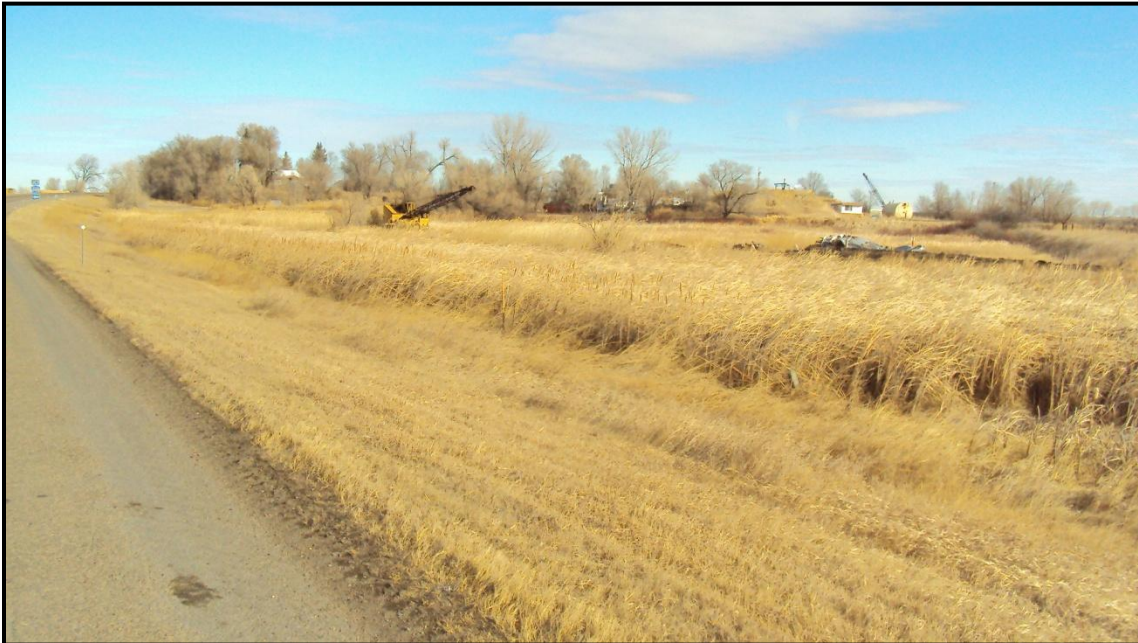
- Areas exhibiting wetland characteristics were observed east and west of MT 16 at RP 47.8. Photos 61 and 62.

**Photo 62.** Looking northeast of MT 16 at areas exhibiting wetland characteristics observed approximately 32 feet from northbound travel lane. RP 47.8.

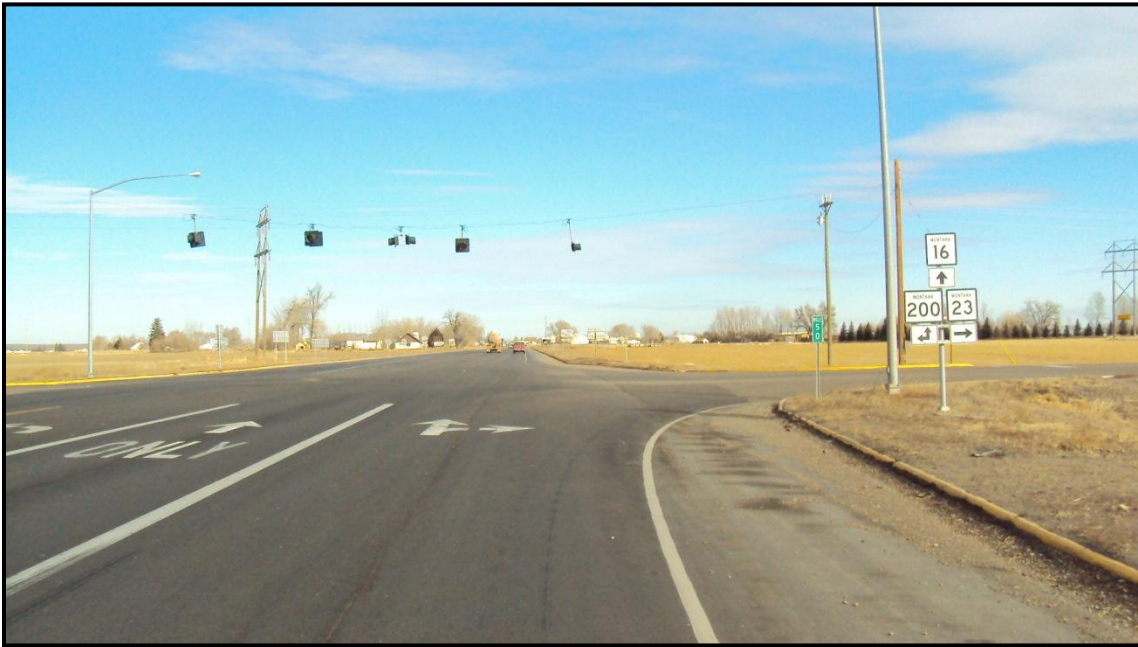
- Intersection of MT 16 / MT 200 and MT 200 / MT 23 at RP 50.0. Photo 63.

**Photo 63.** Looking north on MT 16 at intersection of MT 16 / MT 200 and MT 200 / MT 23. RP 50.0.

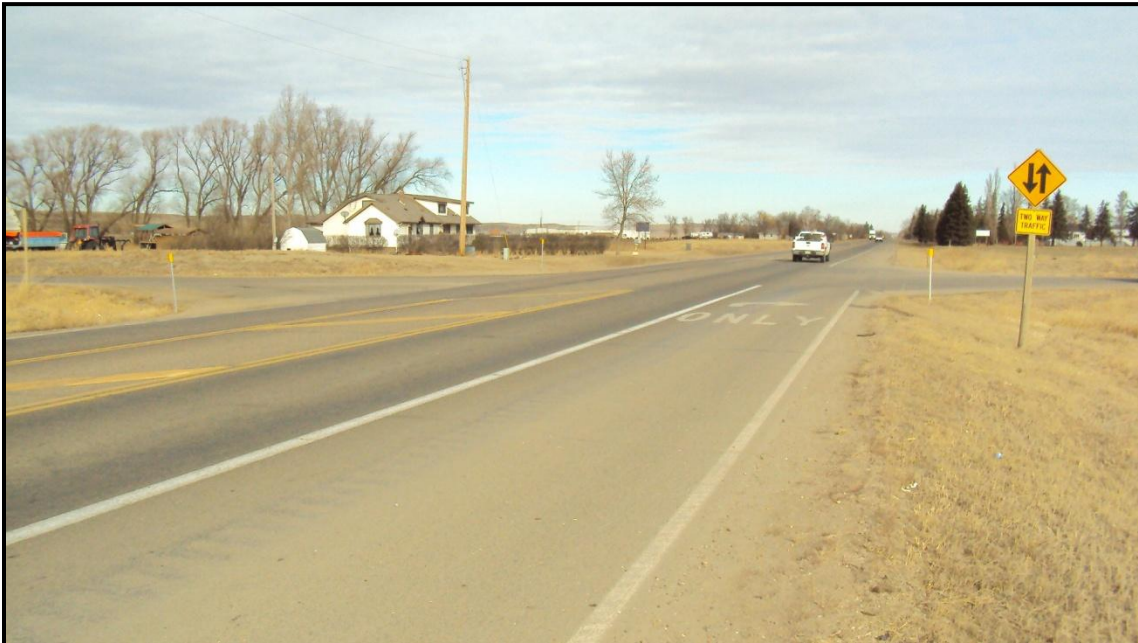
- Return to two-lane configuration and northbound right-turn lane at RP 53.6. Photo 64.

**Photo 64.** Looking north on MT 200 (north of Sidney) at return of two-lane section. RP 53.6.

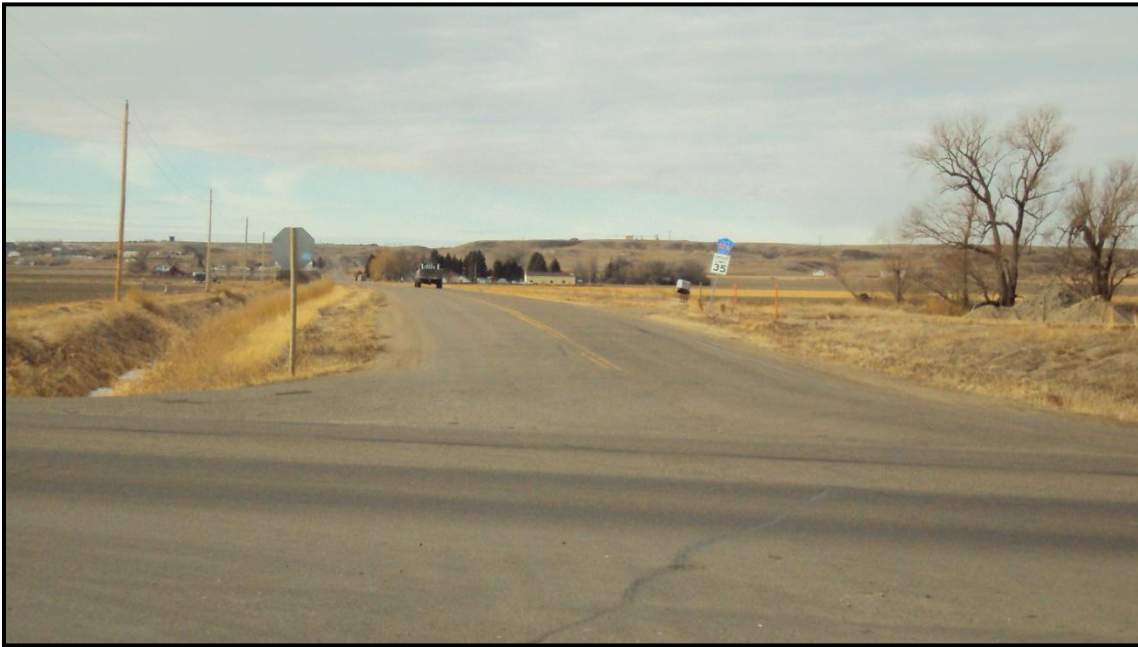
- Intersection of MT 200 and County Road 126 at RP 53.6. Photo 65.

**Photo 65.** Looking at paved intersection of MT 200 and County Road 126. RP 53.6.

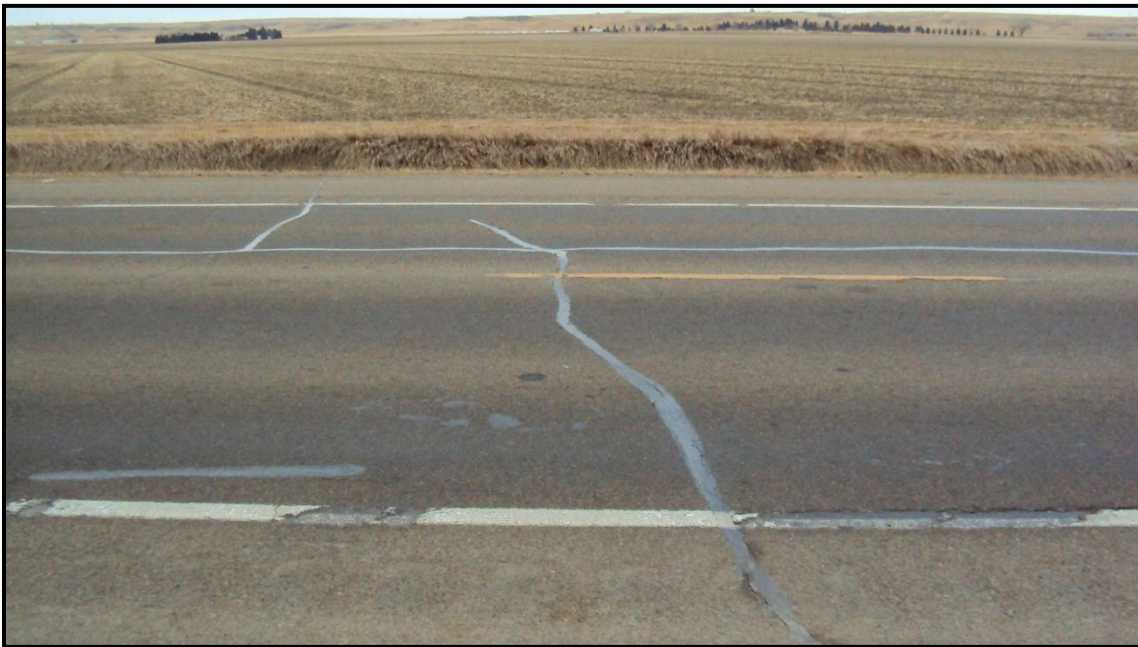
**Photo 66.** Looking at transverse sealed pavement cracking 0.25 inches in width, approximately every 30 feet. Chip seal peeling was observed on the travel way white line. No measurable pavement rutting was observed within the travel way. RP 54.0.

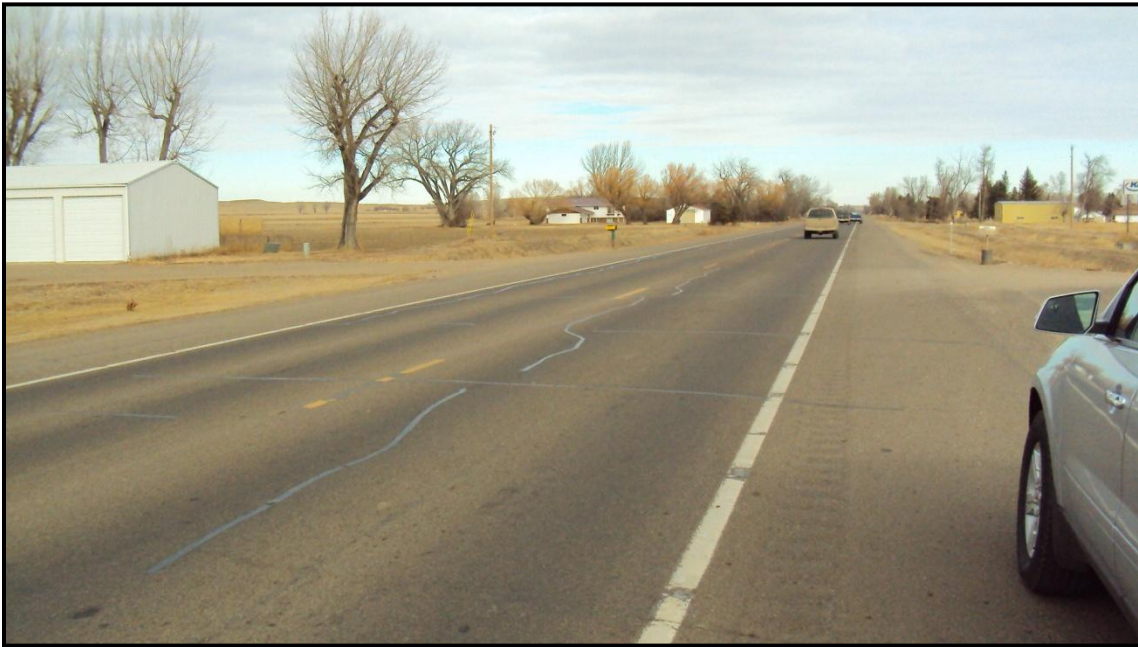
**Photo 67.** Looking north on MT 200 at transverse and longitudinal pavement crack sealing. RP 56.0.

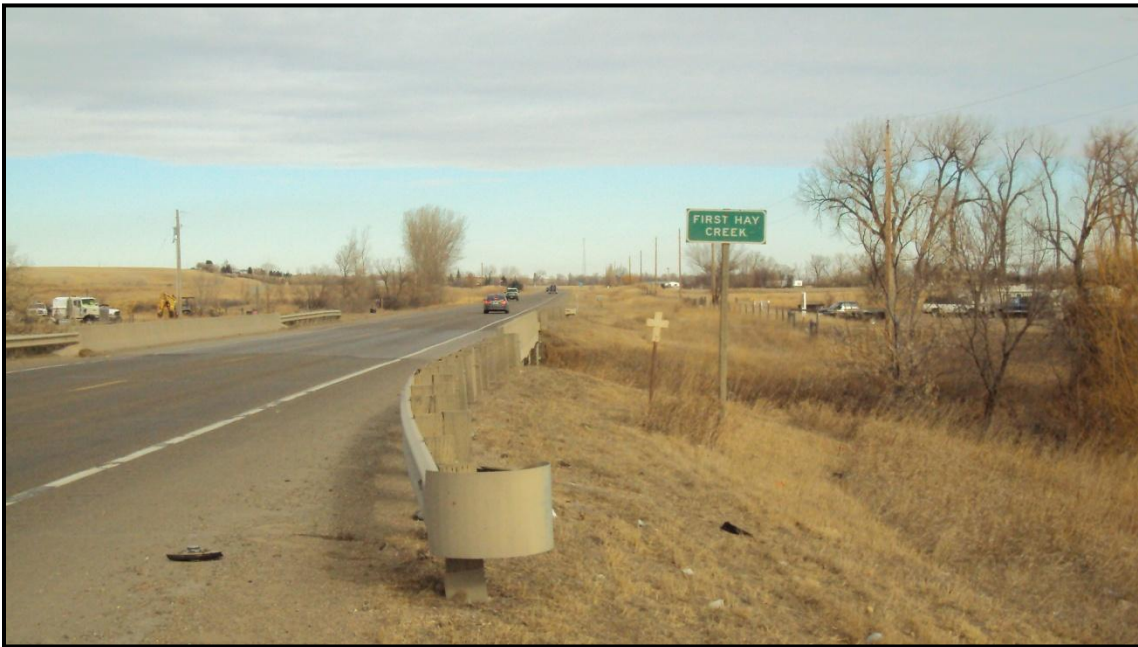
- First Hay Creek at RP 59.5. Photos 70 and 71.
- Second Hay Creek at RP 60.1. Photo 72.

**Photo 70.** Looking north on MT 200 at First Hay Creek. RP 59.5.

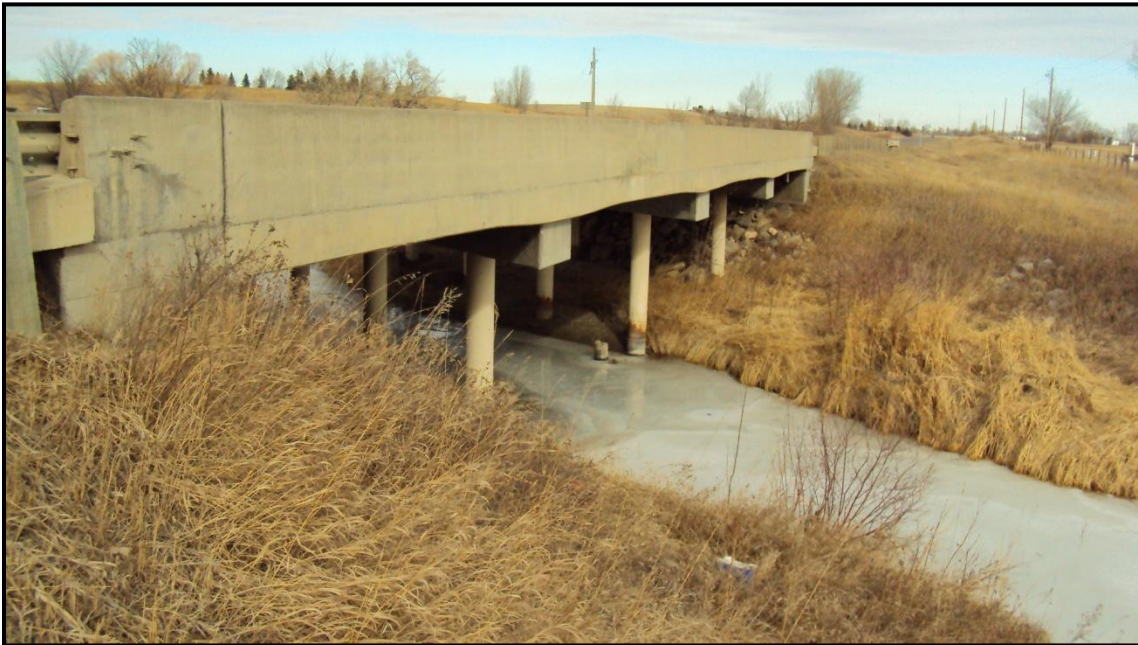
**Photo 71.** Looking north on MT 200 at First Hay Creek Bridge undercrossing. RP 59.5.

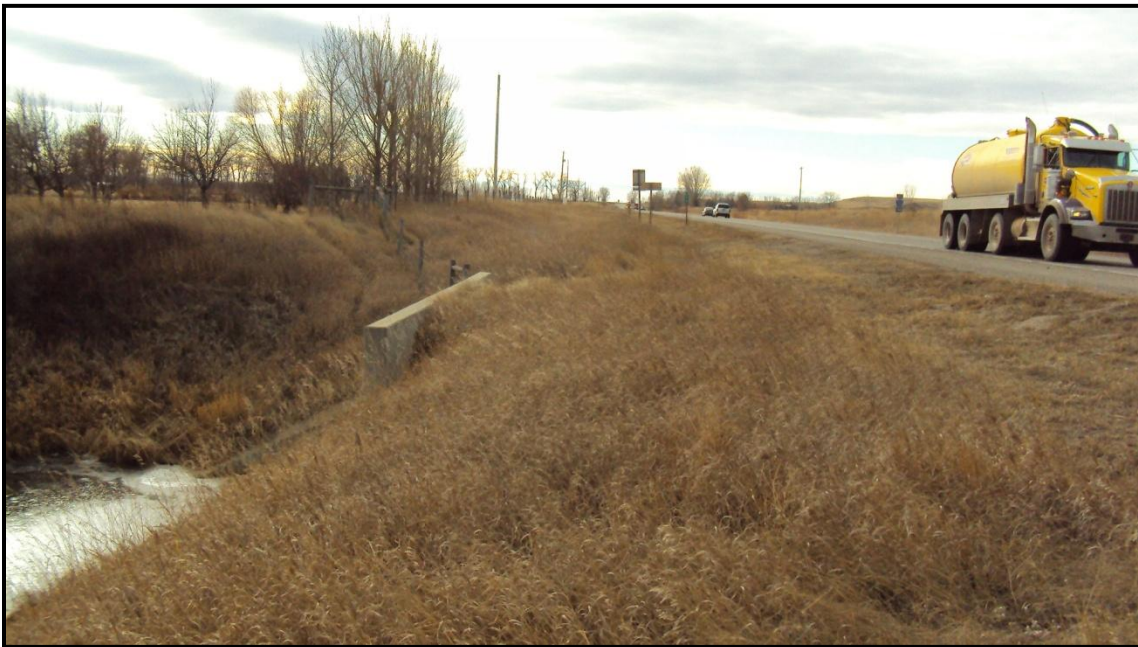
**Photo 72.** Looking south on MT 200 at Second Hay Creek. Distance from the northbound travel lane to concrete wall is approximately 40 feet. RP 60.1
