Planning Study Documentation

Paradise Valley Corridor Planning Study US 89 (Gardiner to Livingston)

MONTANA DEPARTMENT OF TRANSPORTATION

June 4, 2013

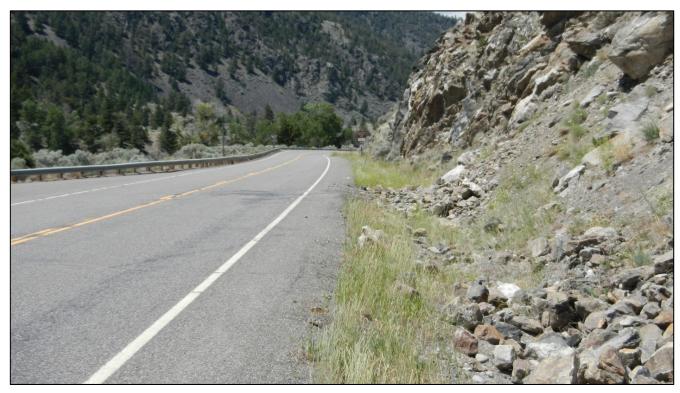
PHOTO 18: RP 13.5, LOOKING WEST (NOTE ROCKFALL ON RIGHT)

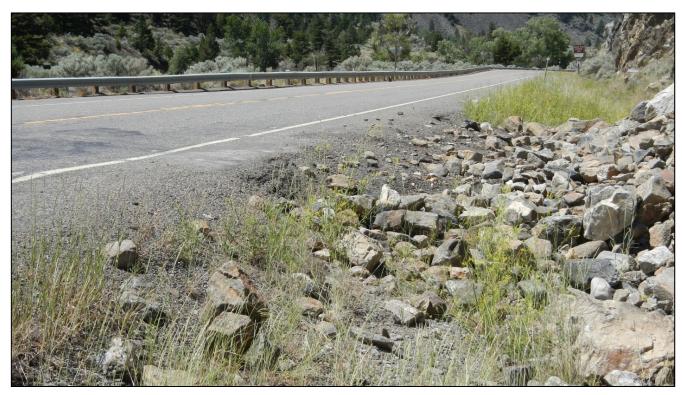
PHOTO 19: RP 13.5, LOOKING WEST (NOTE ROCKFALL ON RIGHT)

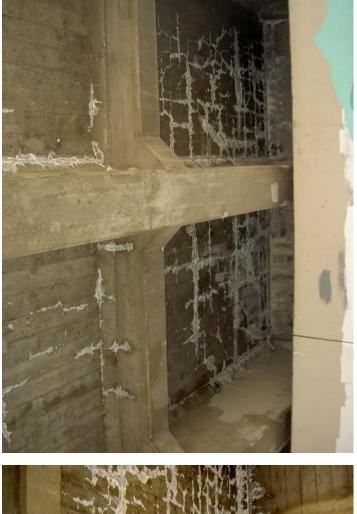
N. Appr. soffit

Much the same conditions exist on the north approach span.
