US 93 Polson Corridor Study

Existing Conditions of US 93

Montana Department of Transportation

Camp Dresser & McKee Inc.

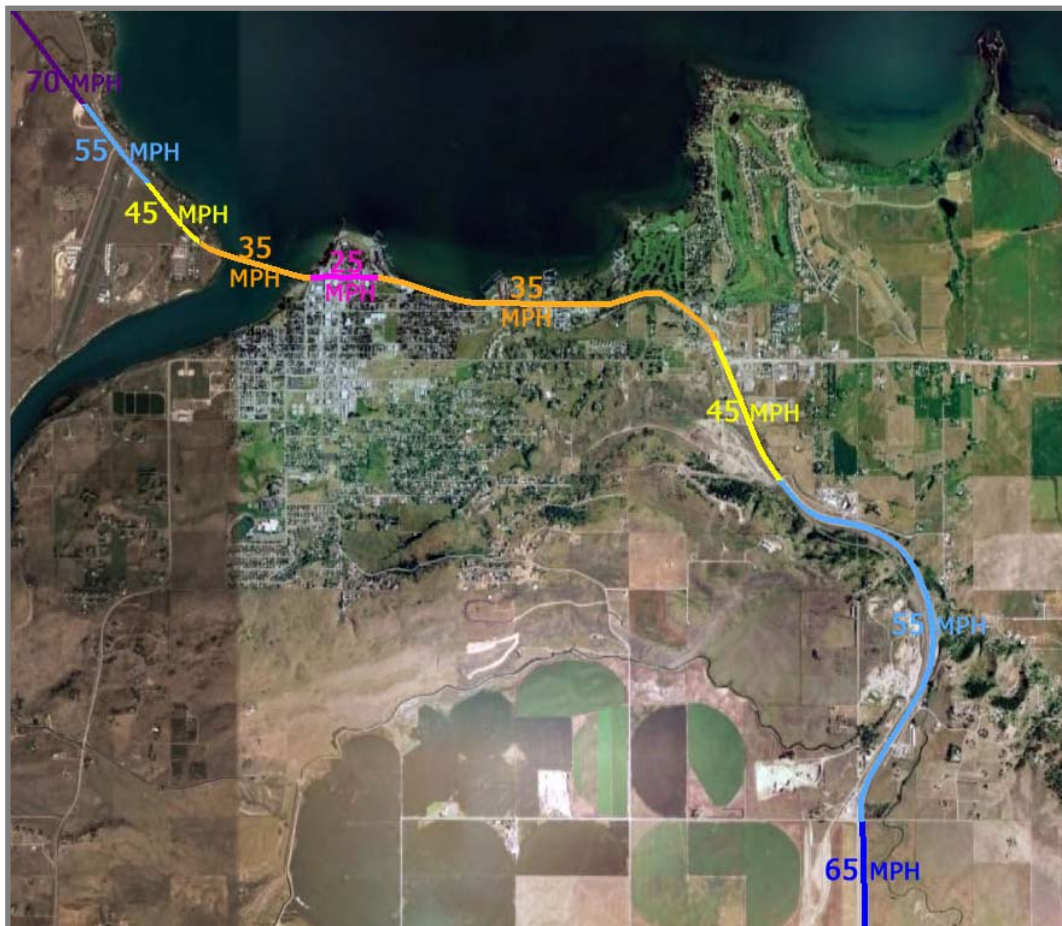
Posted speed limits

US 93 is a major north/south highway providing a vital regional link between Idaho and Canada, and is functionally classified as a Rural Principal Arterial on the NHS Non-Interstate System. This corridor also provides an important link between Missoula, Kalispell, and surrounding communities. At the south end of the corridor (RP 58.5), US 93 functions as a four-lane divided highway which transitions to a four-lane undivided highway with interspersed turning lanes. Just north of the junction of US 93 and MT 35, the four-lane segment of US 93 transitions to a two-lane roadway with interspersed turning lanes. The posted speed limit along the US 93 corridor varies from 25 mph to 70 mph. The graphic below shows the posted speed limits through the US 93 corridor.

The Route Segment Plan does not extend into urban areas, due to certain constraints. Therefore, the section from RP 60.839 to 63.000 does not meet the current recommended surface width of 40 feet or greater. Along with the range of surface widths, the US 93 corridor has varying traffic flows, which can be seen in the posted speed limit graphic on page 6.

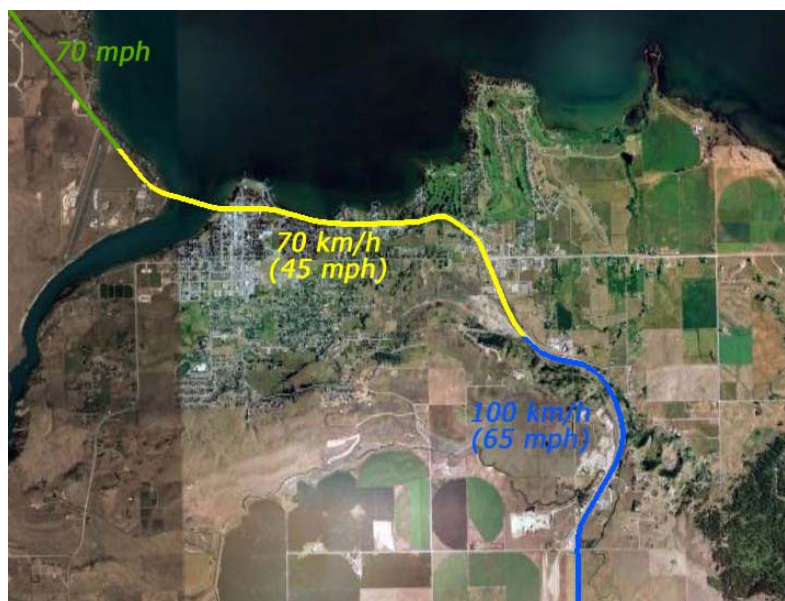
*Design speeds***2.5.2 Vertical Alignment**

The horizontal alignment of US 93 has a major influence on traffic operation and safety and is comprised of elements that include curvature, superelevation, and sight distance. These parameters are directly related to the design speed. The horizontal alignment along US 93 meets current MDT design standards for design speeds ranging from 45 mph to 70 mph. The graphic below shows the range of design speeds through the existing US 93 corridor.
