Winifred to Big Sandy Corridor Study

Existing and Future Conditions Report

November 2010

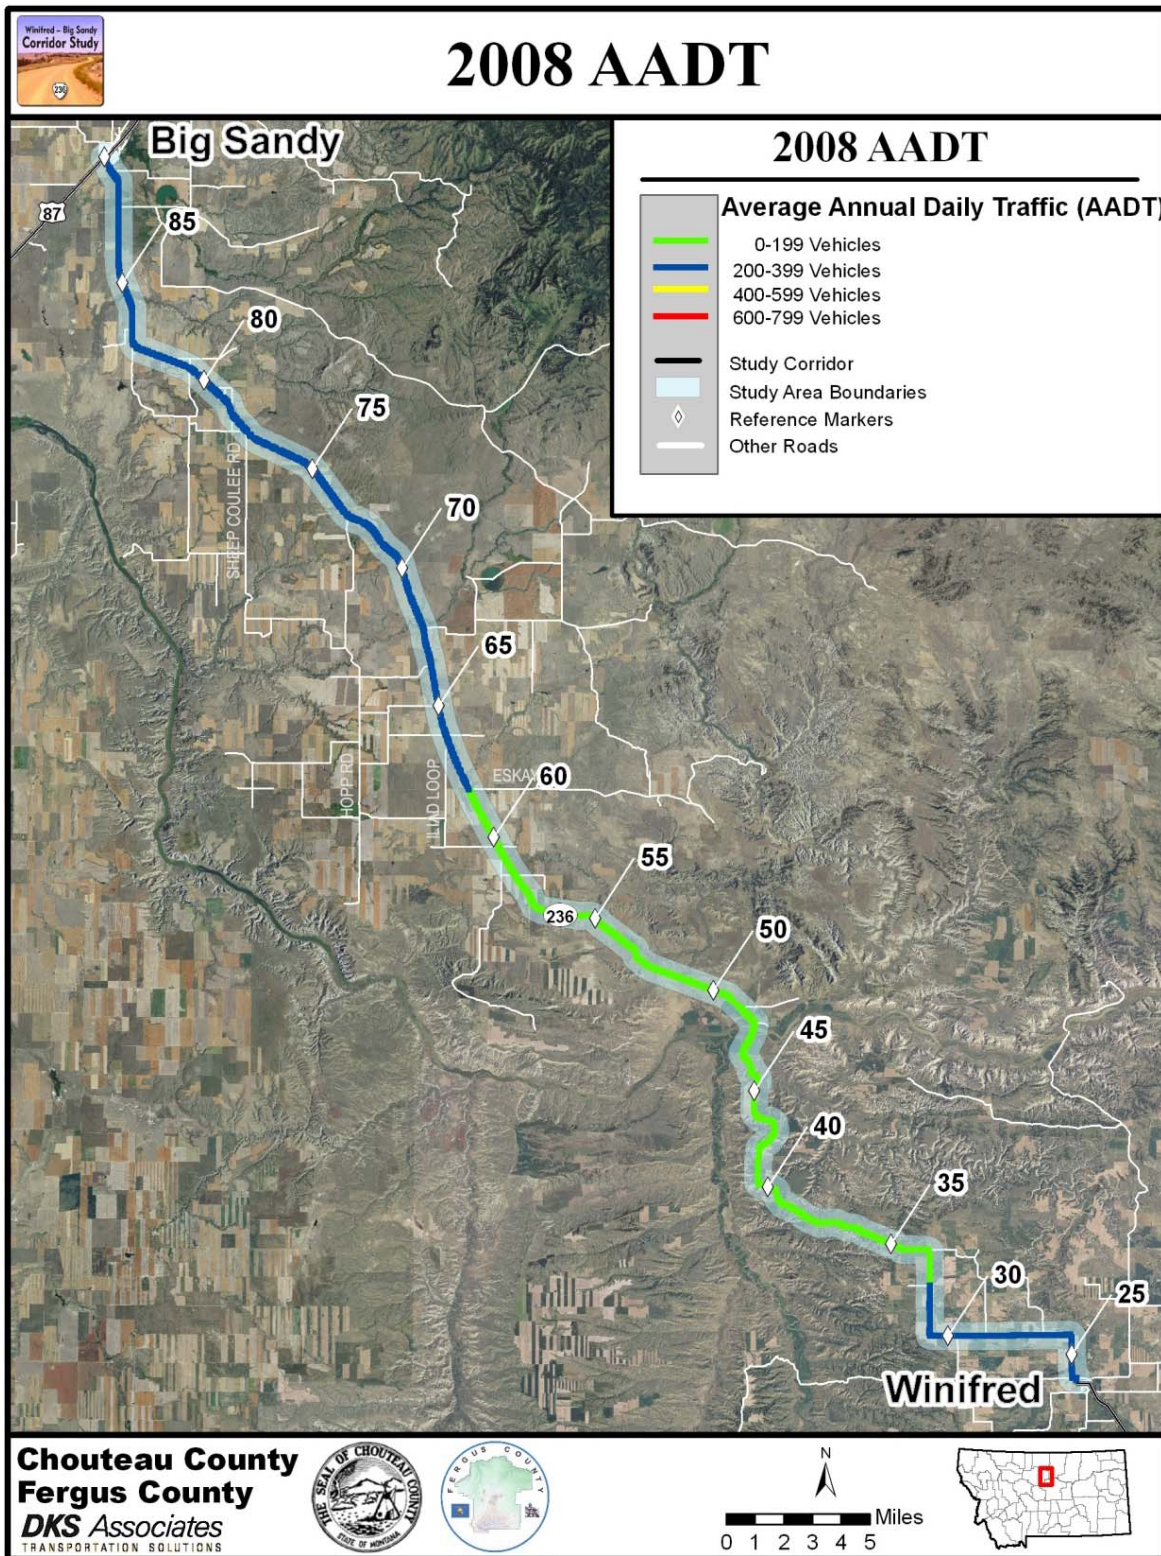
Figure 4
2008 AADT

Existing annual average daily traffic (AADT) volumes are low (Figure 4), ranging from 200 – 300 vehicles per day (vpd) to the north of Winifred and to the south of Big Sandy to less than 200 vpd between Heggem Ln. (R.P. 34) and Eskay Rd. (R.P. 62). AADT is defined as the annual total two-way traffic volume along a particular segment, divided by the number of days in the year. The AADT volumes were derived from traffic volume data received from MDT's Traffic Data Collection Section. Although monthly traffic data was not available, it is likely that volumes are somewhat higher in the summer months due to increased agricultural traffic and recreational traffic destined for the Missouri River.

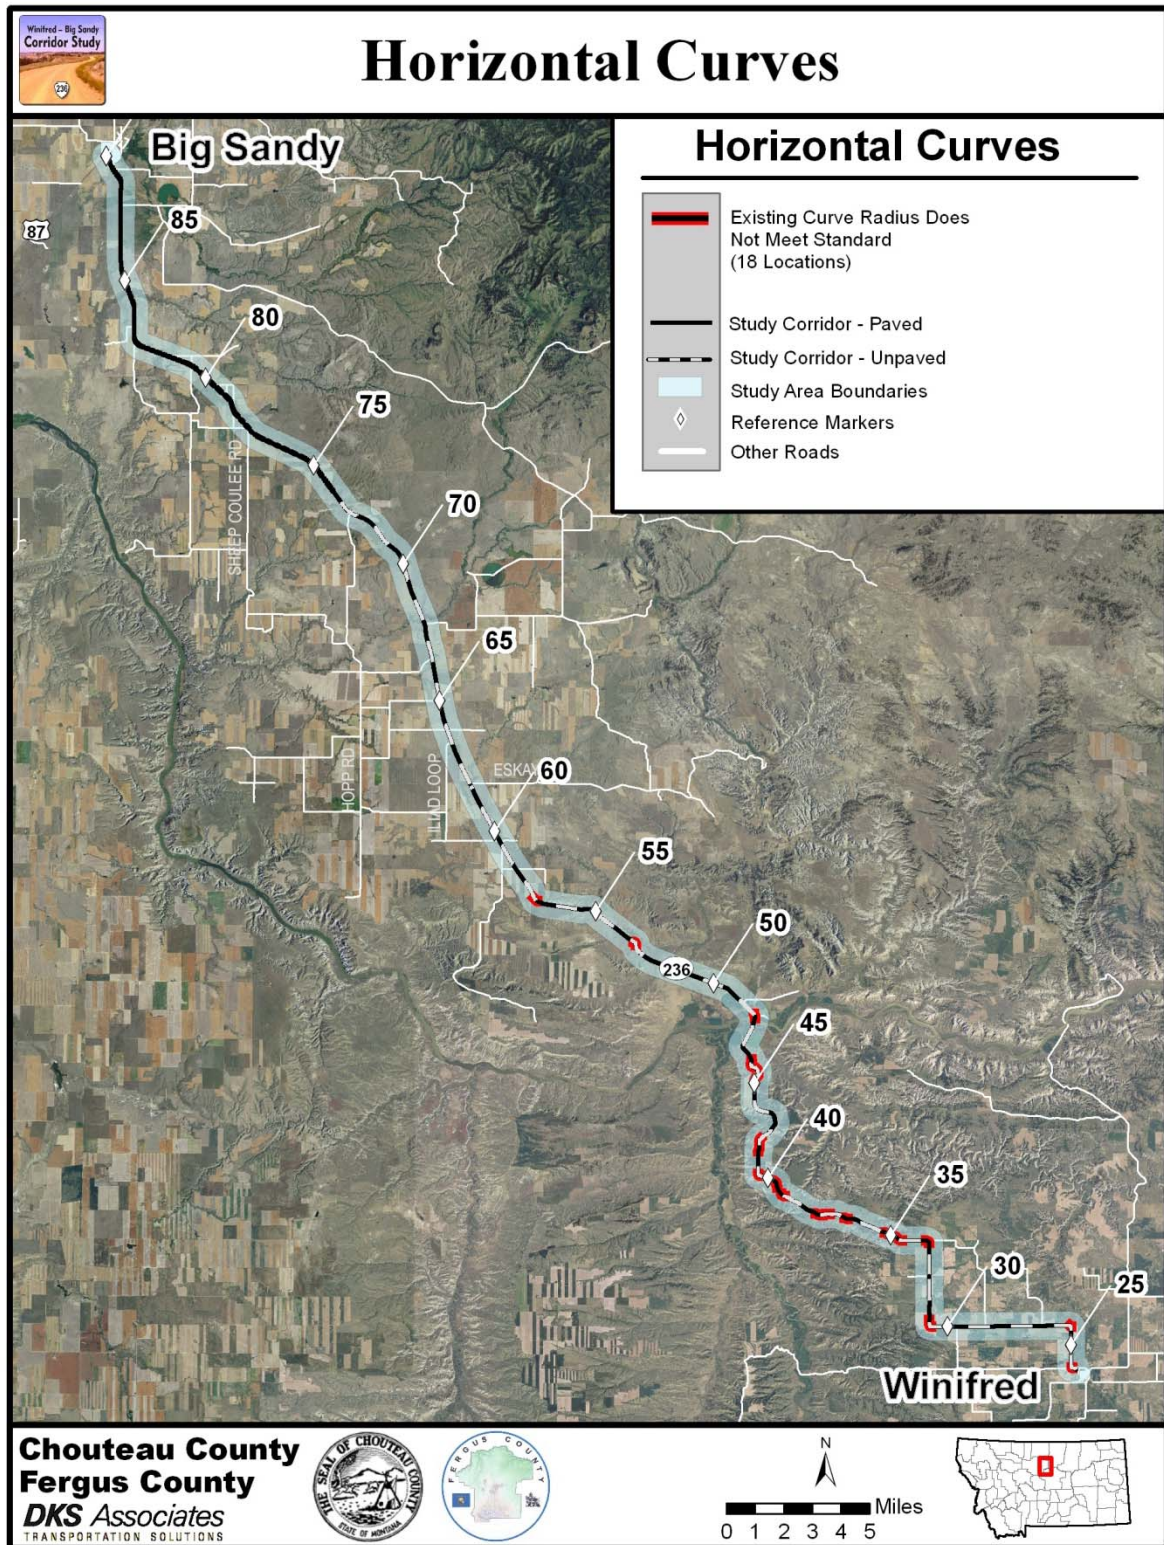
Figure 10
Horizontal Curves

The lengths of the horizontal curve radii were measured using aerial images of the corridor. As shown in Figure 10, there are 18 locations along the corridor where the horizontal curvature does not meet MDT's standards. Similar to the sight distance limitations, all of these are in the southern half of the corridor between R.P. 24 and R.P. 57. The highest concentration is in the area to the south of the Missouri River, where the roadway winds through hilly terrain. This includes three 90-degree curves just to the north of Winifred.

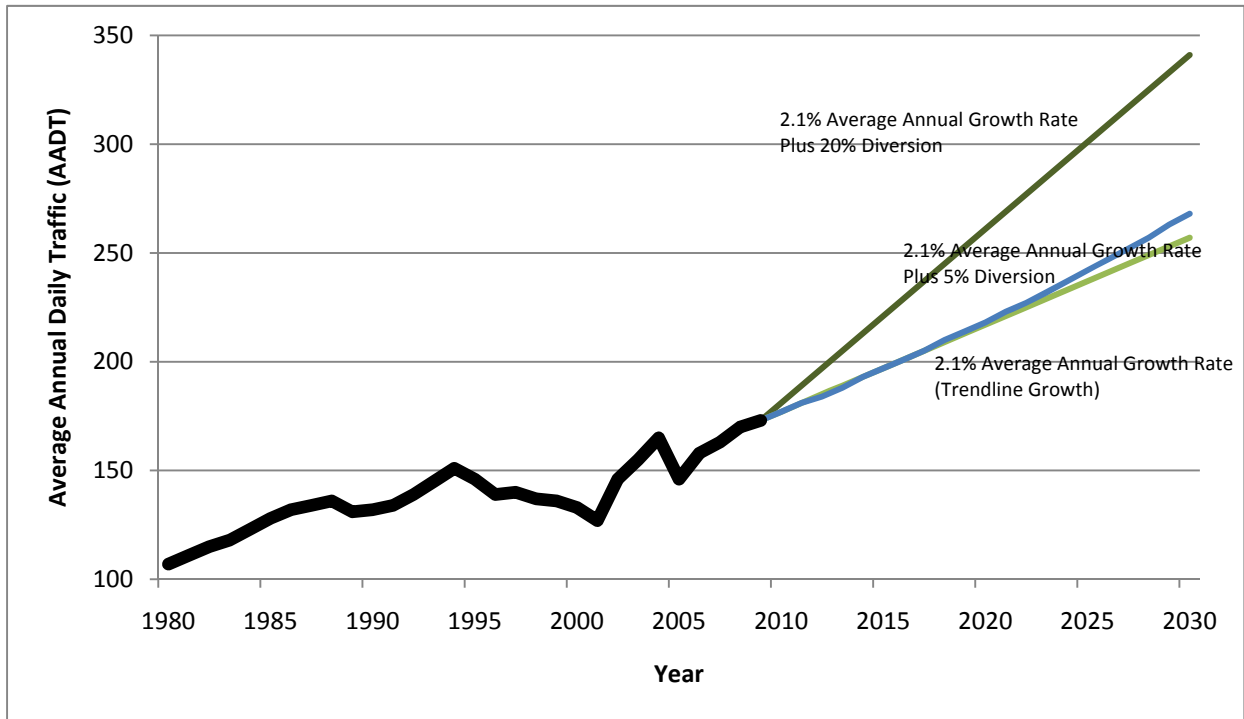
**Figure 17
Future Traffic Growth With Diversion**

the trendline growth-only scenario, the roadway would need to be 28-feet wide for Segment 1 (R.P. 24 – R.P. 32.4) and Segment 5 (R.P. 80.6 – R.P. 89.9) in order to meet the standard. The same width requirements would be true for low (5%) diversion scenario, with volumes
