Montana Department of Transportation
Research Programs
May 2011

EVALUATION OF RECYCLED PLASTIC MATS AS WEED PREVENTION AND EROSION CONTROL AROUND GUARDRAILS

Final Report

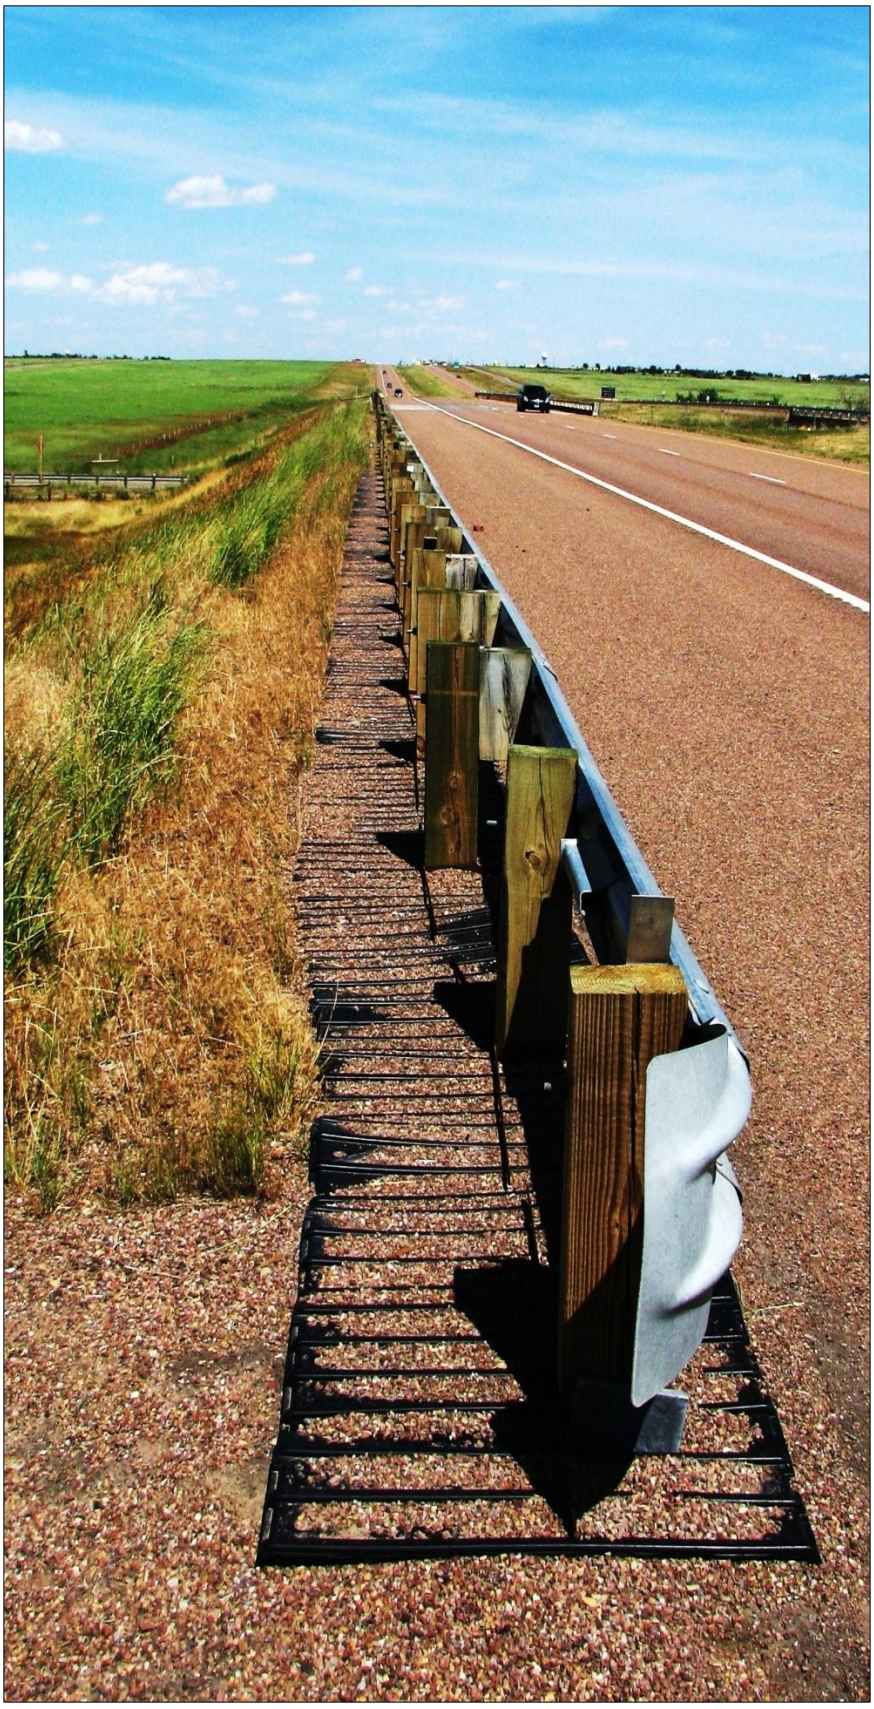
August 2009

← Overview of weed mat installation; northbound lanes, looking south. Image shows that the product to date is effective in weed control around guardrails.

Damage seen in bottom of image is from earlier (assumed) snow-plow damage documented in the August 2008 report.

← Overview of weed mat installation; southbound lanes, looking north. Image shows that the product to date is effective in weed control around guardrails. No erosion is visible to date.

- Fragmentation of the leading edge of mat (to roadway) still continues. This condition affects to date approximately about 15% of the project. It is speculated that accumulated sanding material, road debris, etc.; in addition to snow and ice while being cleared by a snow plow; may be forcing that mass against the mats and supporting brackets creating back pressure that are fracturing the UWC and deforming the brackets without the plow blade coming in contact with the UWC.

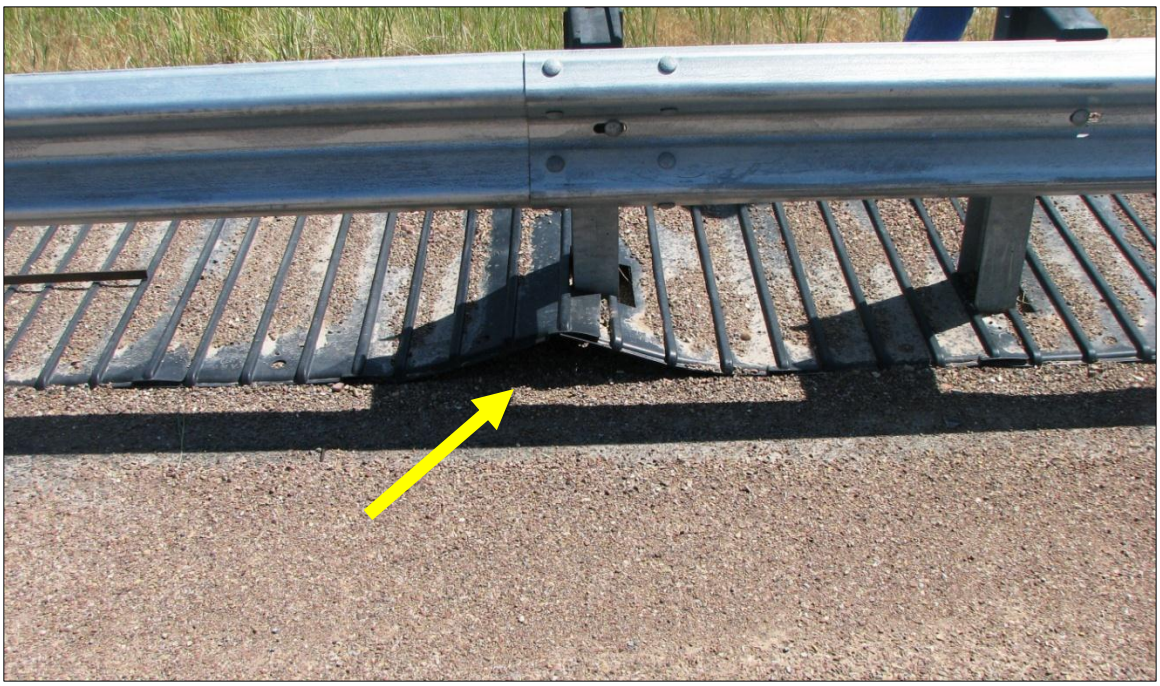
- As seen in the image below. The mats are well behind the rear of the guardrail where a snow plow blade would be unable to come in contact with the mat and cause damage.

⬅⬆ Another issue with durability is the excessive curling (or warping) of the UWM edges (yellow arrows). This may be the result of temperature extremes or sunlight degradation or a combination of both. This condition may also promote further cracking of the mats or allow road debris to accumulate under the UWM reducing its effectiveness.

As seen in these images, small mammals have discovered that the UWM offers a convenient burrowing habitat due to the warping issue. This occurrence is predominate on the southbound lane installation. This use of habitat may promote erosion of the shoulder and slope reducing the integrity if the roadbed due to the potential of runoff entering the burrows.

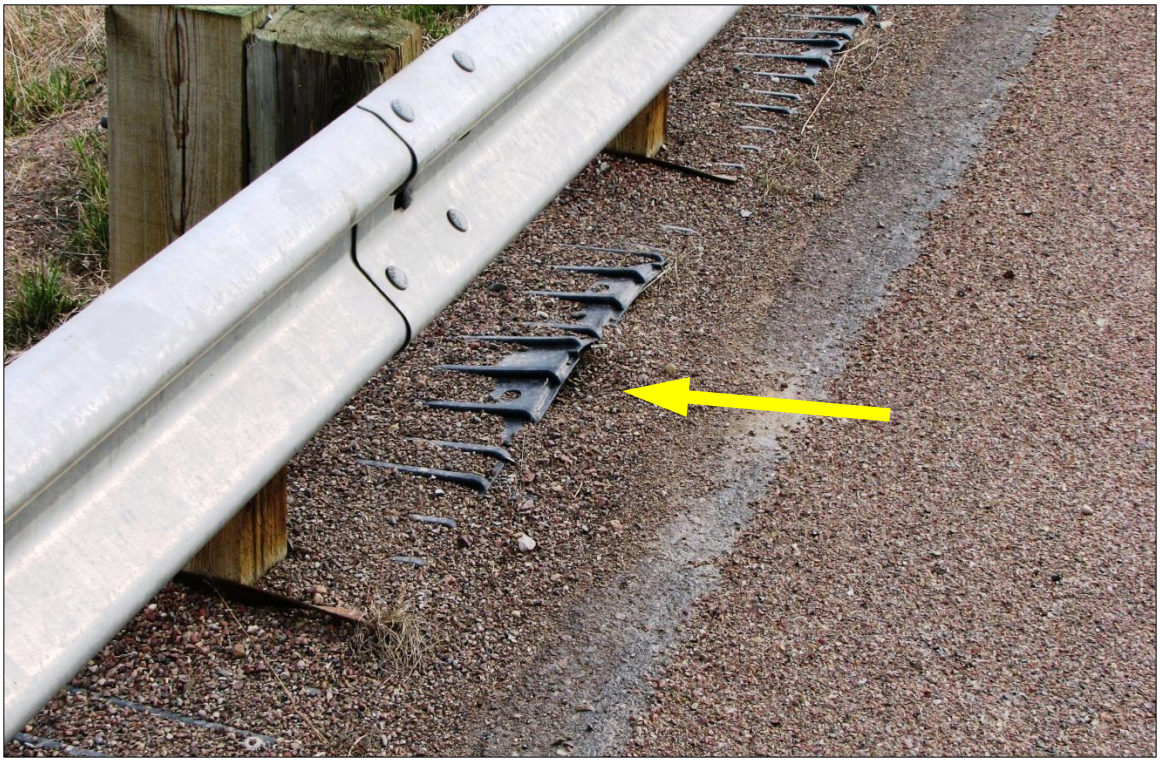
May 2011

🡻🡹 An ongoing problem is the fracturing of the edges of the UMC. As seen in the image below, the mat edge is well inside the interior edge of the guardrail. The current assumption is that during winter snow removal, with accumulated sanding material added to snow and ice; that the action of the passing plow blade inadvertently pushes that mass to the mat causing the damage seen. Currently about 25% of the UMC are affected.

🡅 As seen in this image, vegetation is beginning to broach at the connecting seams of the UMC. This appears mainly on the southbound section.

🡅 As reported in earlier documentation, the curling of the UWM has allowed small mammals to burrow under the mats for habitation. This burrowing may degrade the integrity of the shoulder if water through precipitation and snow melt erode the base. This burrowing has only been seen on the southbound installation.
