ALKALI-SILICA REACTIVITY IN THE STATE OF MONTANA

FHWA/MT-21-006/9577-607

Final Report

prepared for
THE STATE OF MONTANA
DEPARTMENT OF TRANSPORTATION

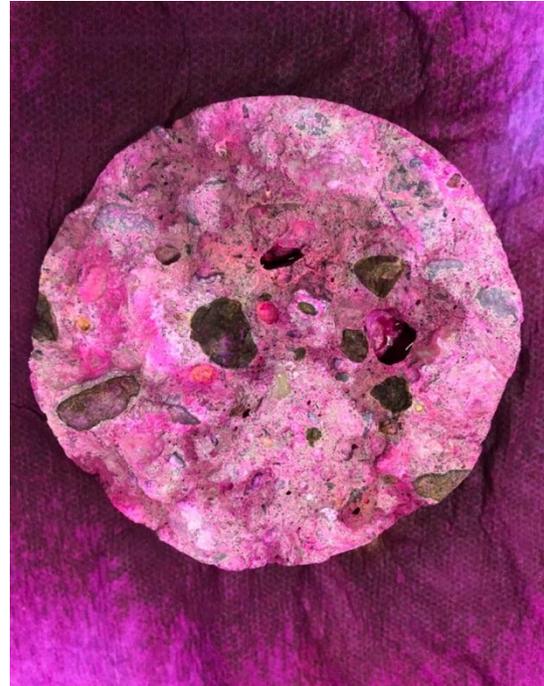
Figure 10: Los Alamos Staining – Yellow

The Los Alamos Staining Method [54] was used to establish the existence of ASR in the concrete cores. Two cores, one from each site, were tested according to this method. To start, distilled water was applied to the freshly broken surface of each test specimen. Next, the yellow reagent was applied to the test surface and subsequently washed off with distilled water spray. The surface was then dried and examined for the presence of ASR gel, indicated by a bright yellow stain. The procedure was completed again on the same test surface using the red reagent. In this case, bright pink with yellow stains were indicative of advanced ASR. The results of the initial round of staining are shown in Figure 10. The bright yellow stain surrounding the aggregate particles and in the voids of the concrete signify that presence of ASR gel in both specimens. The results of the subsequent round of staining, shown in Figure 11 appear to confirm the presence of advanced ASR. It should be noted that the results of this test method were subjective, and in no way definitively confirm the presence of ASR. However, after reviewing the results of the petrographic analysis, and gaining an understanding of the signs of ASR damage, it was evident that these cores were affected by ASR. That said, the extent of the damage cannot be conclusively characterized as severe/advanced based on the results of this method.

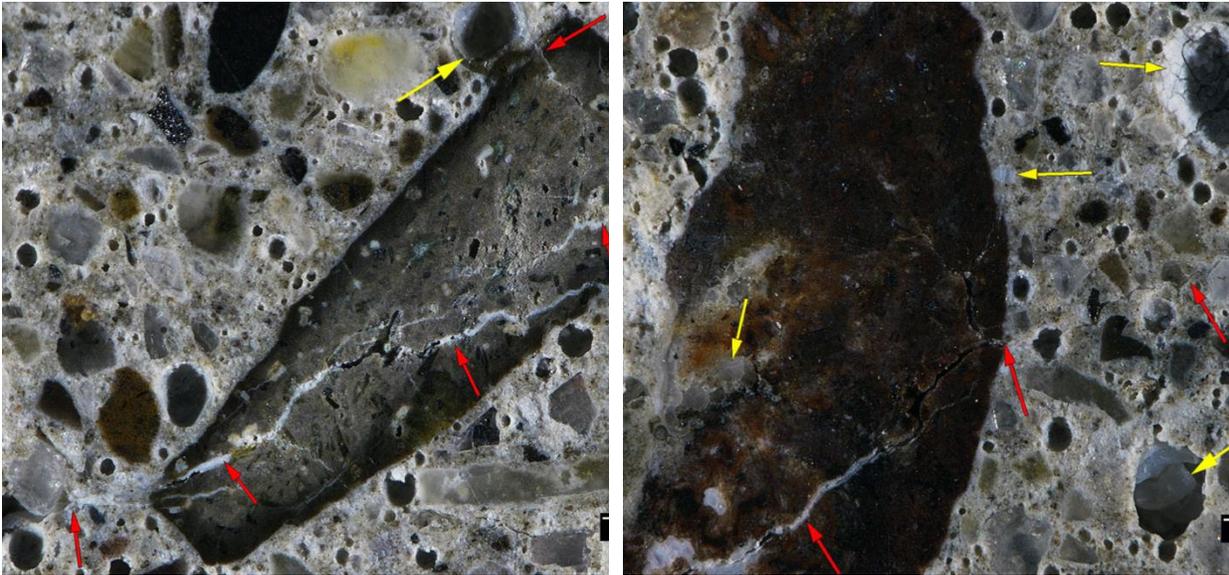
cracking are distinct failure mechanisms, both expedite the existence of alkali-silica reactivity. The ASR-related cracking and microcracking was significant in both cores. ASR gel deposits were detected within the cracks and surrounding the aggregates. Figure 12 shows a reflected light photomicrograph of the polished surface of Core 1a. In these images, microcracks (red arrows), filled with ASR gel, can be seen cutting through various aggregate particles. The yellow arrows indicate ASR gel either lining a void or within an aggregate particle. Similarly, the red arrows, shown in Figure 13 (Core 2a), indicate microcracks filled with ASR gel, while the yellow arrows reveal a significant ASR gel deposit in the middle of the core. As a result of the findings, the ASR in both cores was rated severe according to a criteria developed by DRP (Table 1) and Stage V using an alternative evaluation scheme (Table 2).

Figure 12: Core 1a Microcracking (Red Arrows) and ASR Gel (Yellow Arrows) [60]

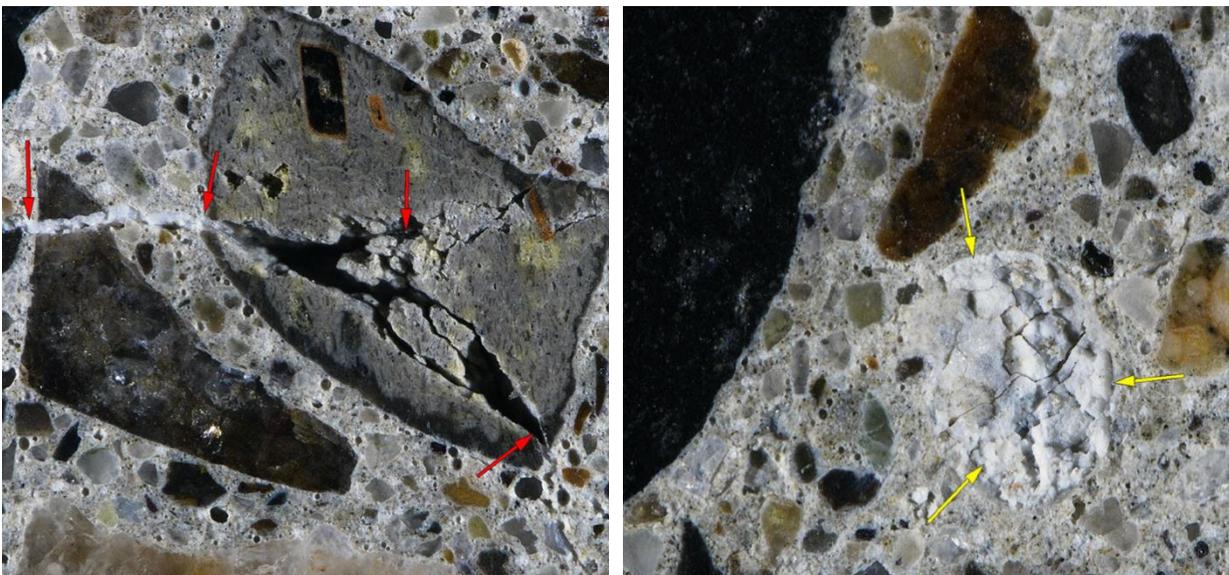
Figure 13: Core 2a Microcracking (Red Arrows) and ASR Gel (Yellow Arrows) [60]

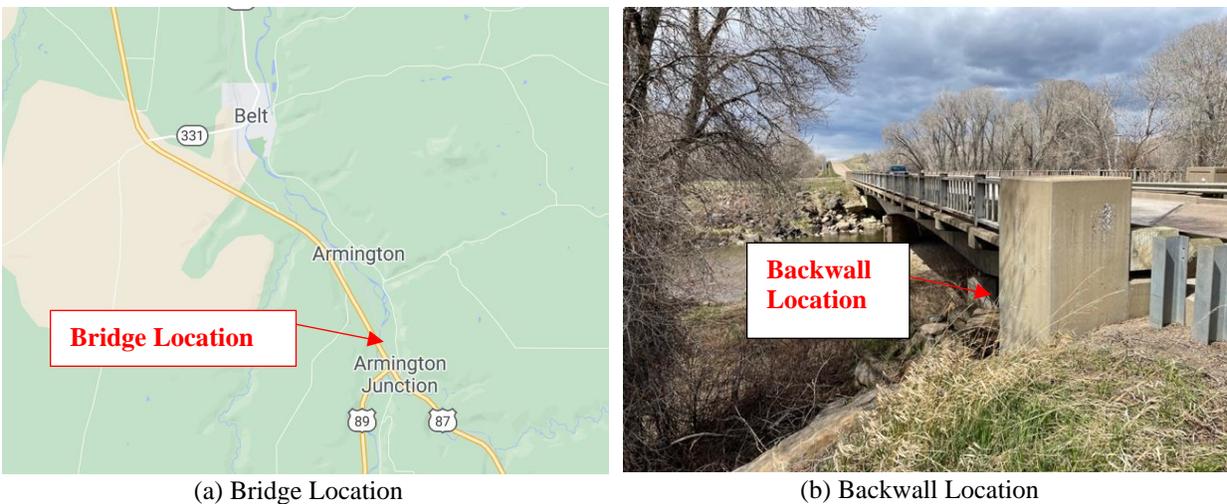
Figure 14: Bridge and Backwall Location

Potential ASR damage was identified by MDT on a bridge on US-87/US-89/MT 200 over Belt Creek southeast of Belt, MT. The site location and the location of the damage relative to the bridge are shown in Figure 14. One of the backwalls and girders were observed to have significant cracking and efflorescence, as shown in Figure 15. The bridge was built in 1954, is 33.5 ft wide, and has an overall span of 156 ft. Little information was available regarding the composition of the concrete (e.g., mix design, aggregate source, mitigation measures). Additionally, no information was readily available regarding the original construction specifications or records of testing completed during or after construction. Based on the petrographic examination (discussed below), ASR was determined to be a factor in the deterioration. This section describes the coring process, and the results from this investigation.

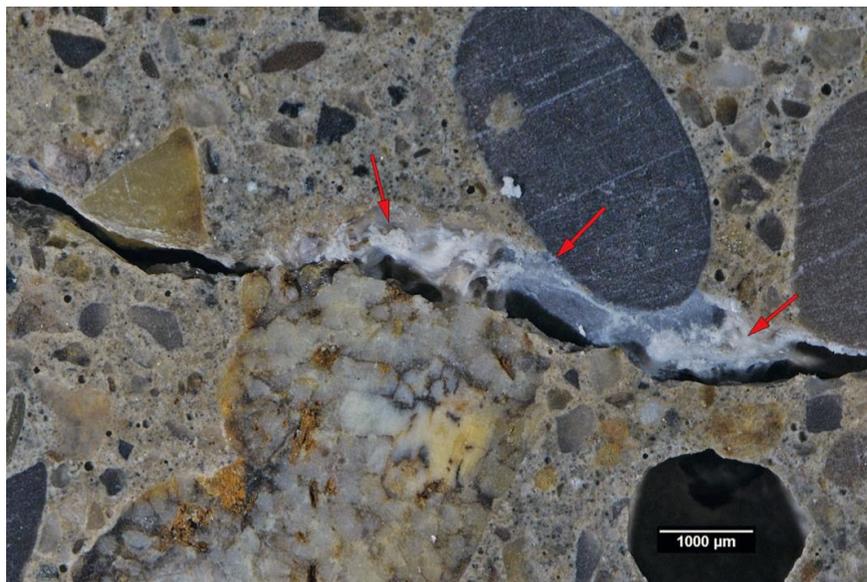
The findings from this scope of work indicate that the concrete shows moderate to severe damage from ASR based on a qualitative scale from DRP (Table 1). The progression of the reaction is at Stage IV of six stages using the scale of Katayama (Table 2). The ASR involves siliceous limestone, quartzite, and granitic rocks in the coarse and fine aggregate. Figure 19 shows the light photomicrographs of the polished surface of the main crack in the core. The area shown in this figure is approximately 20 mm (3⁄4 in.) from the outer surface of the bridge. The red arrows highlight deposits of ASR gel that line the walls of the crack. Figure 20 are photographs of the inner fracture surface of the core showing detail of ASR gel deposits around aggregate particles.

Figure 19: Reflected Light Photomicrographs of the Polished Surface

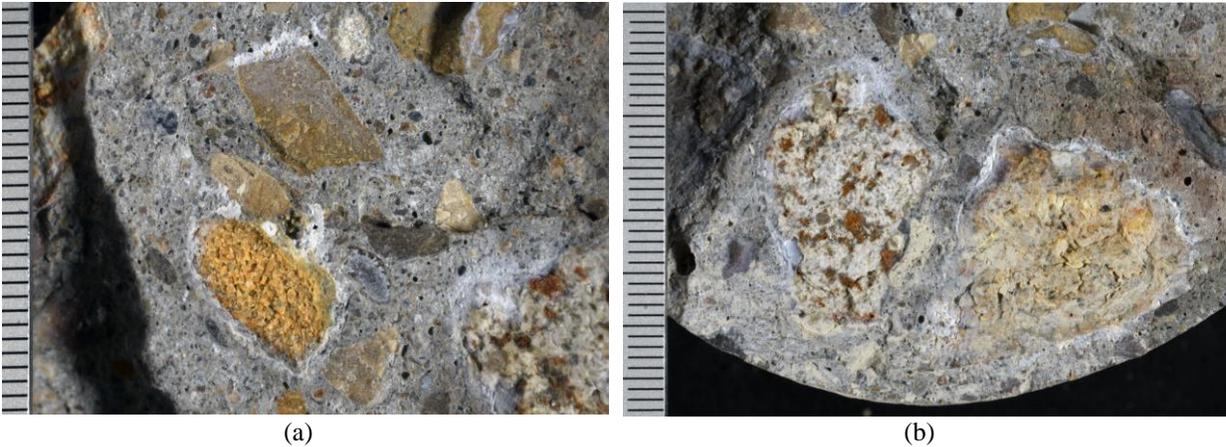
Figure 20: Photographs of the Inner Fracture Surface of the Core
