# **Drilled Shaft Construction**

## **MDT Project Case Studies**

## **Introduction**

This document provides some examples of problems that have occurred with drilled shafts on MDT projects and discusses general construction methods that may help avoid recurrence of the problems. It will be updated periodically.

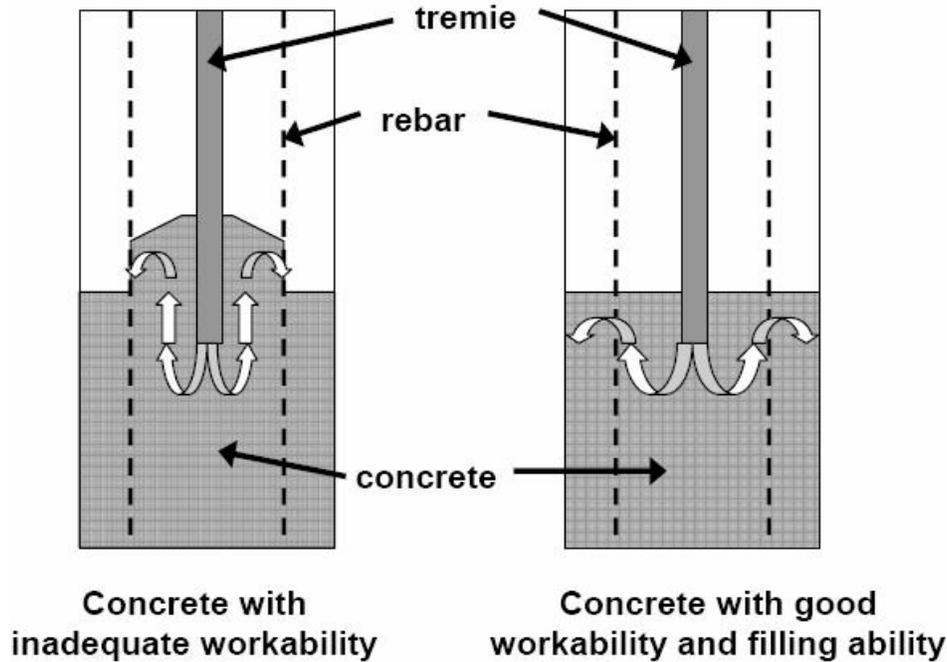
Figure 4. Concrete flow under tremie pipe placement (Brown and Schindler 2007)

- Loss of workability can increase shear resistance between temporary casing and the concrete. The increased shear resistance can cause necking or voids as the temporary casing is removed.
- Loss of workability can create a concrete “vent” during placement allowing laitance to become entrapped. See Figure 1.
- Loss of workability will limit the concrete's ability to flow through the reinforcement cage. An illustration of this can be seen in Figure 10. Laitance or soil can become entrapped along the shaft perimeter as the high level of concrete within the cage spills over or through the rebar cage above rebar splice zones and falls down into the space outside the cage.

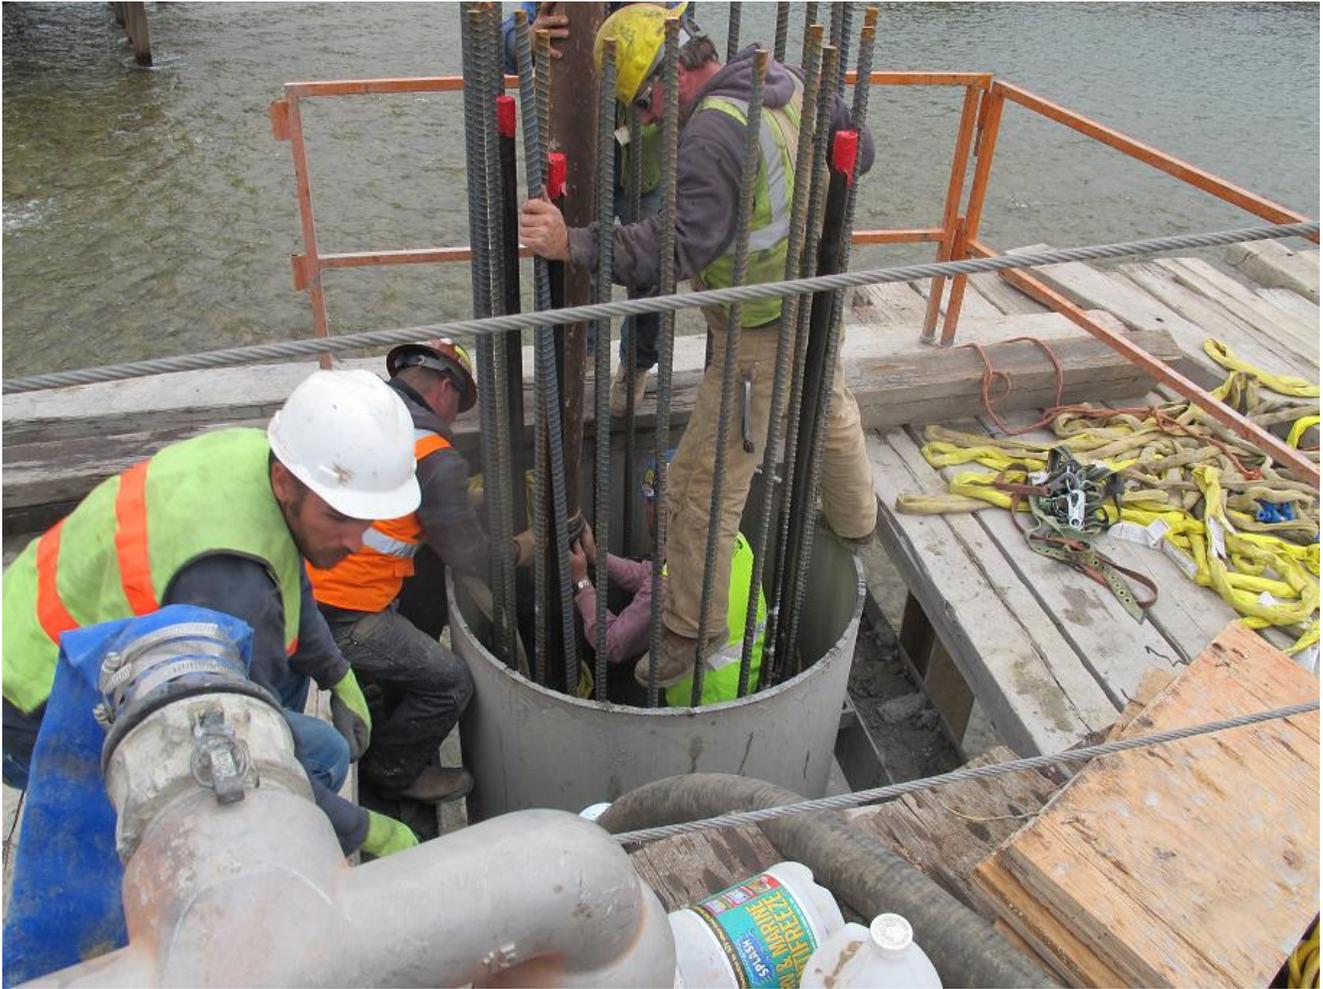
Figure 11 Assembling Concrete Placement Tube

In the photo below, workers are assembling the concrete placement tube which consisted of several 3.1 meter long segments of 150mm diameter steel pipe, coupled together with quick release couplers.

Concrete placement started about 1:30 PM. At 3:30 PM, while concrete was still being placed, it became apparent that one of the couplings in the placement tube had failed which had allowed some volume of concrete to be dropped through the standing water within the shaft. The contractor stopped placement and dewatered the shaft in an attempt to retrieve the disconnected section of pipe. This was unsuccessful and the contractor finally decided to abort the placement and attempt to remove the reinforcing cage. Even though the concrete had not taken set, the contractor was unable to hoist the cage.

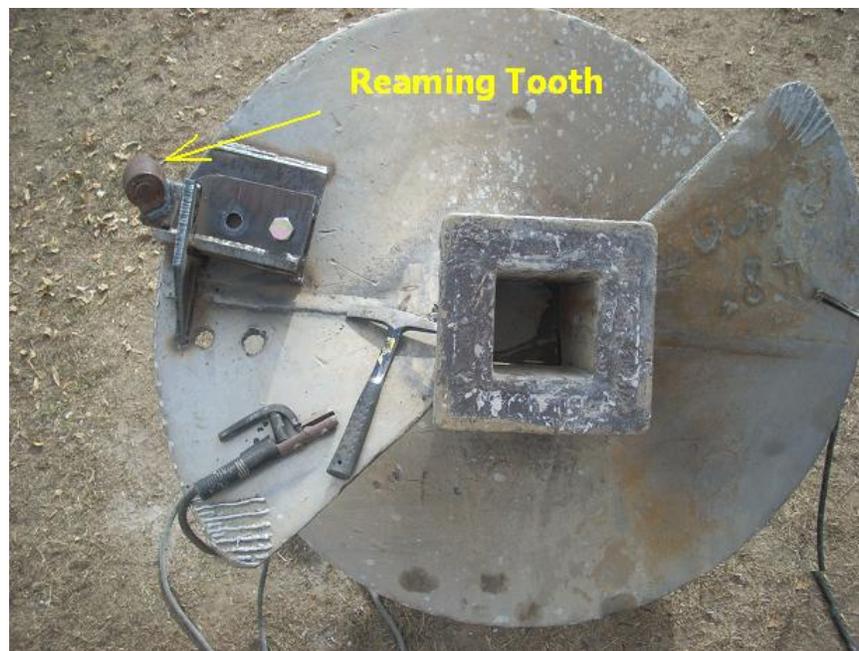
Figure 15 Drilling Tool Modification

After discussions between the project design consultant and the geotechnical sub-consultant, it was determined that the shaft depth would have to be increased by 650mm and the diameter would have to be over-reamed by at least 100mm. The over-reaming was required because of concern that the shaft sides, the claystone layer in particular, may have softened due to long term exposure to water. The contractor fabricated a folding reaming tooth and added it to the drill tool. This allowed the reamer to fit through the upper cased portion of the shaft and then expand to widen the excavation through the claystone layer.

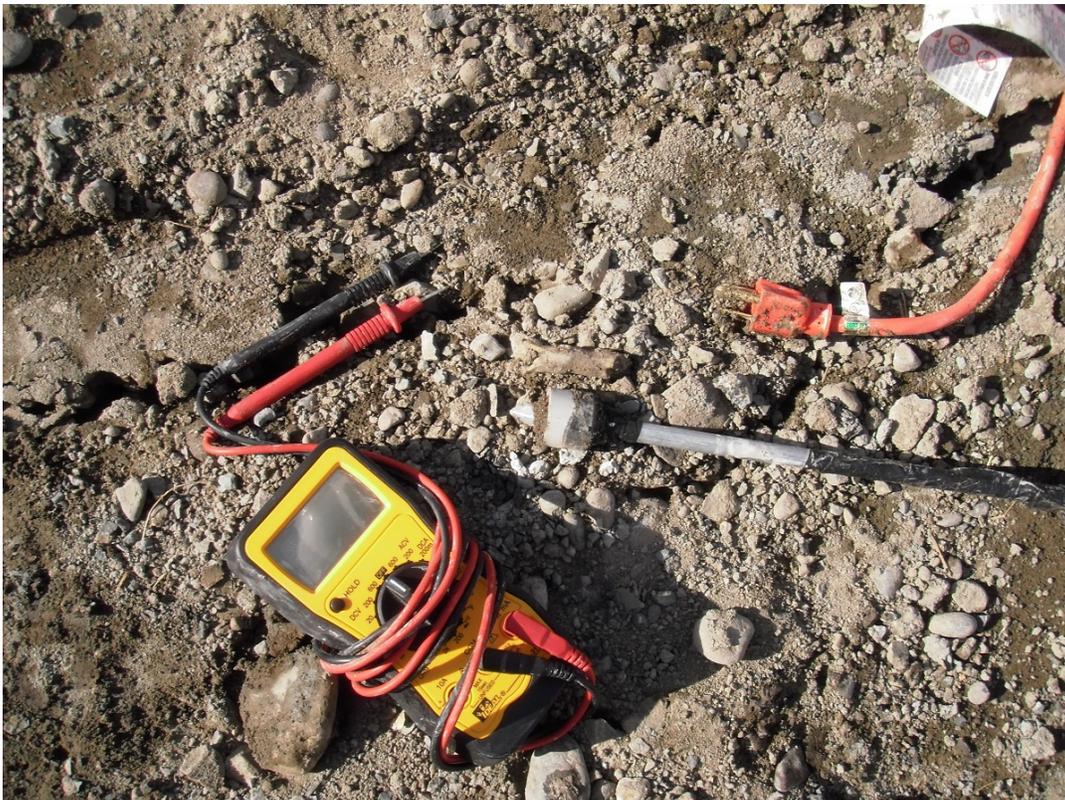
Continuity Probe and Multimeter

The contractor also cored Bent 5. The first two core holes did not find any significant defects. The contractor was then required to remove the fluid from the CSL tubes and drill holes in the steel caps that seal the tube bottoms. The contractor was reluctant to drill beyond the bottom of the caps. Based on before and after measurements, it was not certain whether or not each tube bottom had been penetrated. A continuity tester was made by connecting 100' of wire (an extension cord) to a 12 inch steel spike. The sides and head of the spike were insulated with tape so that only the tip of the spike was exposed to contact when inserted into the CSL pipe. By dropping the probe to the bottom of the CSL tube and checking electrical continuity between the probe and the tube at ground level, it was possible to determine which tubes had not been drilled out. Two tubes required additional drilling.

Measurements taken after drilling found that sand had entered several of the tubes. Two of the tubes had as much as 10 feet of sand. In addition water was applied at low pressure to each of the tubes, in turn, to see what the effects would be. Tubes 5 and 7 produced water when water was applied to tube 6 indicating connectivity there. By comparing the static water level outside the permanent casing and the water level in the tubes after some time, it was thought that there was likely connectivity between the void and the groundwater. All of this information was taken to indicate that a defect was likely present around the perimeter of the base of the shaft so two more cores were drilled. Sand pockets were found at a depth of approximately 52' and at the shaft bottom. Dave Cunningham of MDT Geotech was on site for several days assisting the project staff with logging the cores.

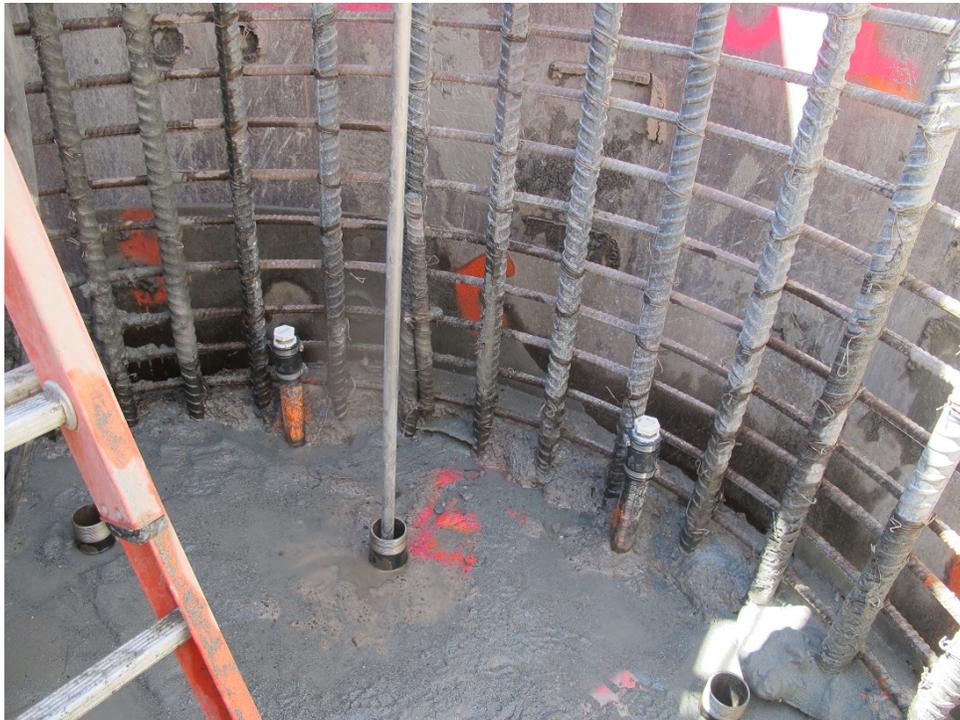
Top of the Bent 4 Drilled Shaft

The photo below shows CSL tubes capped with plumbing fittings and core holes having short threaded steel pipes grouted in place to facilitate capping and pressurizing.

4/10/2013: A similar procedure was used for repair of the Bent 4 shaft. However, using compressed air to clean the voids was not effective for this shaft due to inflow of new sand. Flushing the voids with water while maintaining a full head of water within the void system appeared to be effective at removing much of the sand. The Bent 4 shaft required approximately 6 cubic yards of grout and the grouting process took approximately 6 hours to complete.

- **Be certain that unstable soils are prevented from entering the excavation.**
- **For defects occurring at the shaft bottom, consider drilling out CSL tubes bottoms to use as cleaning and grouting ports. This was very effective on this project.**
- **When grouting defects, the pneumatic packers were found to be unreliable. It is recommended that threaded steel nipples be grouted into each core hole that will be used in the repair process.**

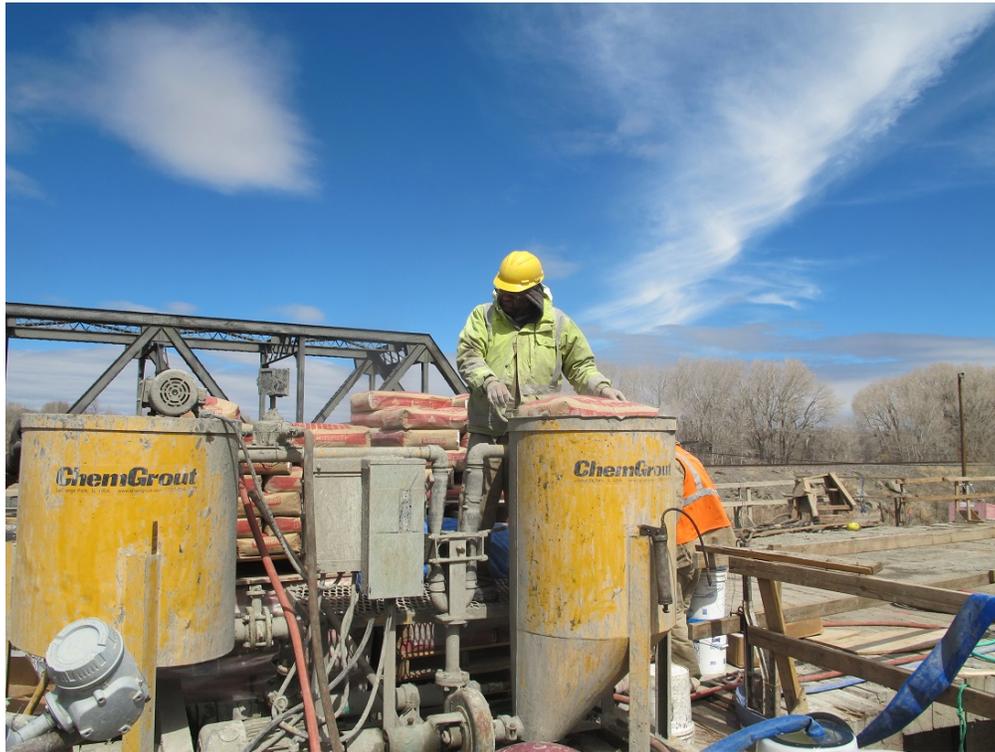
Mixing Grout on Site with Portable Mixing Plant

Grout was mixed on site. The mixture used consisted of cement, water, set retarder and a shrink reducing admixture.

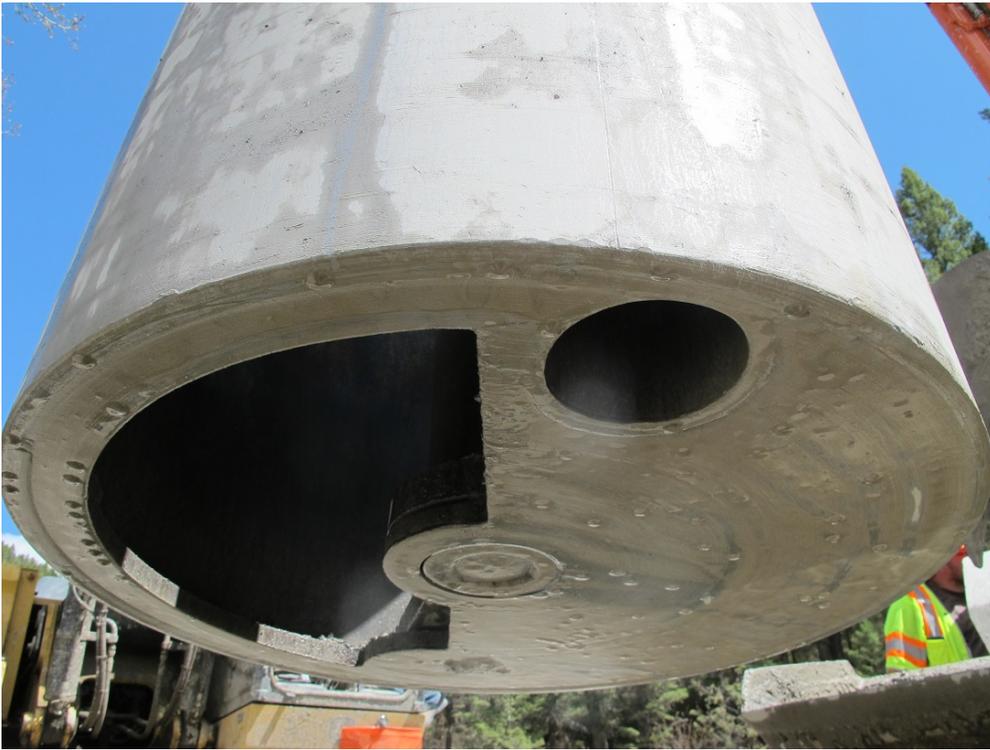
Figure 16 Bottom of Cleanout Bucket.

Shaft 4 was sounded a second time, after the reinforcing cage was placed, and it was determined that the bottom was no longer clean. The contractor removed the cage and performed additional cleanout. The presence of sand was observed on the bottom hoop of the cage, indicating sand was present in the excavation to a depth of at least 8 inches.

After additional cleanout the excavation was sounded again and thought to be clean. The cage was replaced and concrete was cast.

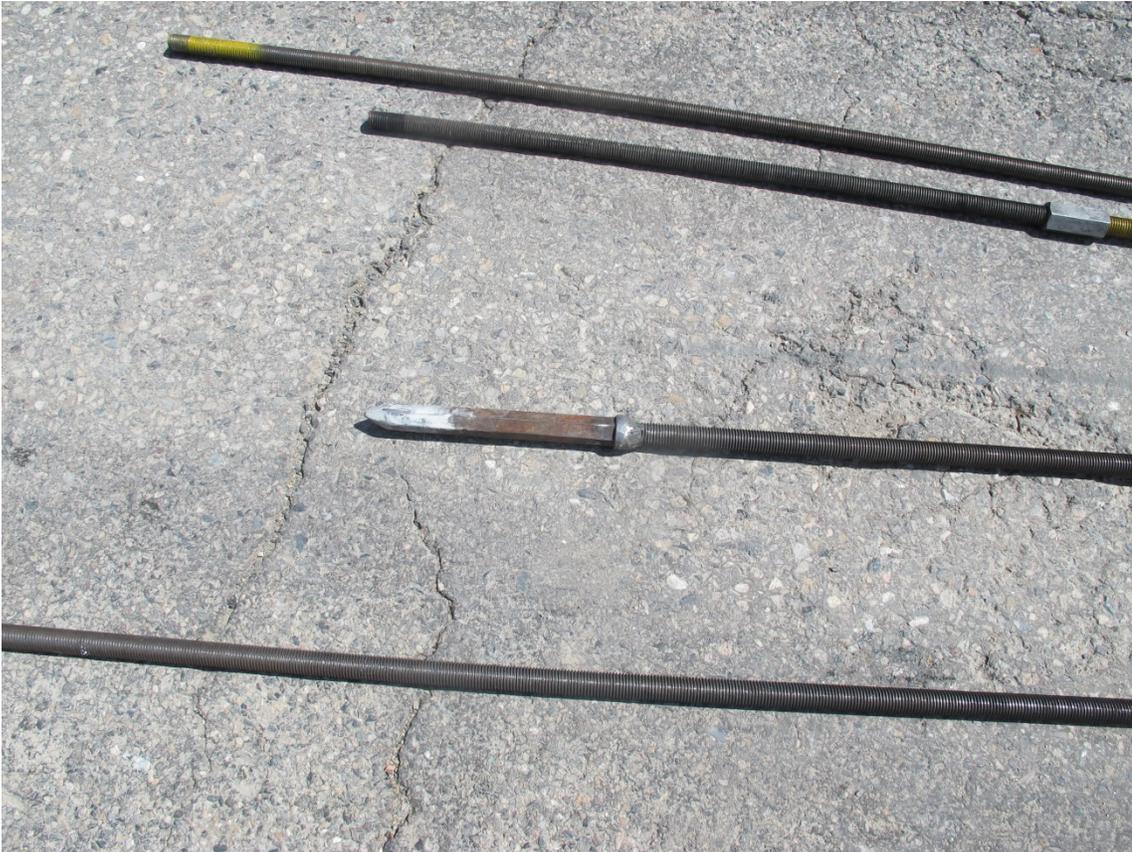
Figure 18 Spear Tool with Rod Extensions

The contractor tried drilling and then puncturing the CSL tube caps. It was found that puncturing the caps with a spear type device was by far more effective than drilling.

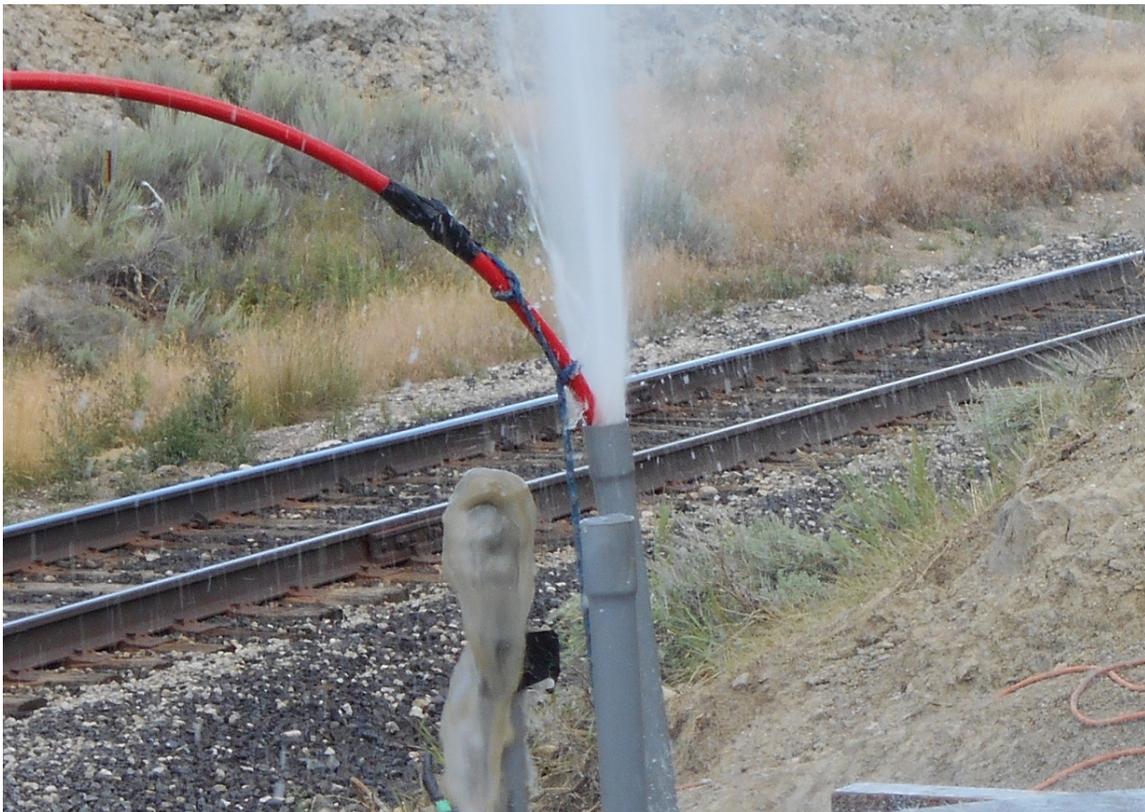
Figure 20 Air Lifting to Clean Out Shaft Toe

After the presence of sand/gravel was confirmed, the contractor used air lifting to flush the void clean. The illustration below shows a typical system. Note that this system has been used on several repairs and is has proven to be a very durable and effective system for removing loose material from within a drilled shaft. Plumbing fittings are arranged to allow the operator to alternately inject water and compressed air into the shaft at the toe. The PEX pipe is easily inserted to the shaft bottom in a core hole or a punctured CSL pipe. To operate, the tube is initially filled with water (water valve open, air valve closed). Next, the water valve is closed and the air valve is opened. A burst of compressed air lifts out loose material that is small enough to exit the annular space between the CSL pipe and PEX pipe. The process is repeated many times in each hole until the void is sufficiently clean. Note that the PEX line must be secured to the CSL tube or rebar cage prior to pressurizing with air. An effective method for doing this

Injecting water into one location, while airlifting from another, was also found to be an effective technique for cleaning the defective areas. Eventually, it was possible to pump water into one tube and observe water free flowing from the other tubes.

After cleanout, the shafts were repaired using a replacement grouting process.
