EXPERIMENTAL PROJECTS FINAL REPORT

CONTECH® A-2000 POLYVINYL CHLORIDE (PVC) PLASTIC PIPE

Project Name: Checkerboard - Martinsdale (CN 4803000)

Project Number: STPP 14-2(20)63

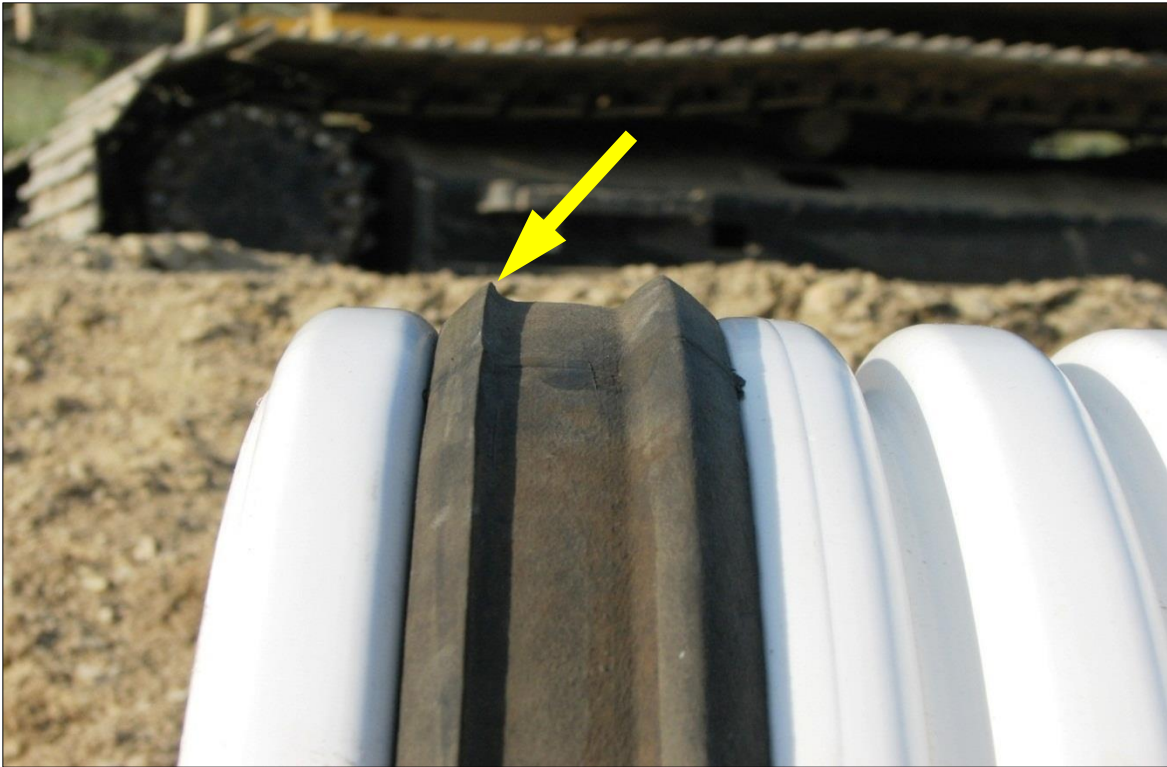
- ↑ Close-up of A-2000 gasket: The low height seal (yellow arrow) is inserted into the first corrugation. This double seal design prevents rolling of the gasket as the sections are being connected.
- ↓ Prior to the pipe connection gasket lube is liberally applied to the gasket and spigot end.

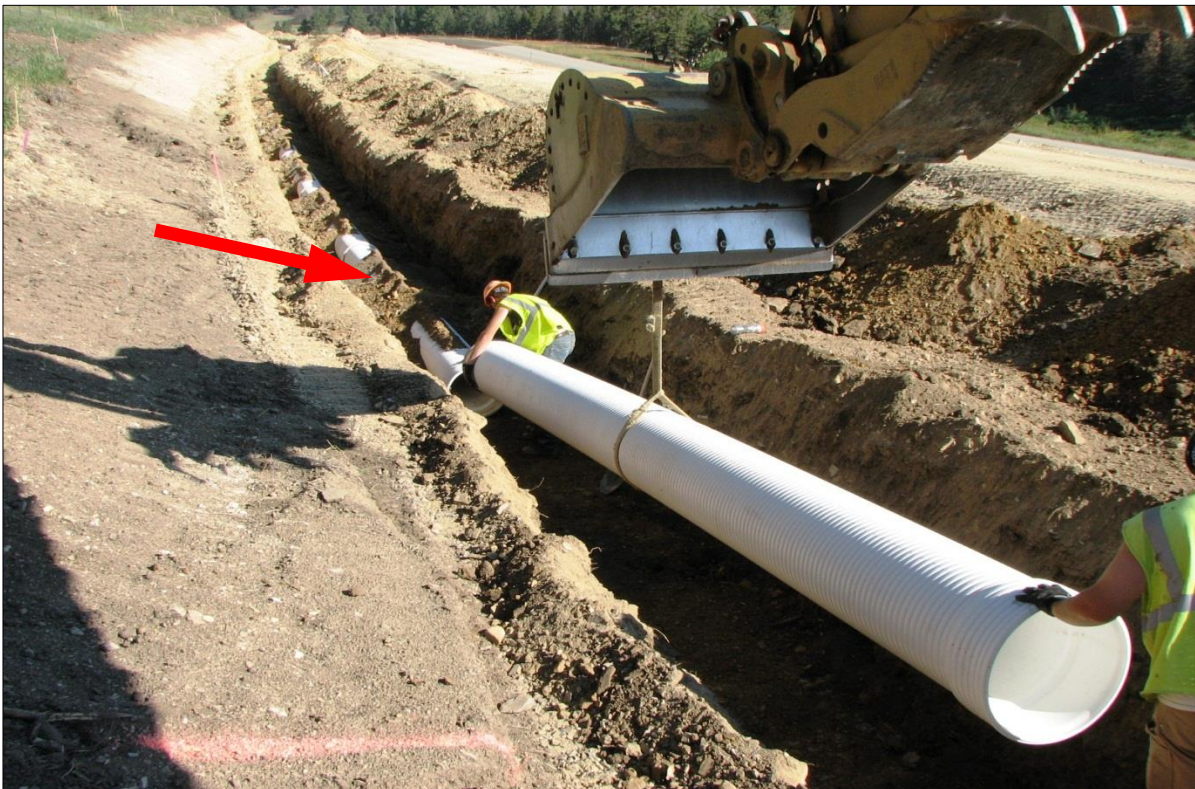
↓ Using an excavator, the pipe section (22'/6.7 m) is brought to the bell connection point. Also note (red arrow) the contractor is using the excavated fill from the trench to initially place and secure the pipe.

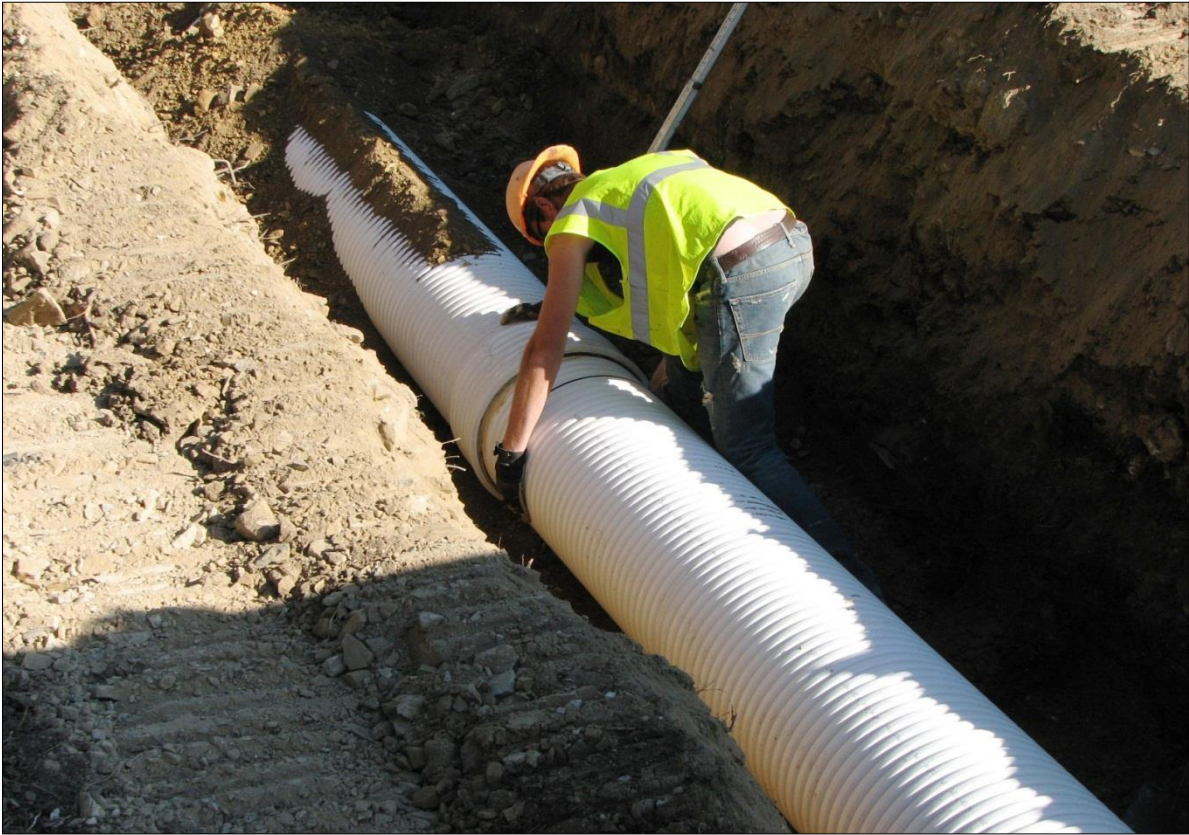
↓ Initially the contractor placed a wooden beam at the base of the pipe then used the excavator bucket to shove the connection to the proper seat.
