EXPERIMENTAL PROJECTS CONSTRUCTION AND EVALUATION REPORT

CENTERLINE CONTRAST STRIPING AND THE ADDITION OF HIGH-VISIBILITY STRIPING MATERIAL FOR ADDED CONSPICUITY IN NIGHTTIME AND WET DRIVING CONDITIONS

Location:	Missoula/Missoula County: North Reserve St. Highway 93 (N 92) – Reference Point 0.0-5.4
Project Name:	Pavement Markings – Reserve St.
Project Number:	NH 92-1(12)0
Experimental Project No.	MT-14-07
Type of Project:	Enhanced Pavement Markings
Principal Investigator:	Craig Abernathy: Experimental Project Manager (ExPM)
Technical Contact:	Gabe B. Priebe, P.E.: Traffic Project Engineer
Date of Installation:	September 2015

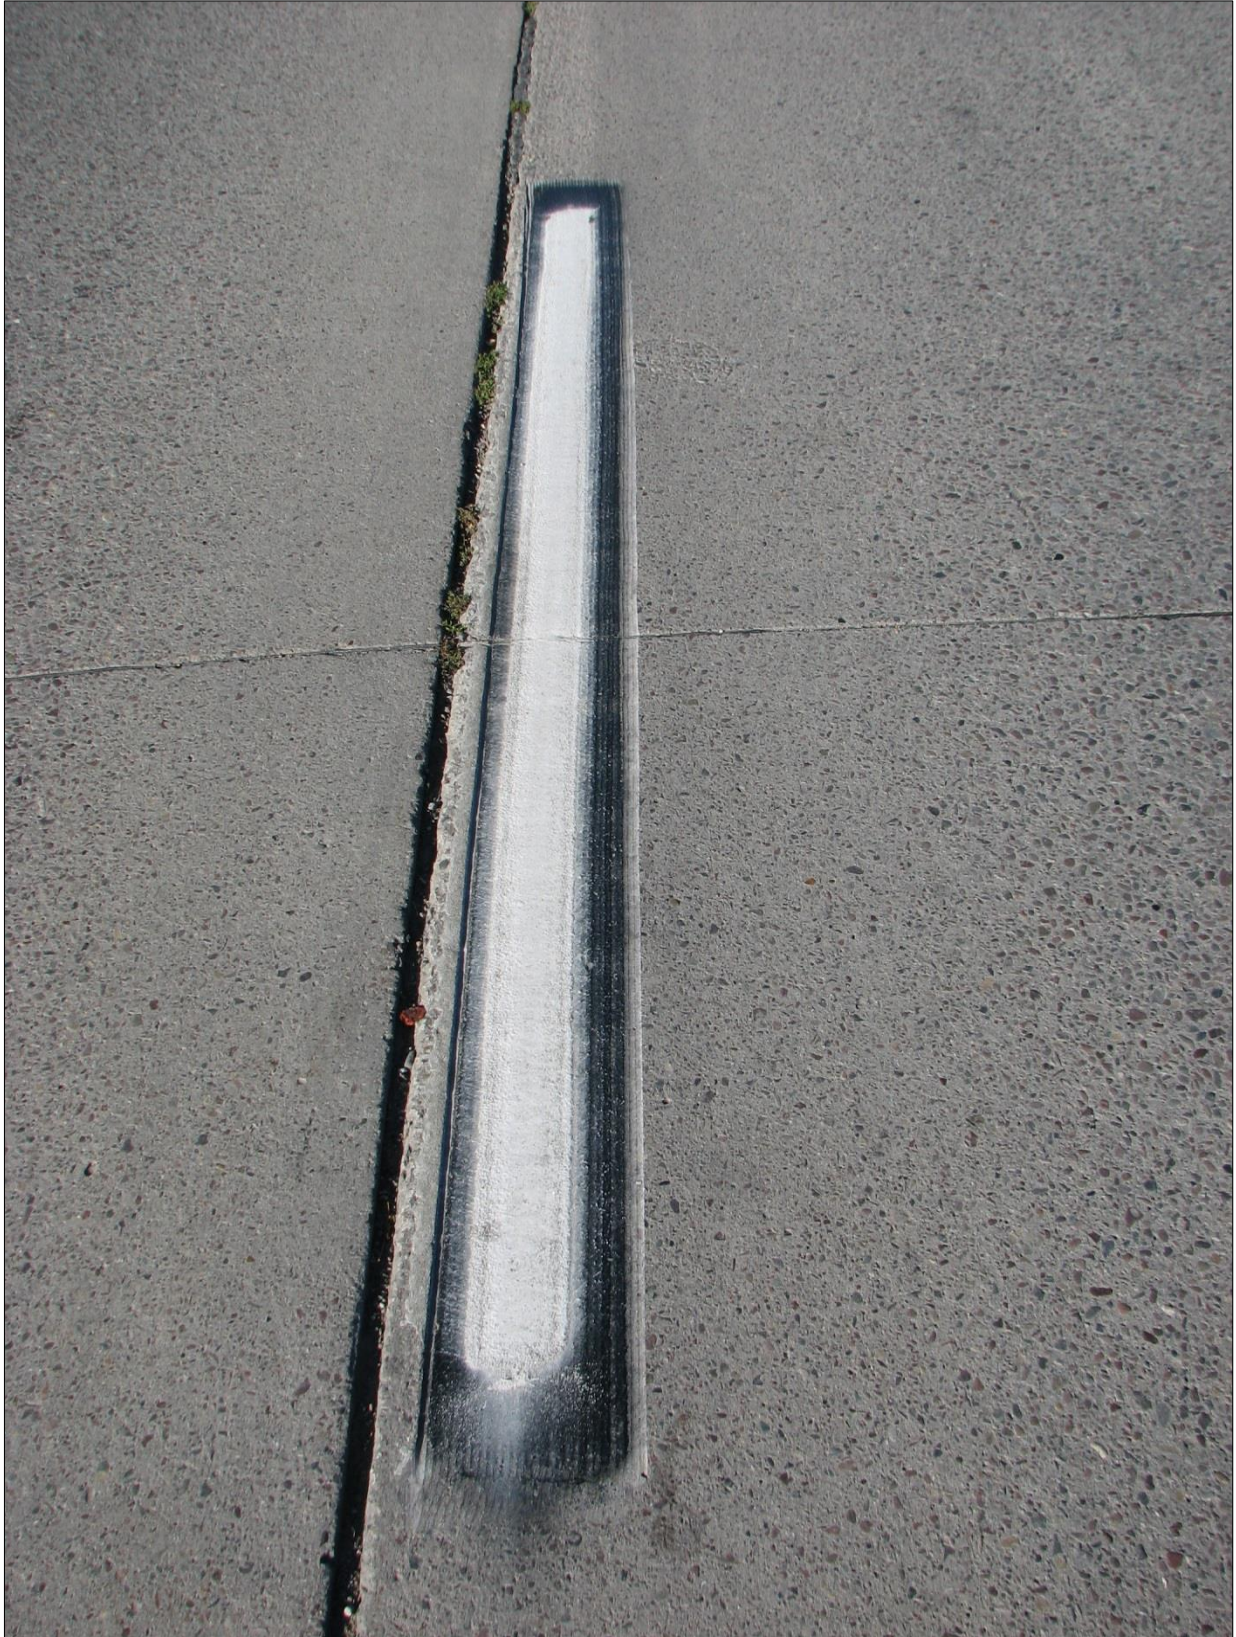
↑ General representation of completed white on black epoxy box contrast (9') stripe relative to all sections within the project.

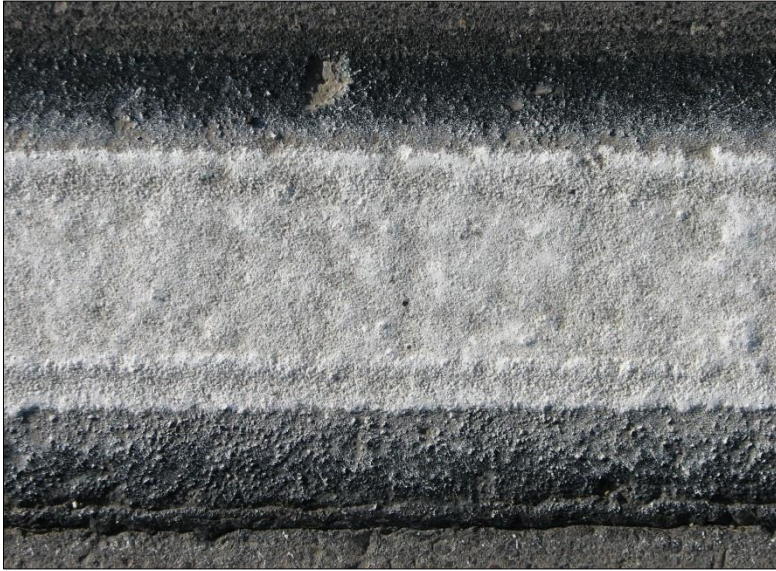
← Section3: Type 2 Glass Bead (RP 3.64 – 5.40), Union Pacific St. to I-90.

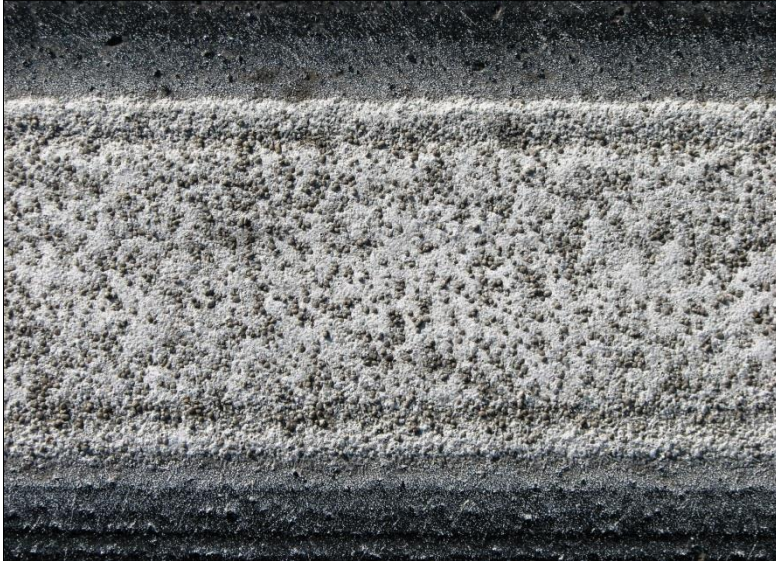
← Section 2: 3M Reflective Elements (RP 1.82 – 3.64), Seventh St. to Union Pacific St.

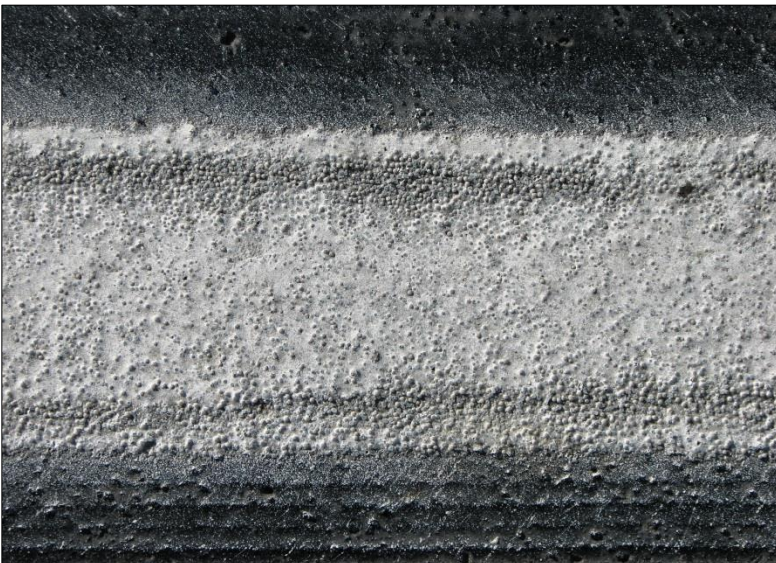
← Section1: Potters Visimax Plus (RP 0.0 – 1.82) Brooks St. to Seventh St.

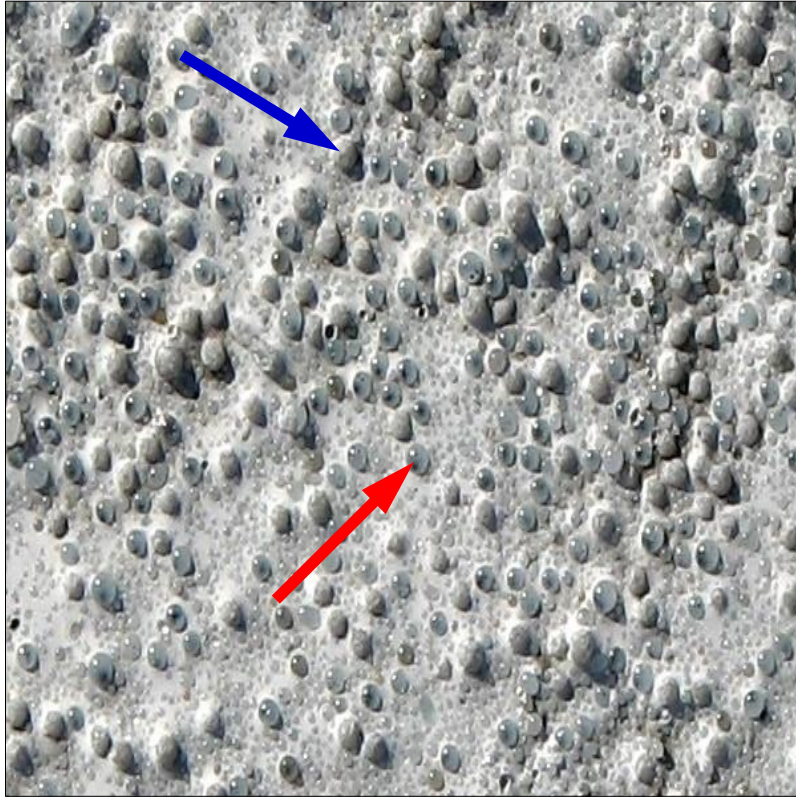
← Visimax Plus Blended Beads:

The blend consist of larger type 4 beads (red arrow).

The blue arrow denotes spheres that have thousands of high index beads laminated to an outer shell.

The proportion of blend with Type 2 beads is approximately 50/50.

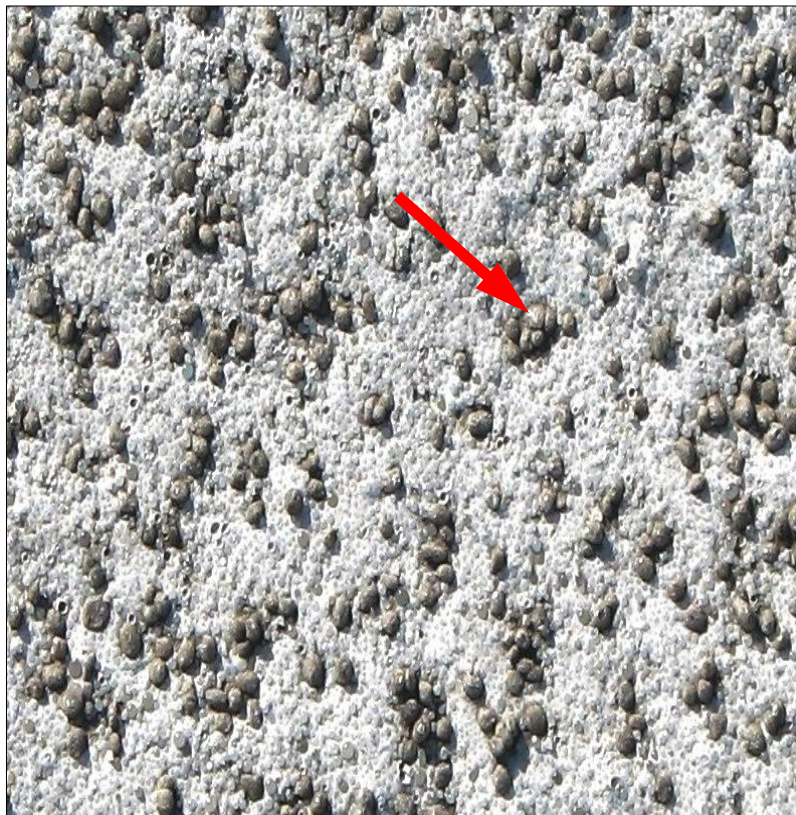
← 3M Reflective Elements:

The elements consist of microcrystalline ceramic beads embedded on a center core (red arrow).

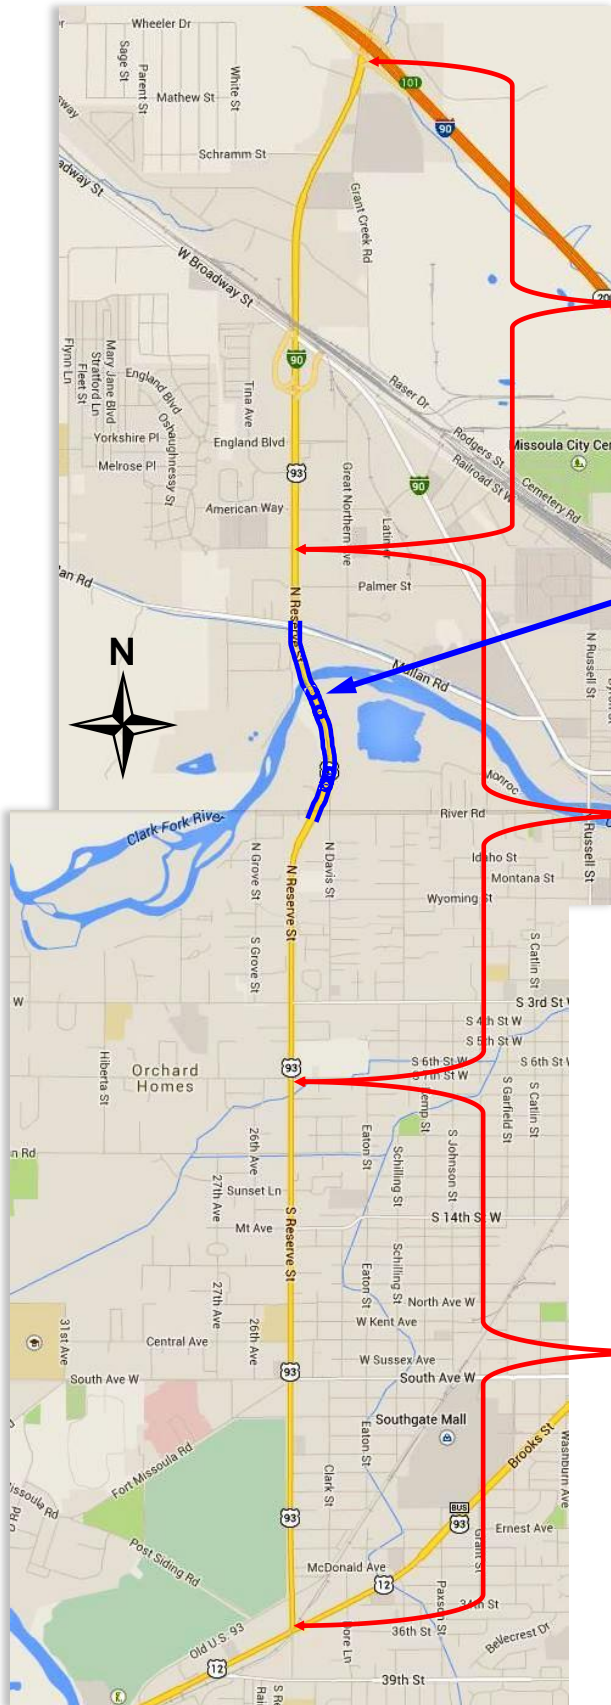
*Experimental Project Sections: Missoula/Reserve St. /NH 92-1(12)0 – RP 0.0-5.40

Note: All sections received white on black contrast epoxy striping within an average groove depth of 140 mils except the blue section.

Section 3 - Control: Type 2 Glass Bead – Reference Point 3.64 (Union Pacific St.) to 5.40 (Interstate 90).
