## EXPERIMENTAL PROJECTS FINAL REPORT

### EVALUATION OF THE METADOME TRUNCATED DOME USED IN EXISTING AND NEW ASPHALT APPLICATIONS

**Project Name:** ADA Asphalt DWD

**Project Number:** STPP-STPE 13-5(8)96

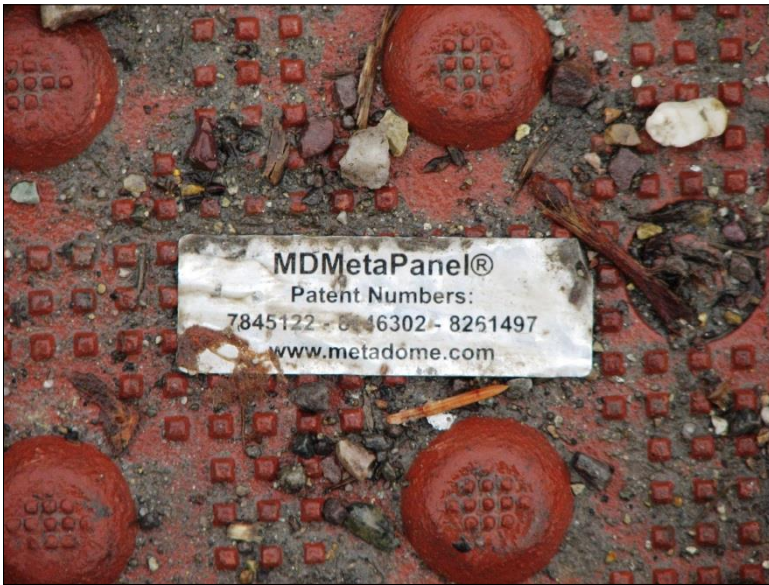
← Close-up of the Metadome cast-iron MetaPanel DWD's replacing the damaged stainless-steel units.

These are the same panels being used on the Three Forks project which were placed in new asphalt on October 2012.

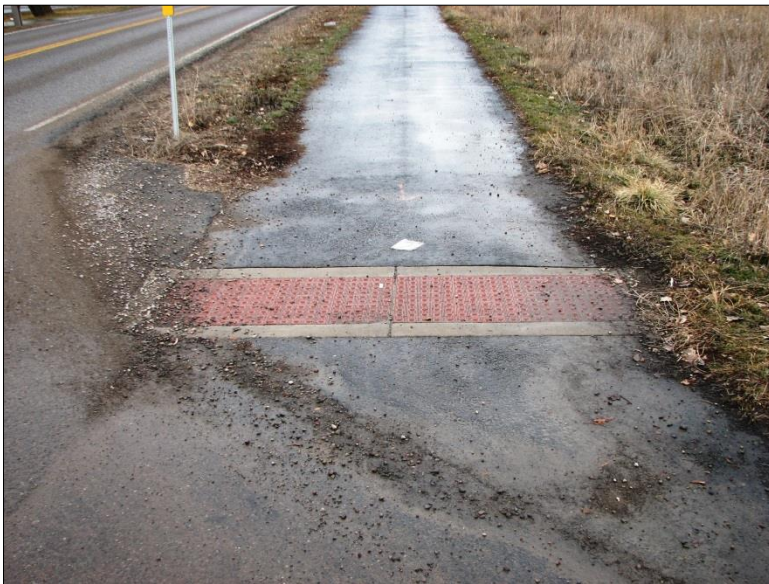
← Another example of a replaced DWD at the intersection of Spurgin and Clements Rd. (southwest corner).

As the stainless-steel panels begin to exhibit distress or are actually damaged, they are replaced with cast iron units in a perimeter of portland cement concrete (PCC).

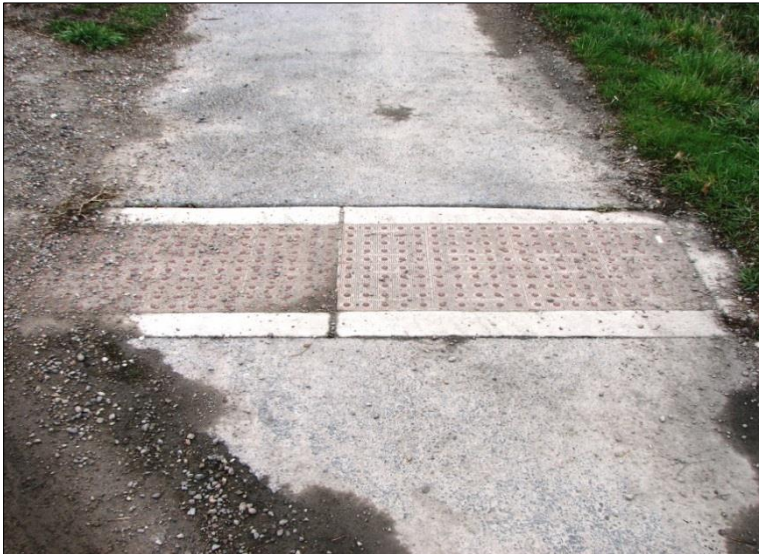
↙ Another unit at the Spurgin Rd. intersection that has been replaced by cast-iron DWD's.

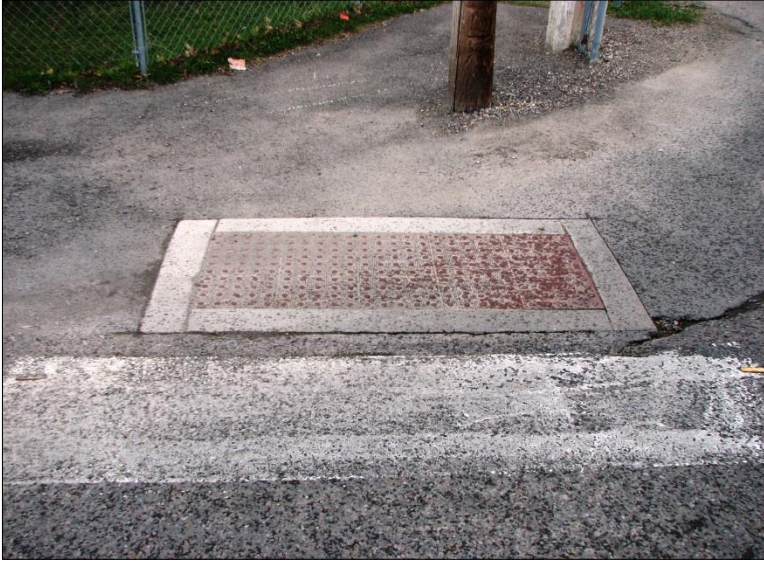
← Another unit replaced with cast-iron at the Mount Rd. intersection.

As stated in earlier site inspections the District is replacing the damaged stainless steel DWD's with cast iron units.

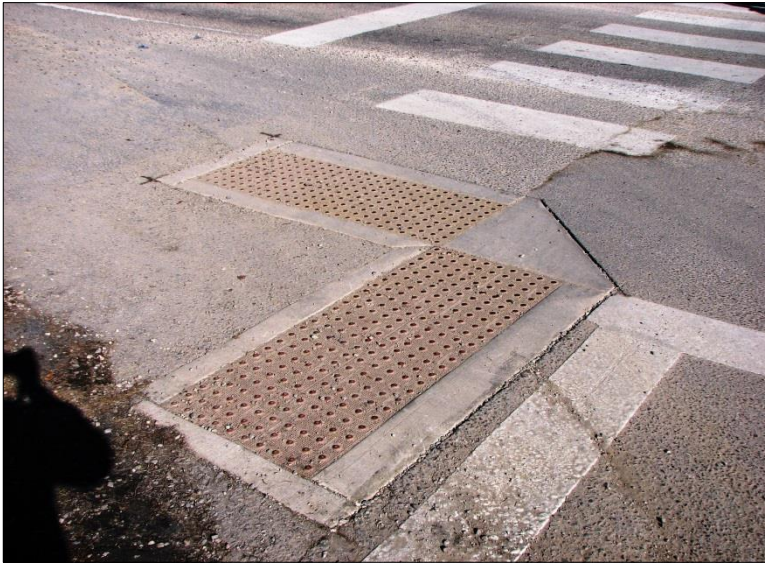
← Example of cast-iron DWD's replacing the damaged stainless-steel units.

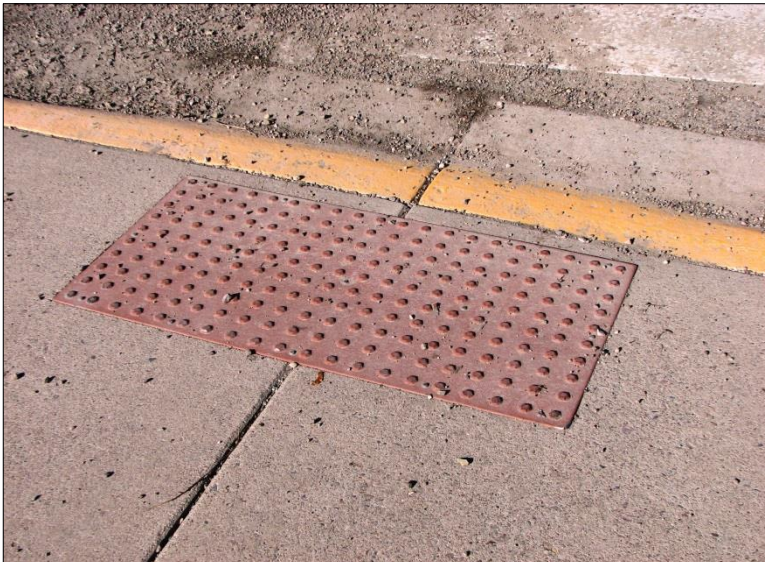
← General example of stainless steel DWD still in service.

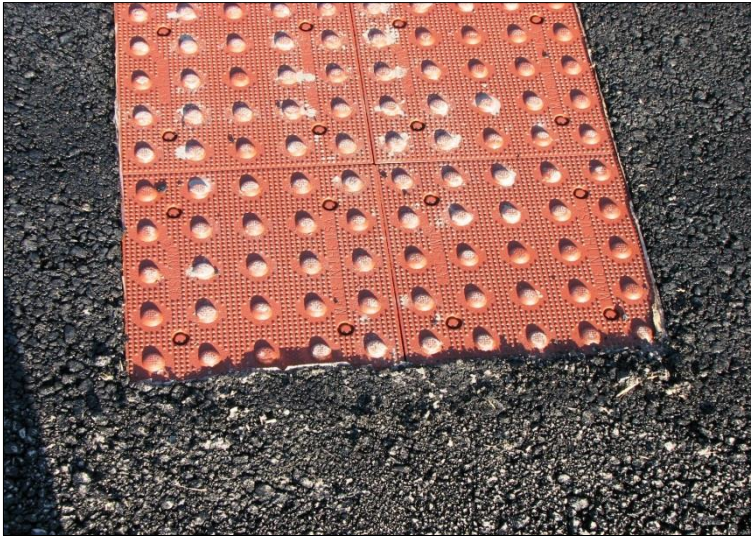
← Close-up of completed ADA asphalt DWD cast iron panels.

All panels installed on the project inspected were visually placed well in the pavement with plate edges either flush to the asphalt surface or several millimeters below. All plates appeared securely anchored.

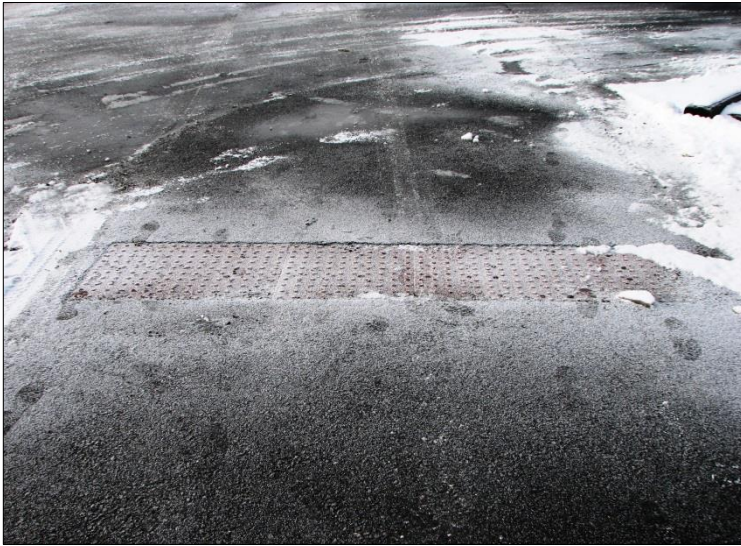
↩️ The images on this page represent the average condition of the cast-iron DWD's.

All units on the project exhibited no distress, movement or debonding from the asphalt cement (AC) base.

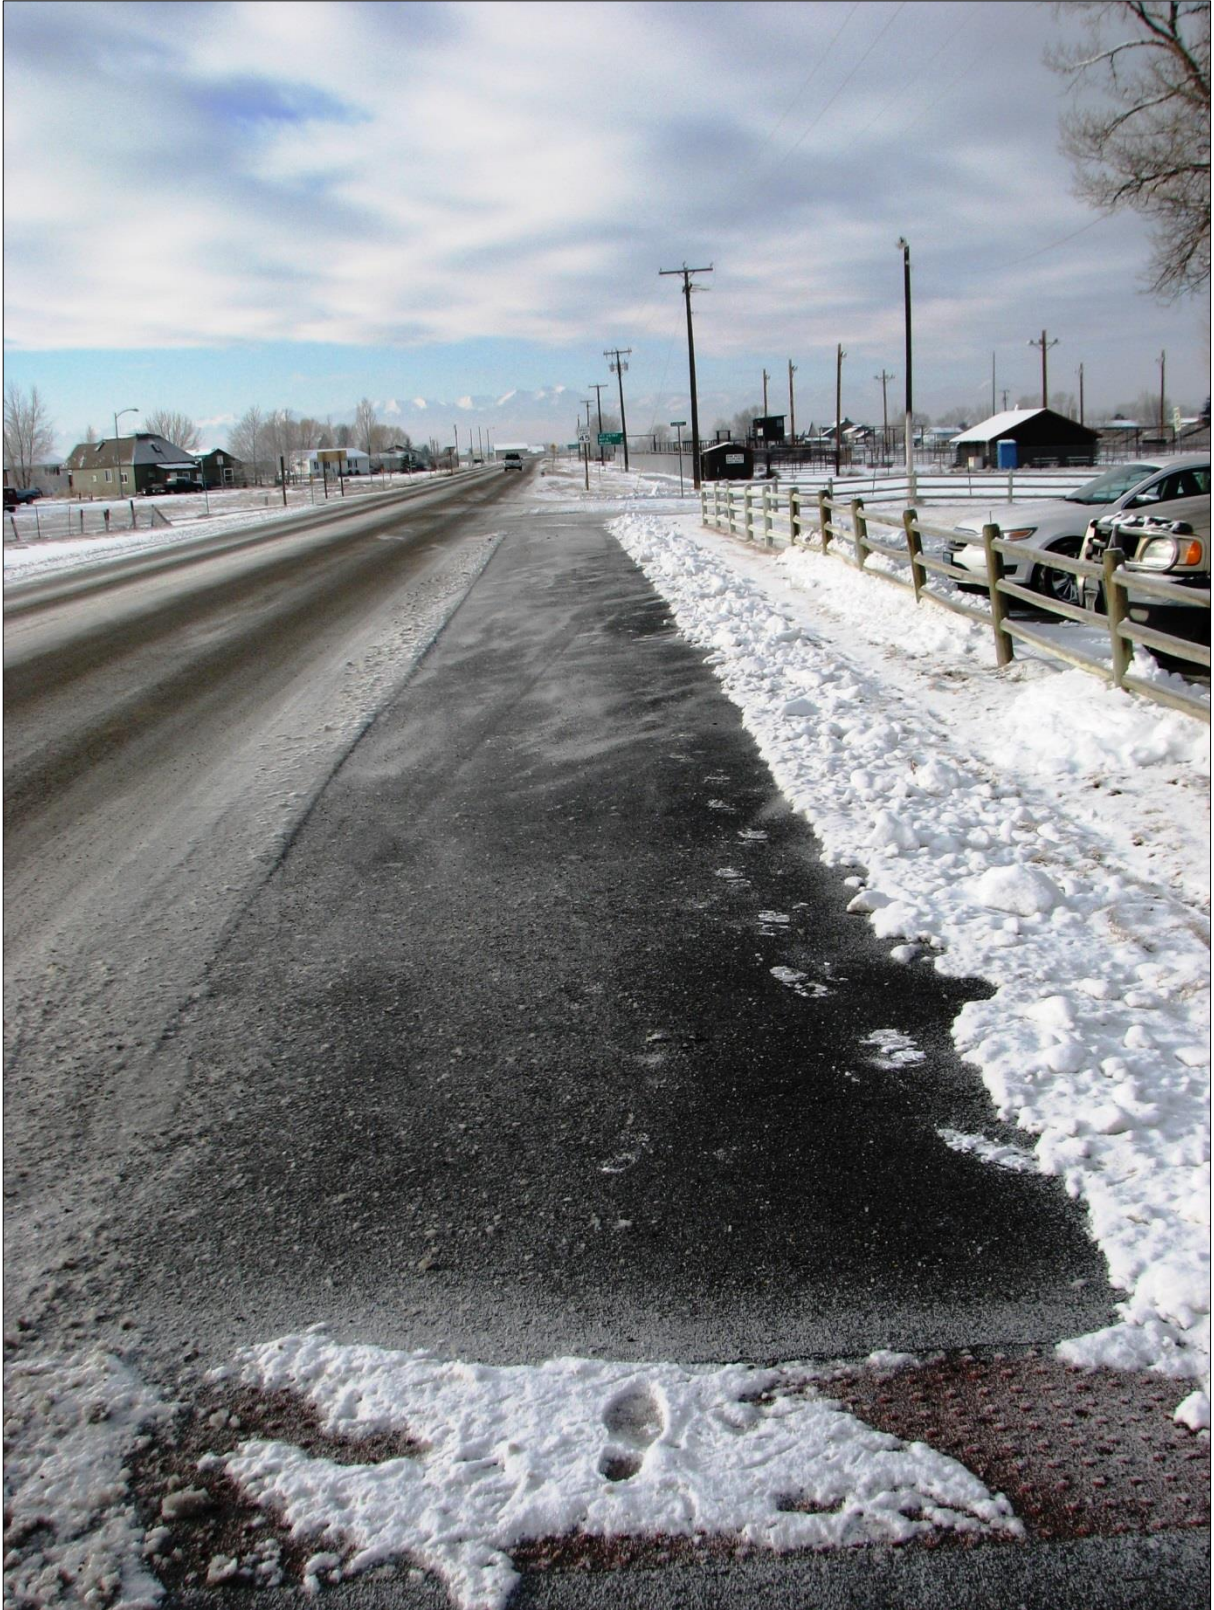
↑ Per information received from the Three Forks Road Superintendent, the bike/walk pathway snow removal is maintained by truck-mounted snow plow. They report no issues with plow blade moving over the DWD's

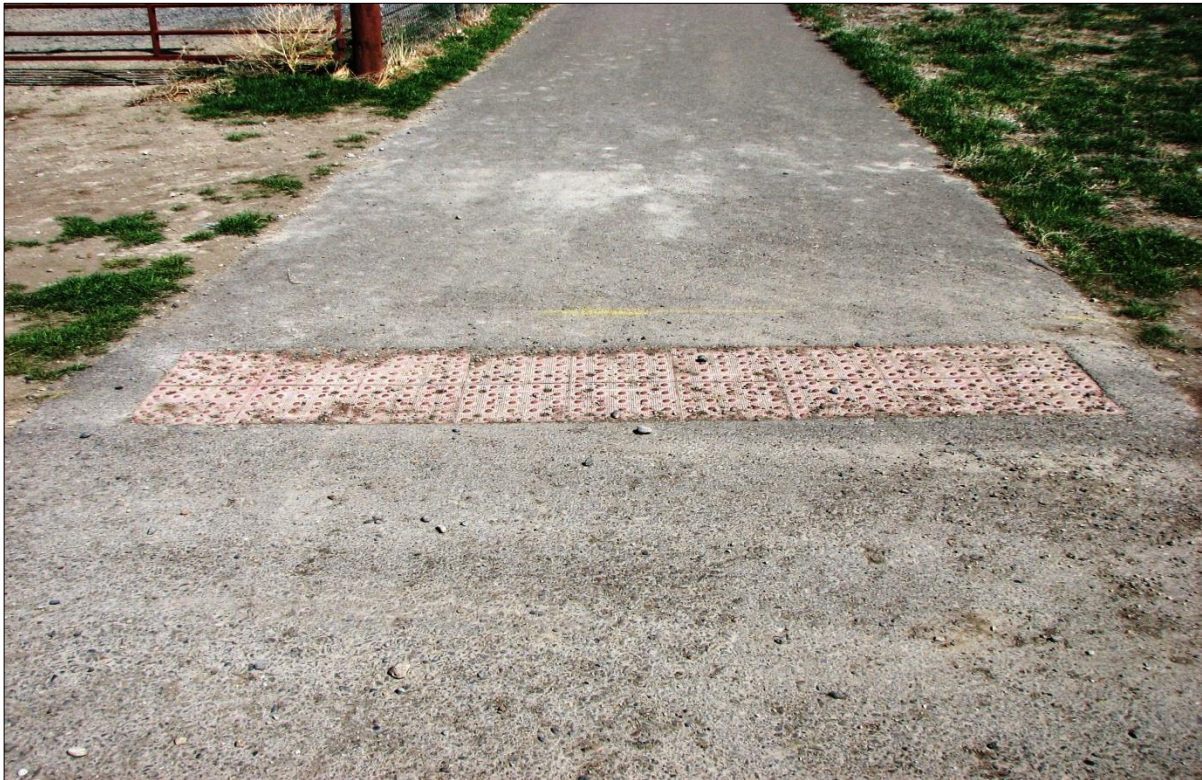
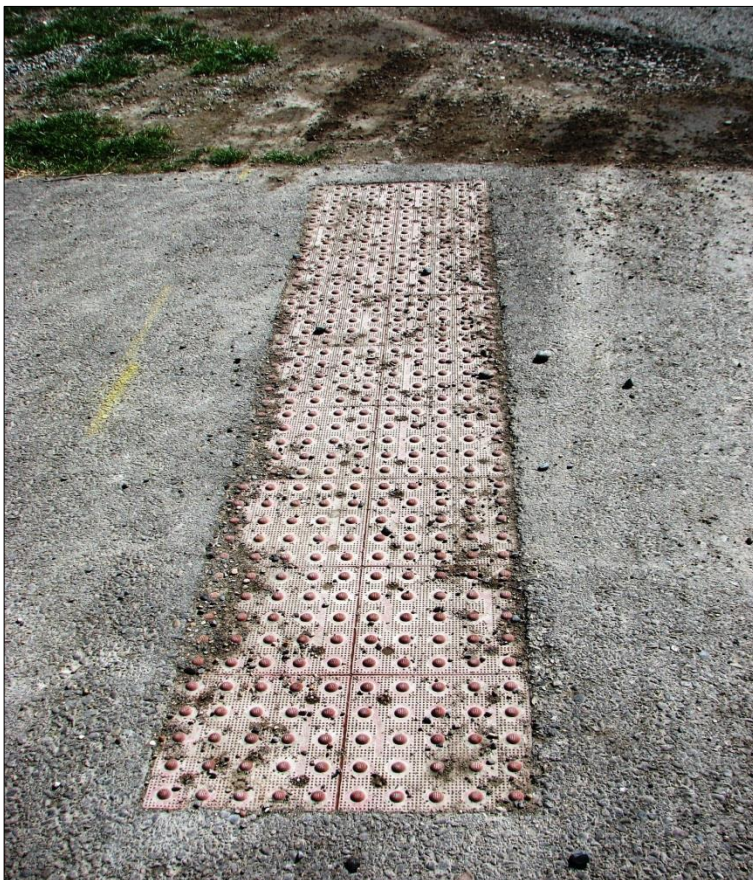
**April 2015 Three Forks Site Inspection**

↑ ← Representative images of the general condition of the project DWD's.

All units are intact with no appreciable performance issues to date.

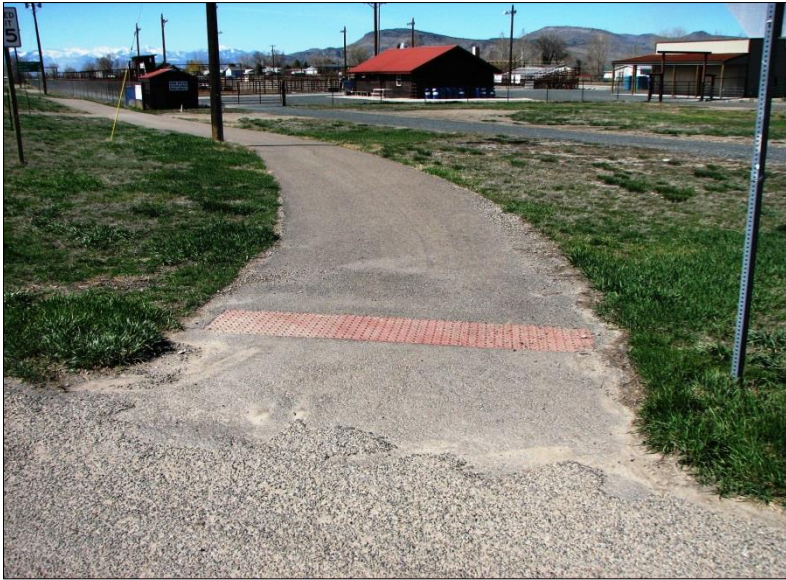
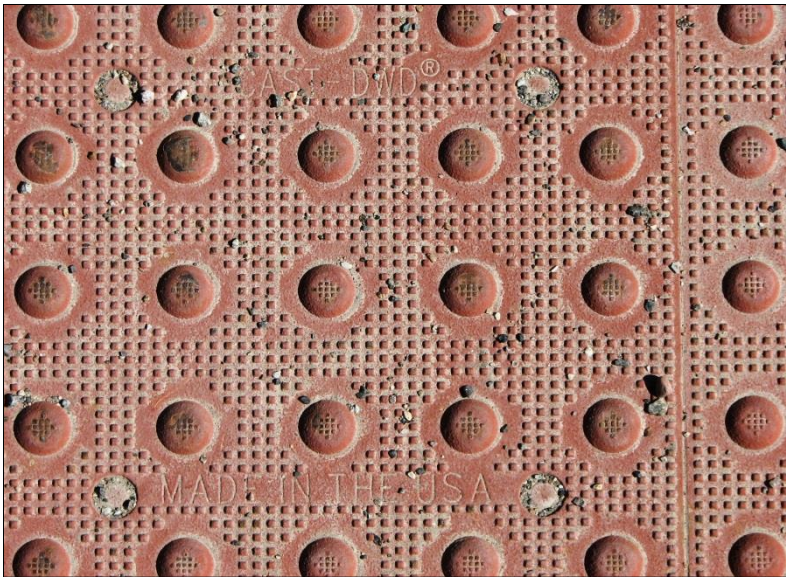
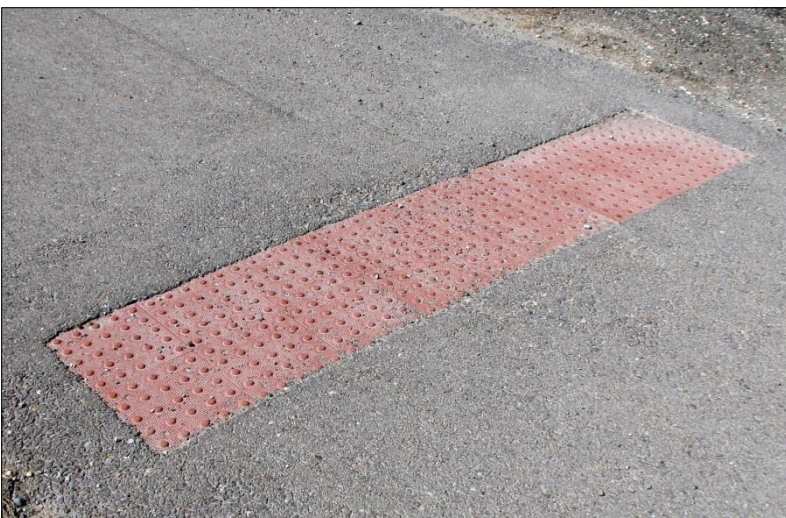
**May 2016: Three Forks Site Inspection**

↙↓ Images represent general condition of cast iron units.

No distress to report to date.
