Montana Department of Transportation
Research Program
October 2003

POST-CONSTRUCTION INITIAL EVALUATION REPORT

Detectable Warning Devices (Truncated Domes) for use by the Visually Impaired

Location: Great Falls, 6th St. N. W.
Project No.: STPU 5201(11)
Description: Baseline experimental evaluation of various detectable warning devices for sidewalk curb ramps
Evaluation Date: October 22, 2003
Participants: Craig Abernathy
Experimental Project Coordinator

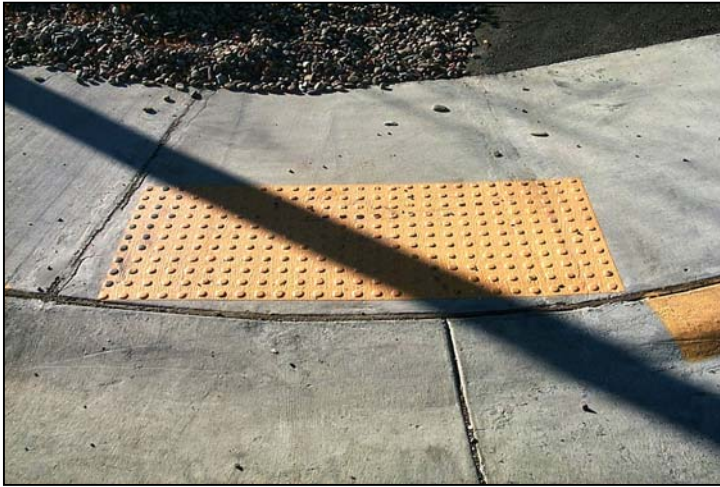
Installation 4A: Located on the southwest corner of 5th Ave. N. W. and 6th St. N. W.

All installations were in good condition at the time of inspection. All of the mortar domes are intact

This treatment connects the north-south pedestrian walkway.

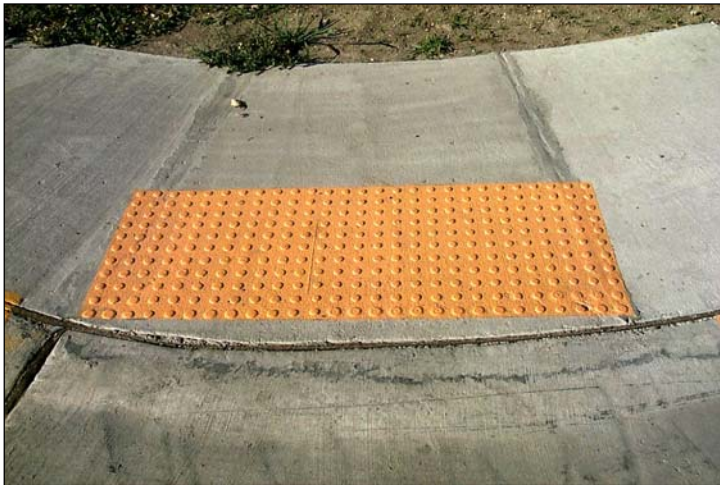
Installation 4B: Located on the northwest corner of 5th Ave. N. W. and 6th St. N. W.

This treatment connects the east-west pedestrian walkway.

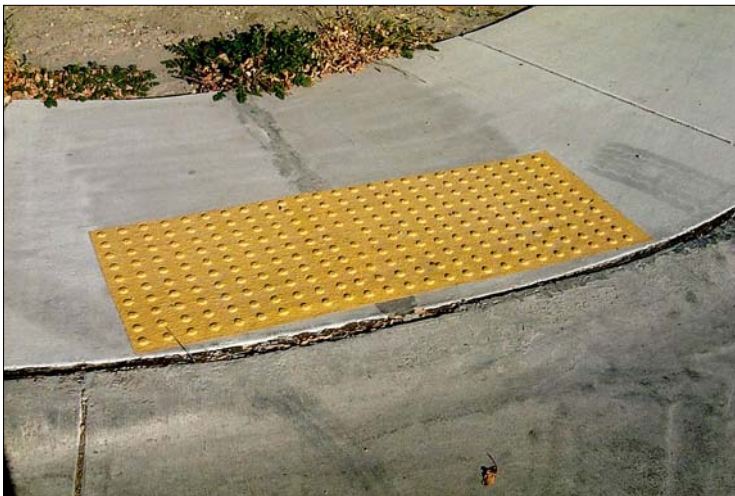
Installation 6B: located on the northwest corner of the intersection 4th Ave. N. W. and 6th St. N. W.

All installations were in good condition at the time of inspection. All domes are intact.
