Montana Department of Transportation  
Research Program  
November 2007

**EXPERIMENTAL EVALUATION FINAL REPORT**

**Emulsified Asphalt Treated Aggregate (EATA)**

Project No.: Sportsman's Campground – East STPP 46-5(2)51; CN 2137

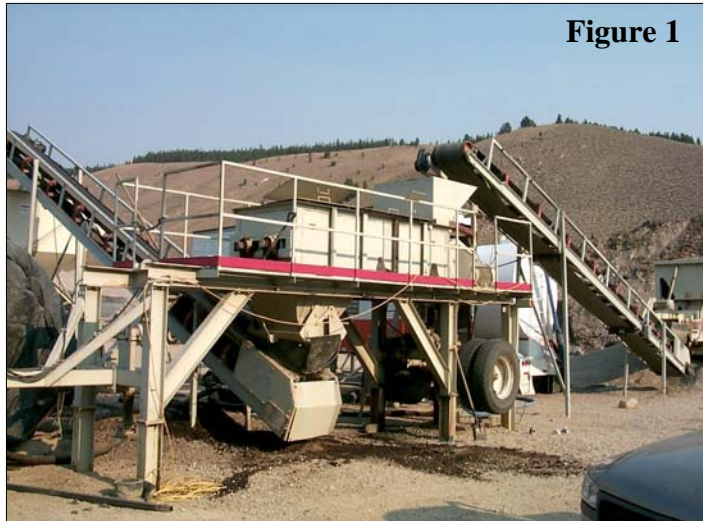
Figure 1

The contractor used a double-screw-type pug mill to incorporate the CSS-1H with the CAC as seen in figure 1. The blended EATA was then sent to a holding bin and subsequently loaded by conveyor belt to waiting trucks. The contractor explained that this method of pug milling allowed the CSS-1H product to coat the aggregate at each stage of the process including the loading of the truck (figure 2).

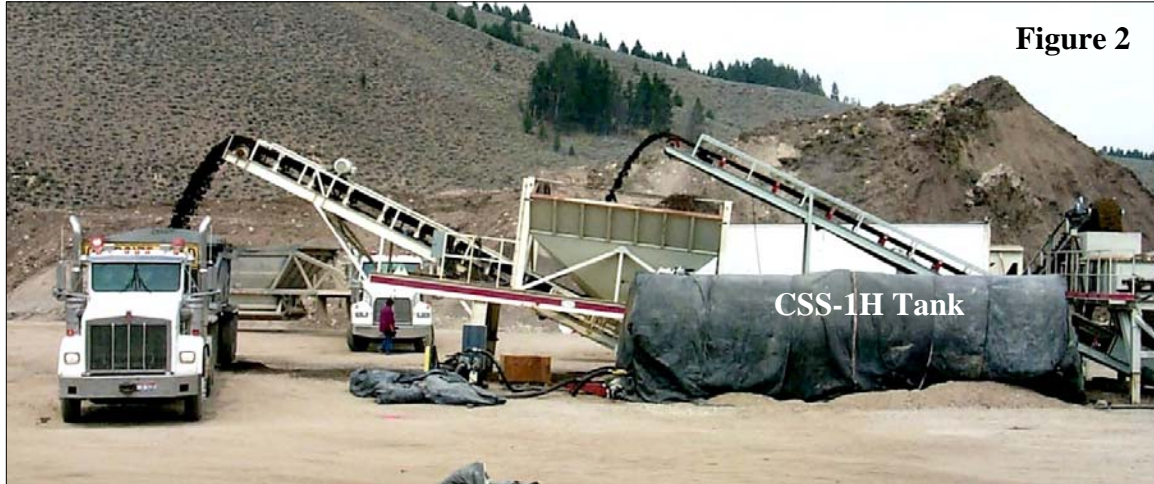
Figure 2

It was observed on several occasions during the loading of the trucks, based on visual inspection only, the blended CAC had the appearance of an even coating of product.

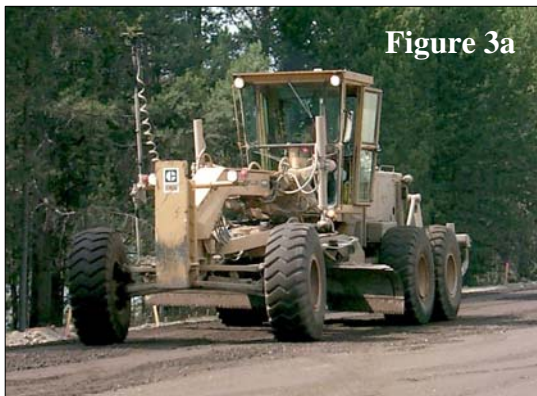
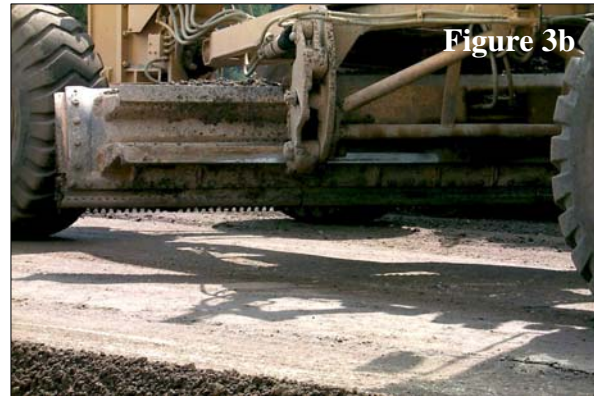
observer saw the belly dump used more frequent. The material was bladed to grade with GPS machine control using a finish blade with serrated cutting teeth (figures 3a & b).

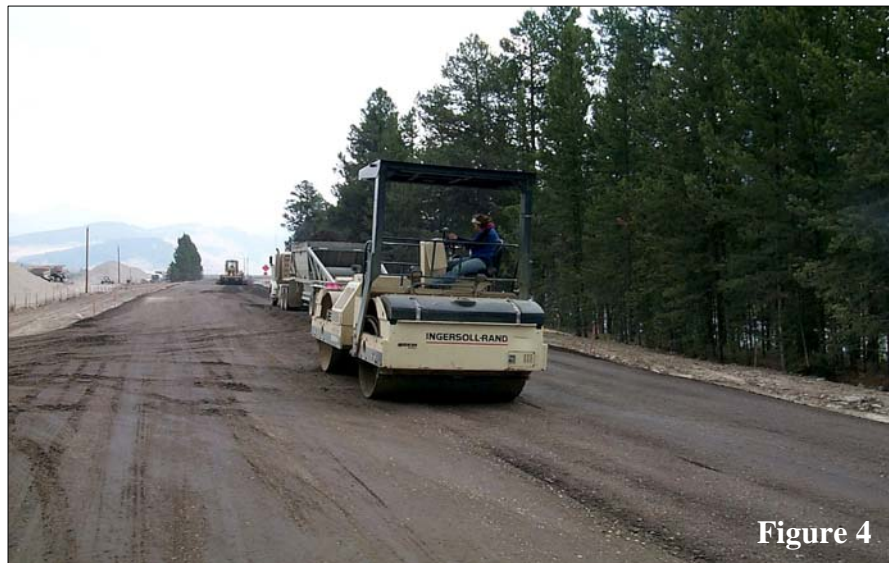
Figure 4

Once graded the EATA was compacted using steel drum rollers (figure 4). With the installation of the first test section (1.5% EATA at 100mm depth) did exhibit segregation (or raveling) at the surface predominately between the wheel paths and shoulders (figure 5). Over time as the treatment cured and as the loose aggregate was displaced or compacted by traffic the section began to display a more uniform appearance. All the test sections (with the exception of the gravel control) developed a more uniform appearance after a short cure time. The EATA sections had good workability and compacted easily. Once placement was finished, traffic and construction equipment had no visual effect on the material. The product did not track onto vehicle body or tires. The amount of moisture on the surface did not add to any tracking issues.

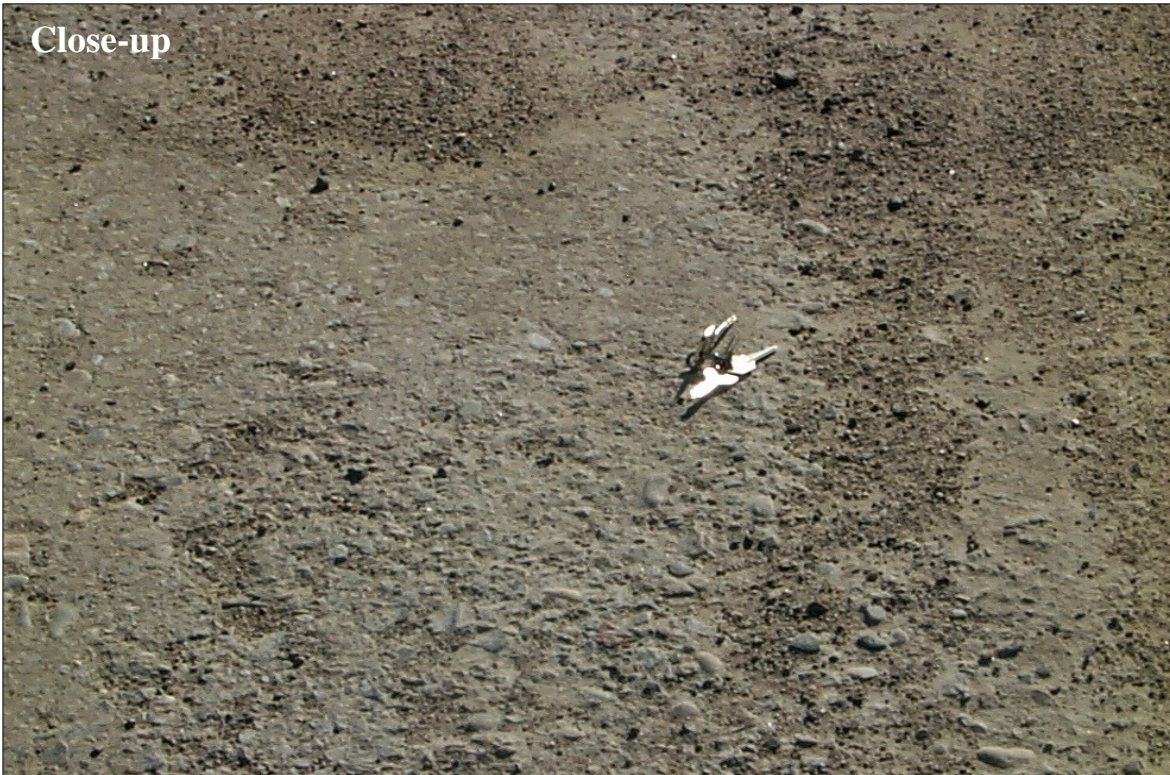
**Close-up**

Note: In each test section there were areas of raveling, and unconsolidated material; some more prevalent from one section to another. A close-up shot of each surface treatment is included in each section. The close-up image is meant to represent the norm of surface condition for that treatment during the duration of the inspections. Unless otherwise stated, all views are looking East.
