EXPERIMENTAL PROJECTS CONSTRUCTION AND EVALUATION REPORT

Evaluation of Durable Traffic Pavement Marking Tape (PMT)

Project Name: Lyndale Intersections

Experimental Project: MT-14-02

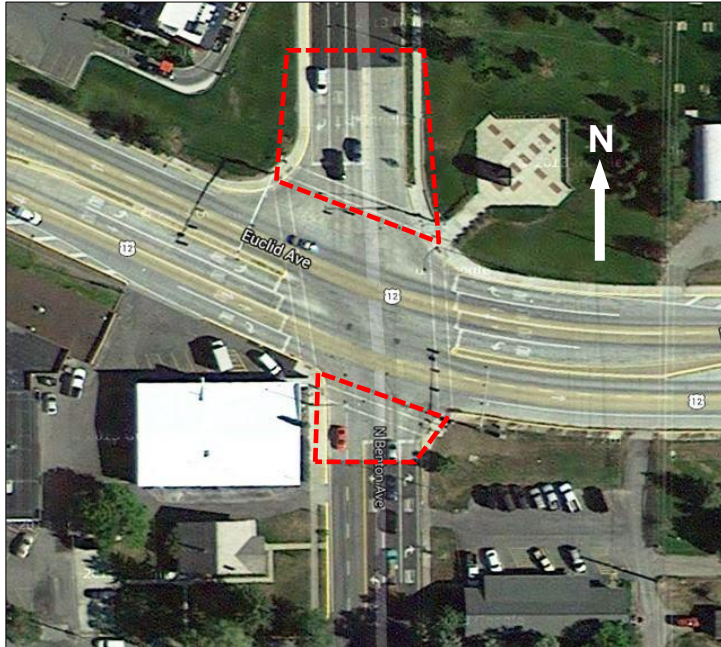
← Overview view of the Euclid/Lyndale & North Benton Ave. Intersection (TS1).

This site received the Swarco Director 35 tape application installed on June 10.

Note the areas of the N. Benton Ave. intersection denoted by the red dash received the 3M Stamark pavement tape approximately one month after the Swarco installation.

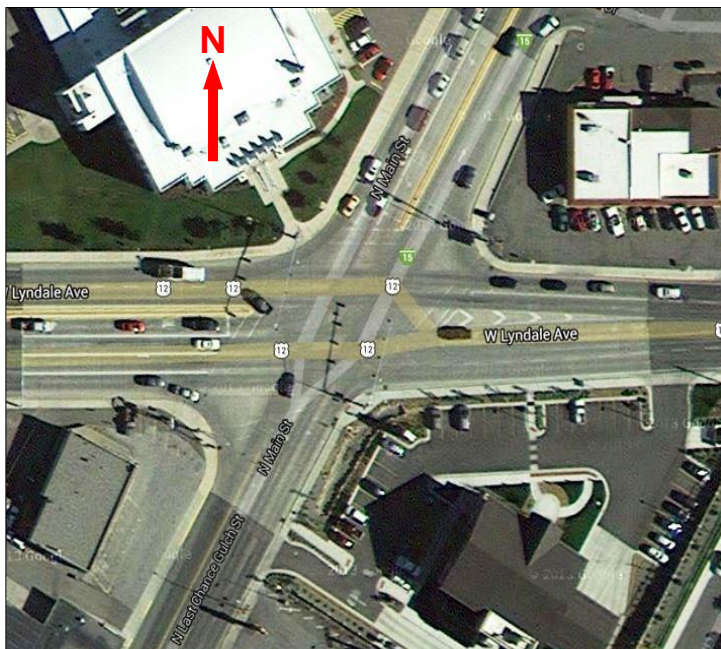
← Overview view of the Lyndale & Last Chance Gulch Intersection (TS2).

This site received the 3M Stamark tape application installed on June 3.

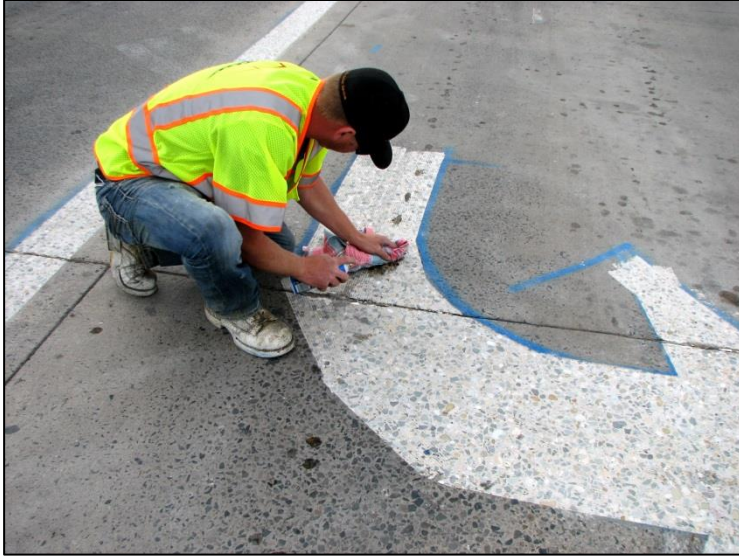
← In areas where the grooving machine deposited oil on the surface of the grind; the contractor used spray solvent to remove the oil prior to the application of the Stamark Contact Cement E-44T.

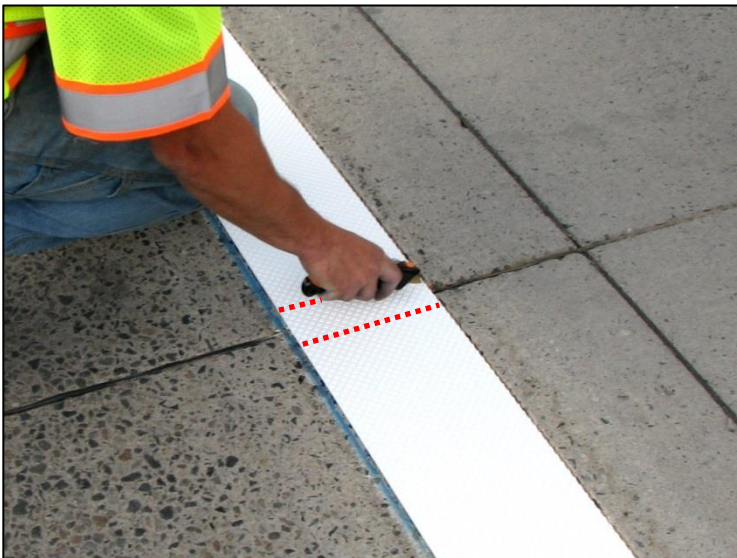
← Those markings positioned over pavement joints are cut roughly 1" on either side of the joint (red dash lines).

This procedure was also used on the Swarco Director 35 application.

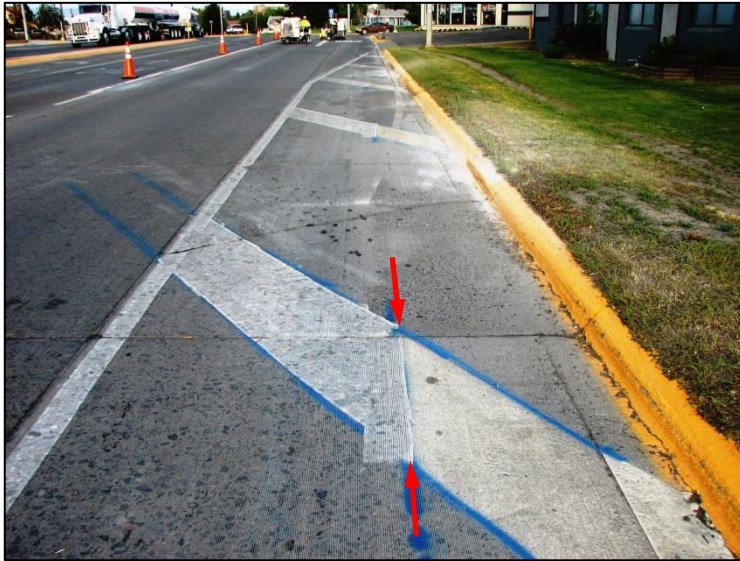
← Note that the cross hatch lines (eastbound/west side Euclid) were not placed directly to the curb but at halfway (red arrows).

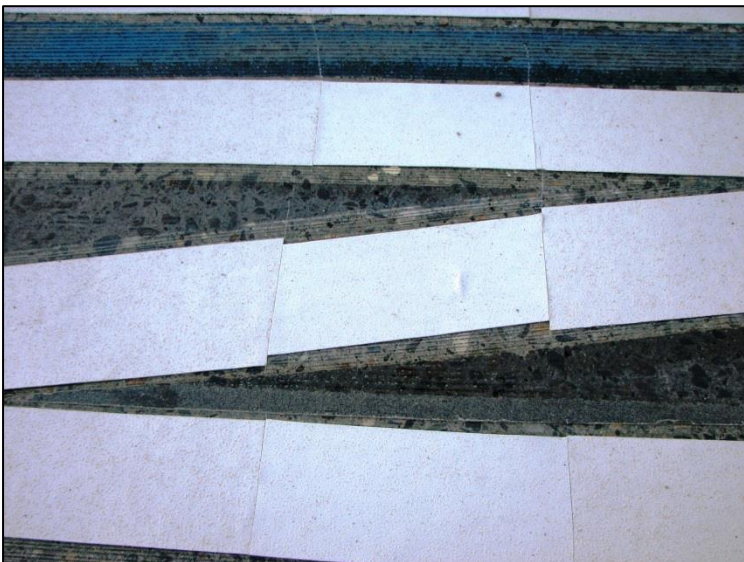
← A cut and paste approach was used to modify the markings.

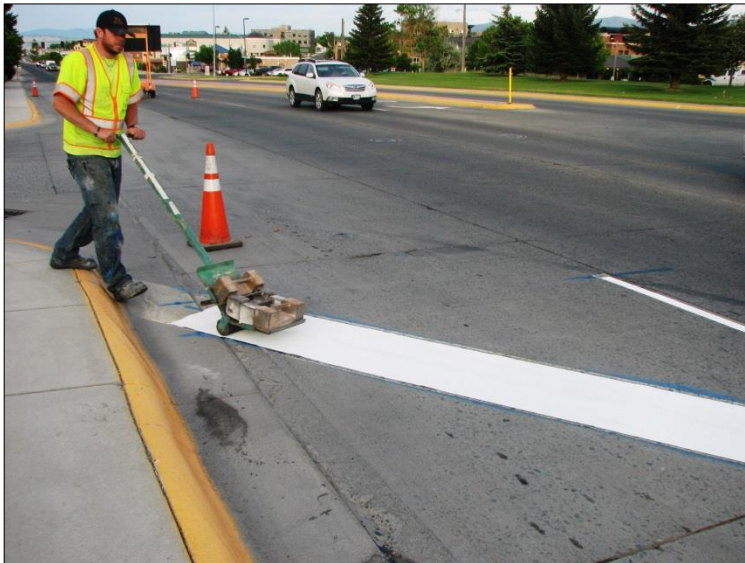
← All marking applications were tamped with a 200 lb. roller cart.

It was observed while during tamping the cart would track up reflective beads on the roller.

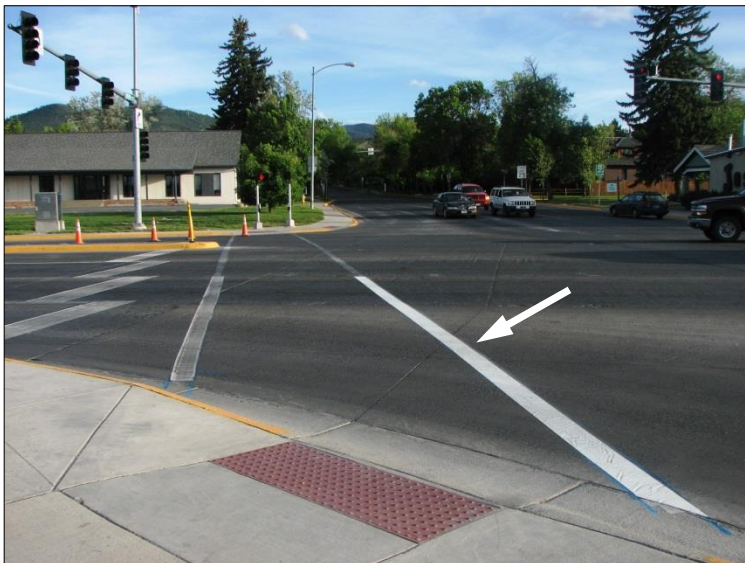
← Note that the contractor elected to install a section of Methyl Methacrylate (MMA) at the eastside pedestrian crosswalk marking, westbound West Lyndale Ave. and North Benton Ave.

The length of MMA runs approximately 37' of the pedestrian line.
