## EVALUATION REPORT

### FIBER-REINFORCED POLYMER (FRP) PULTRUDED DECKING MATERIAL AND HELICAL ANCHORING SYSTEM FOR USE IN SNOW FENCE APPLICATIONS

Project No.: IM90-7(63)331

Description: Fifth semi-annual evaluation of remaining test section of snow fence using proprietary EZ-Deck Fiber-Reinforced Polymer (FRP).

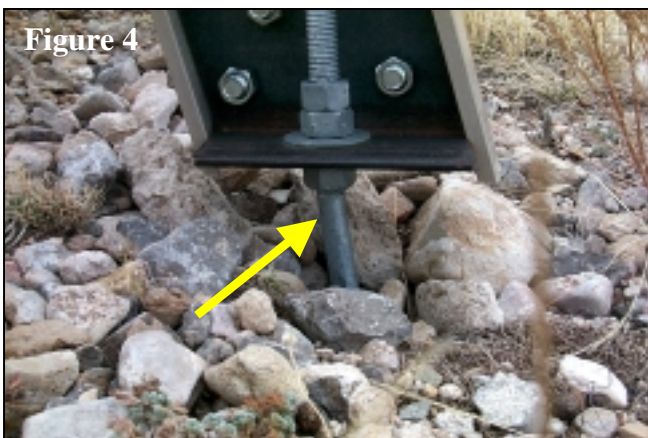
As noted in the October 2000 Report. The right, rear bolt attachment to the frame sill has broken (Figure 3). During this investigation, it was observed the sill had jumped once more to cover the broken bolt of the rear ground support. This broken sill support has, up to this time, not caused a catastrophic failure of section TS1. Nor is there any evidence that this loose rear sill attachment may have caused stress that allowed the center clip bracket to shear off. It was also observed the front frame to bolt attachment has bent slightly. This may be the result of the freedom of the rear connection, which is allowing the stress from wind turbulence to deflect the bolt. The sill frame will be closely monitored in future evaluations.
