#### Montana Department of Transportation Research Programs November 2013

#### **EXPERIMENTAL PROJECTS INSTALLATION REPORT**

### TAPCO (BLINKERBEAM/BLINKSYNC) BLINKERCHEVRON TRAFFIC CONTROL SIGNAGE

| Location: | MT Highway 41 (P-49) Reference Point 14.3; Madison<br>County: Butte District |
|---|--|
| Project Name: | Curve Near Beaverhead Rock |

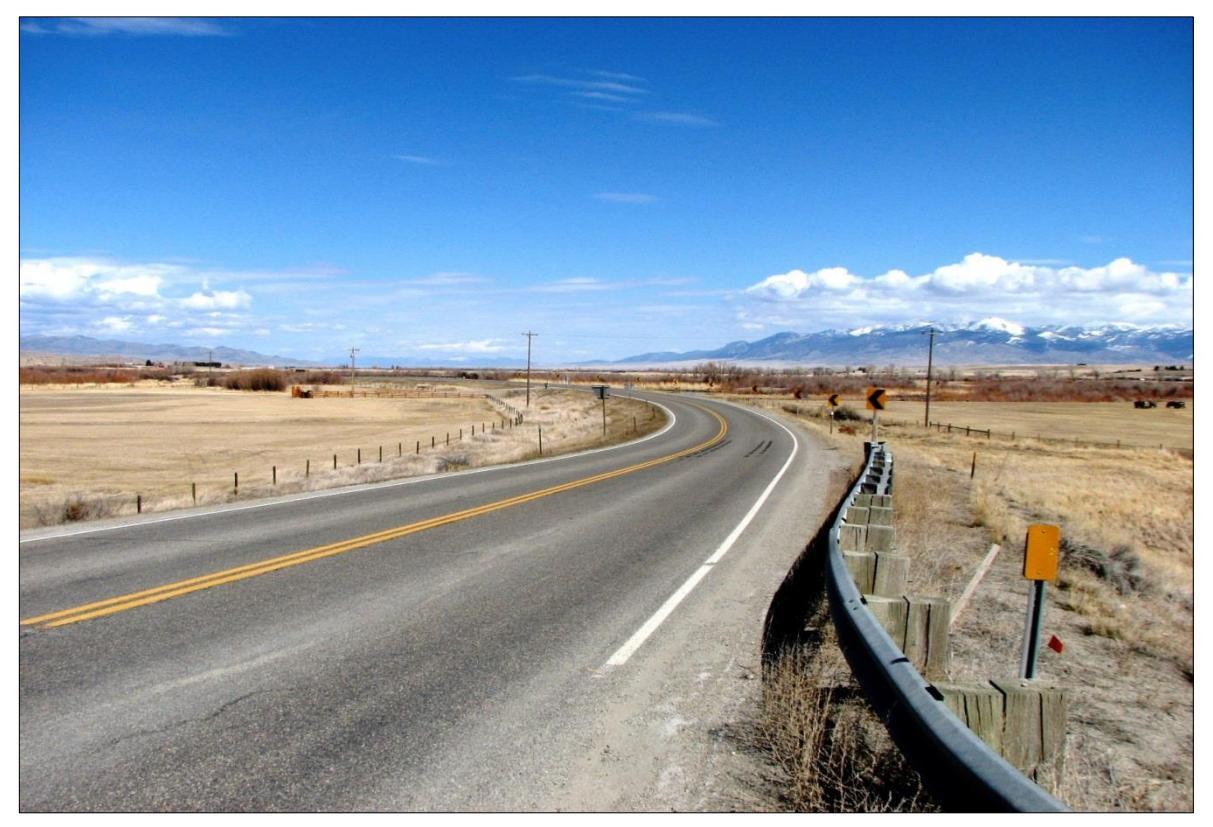
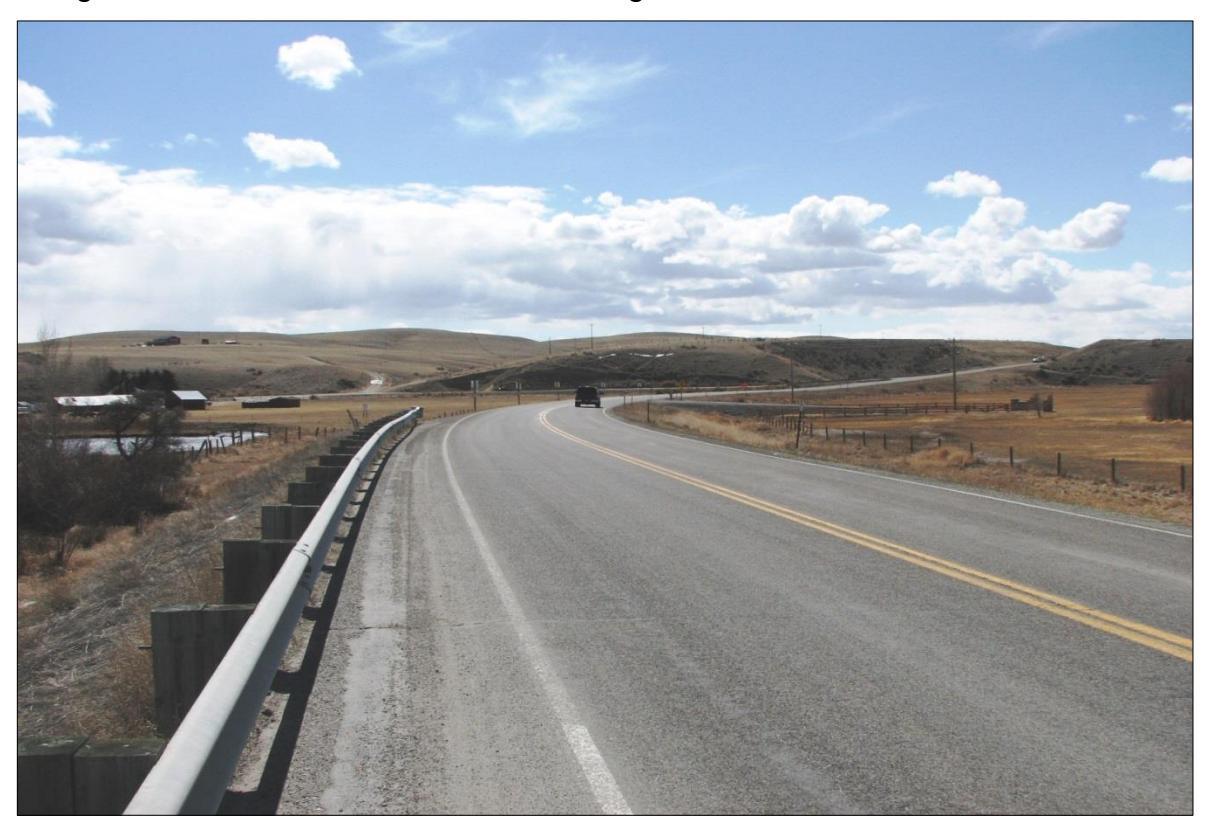
## March 2013

Project site pre-installation images of the curve at Beaverhead Rock: ↑ Upper image is the northbound view; ↓ lower image is southbound.

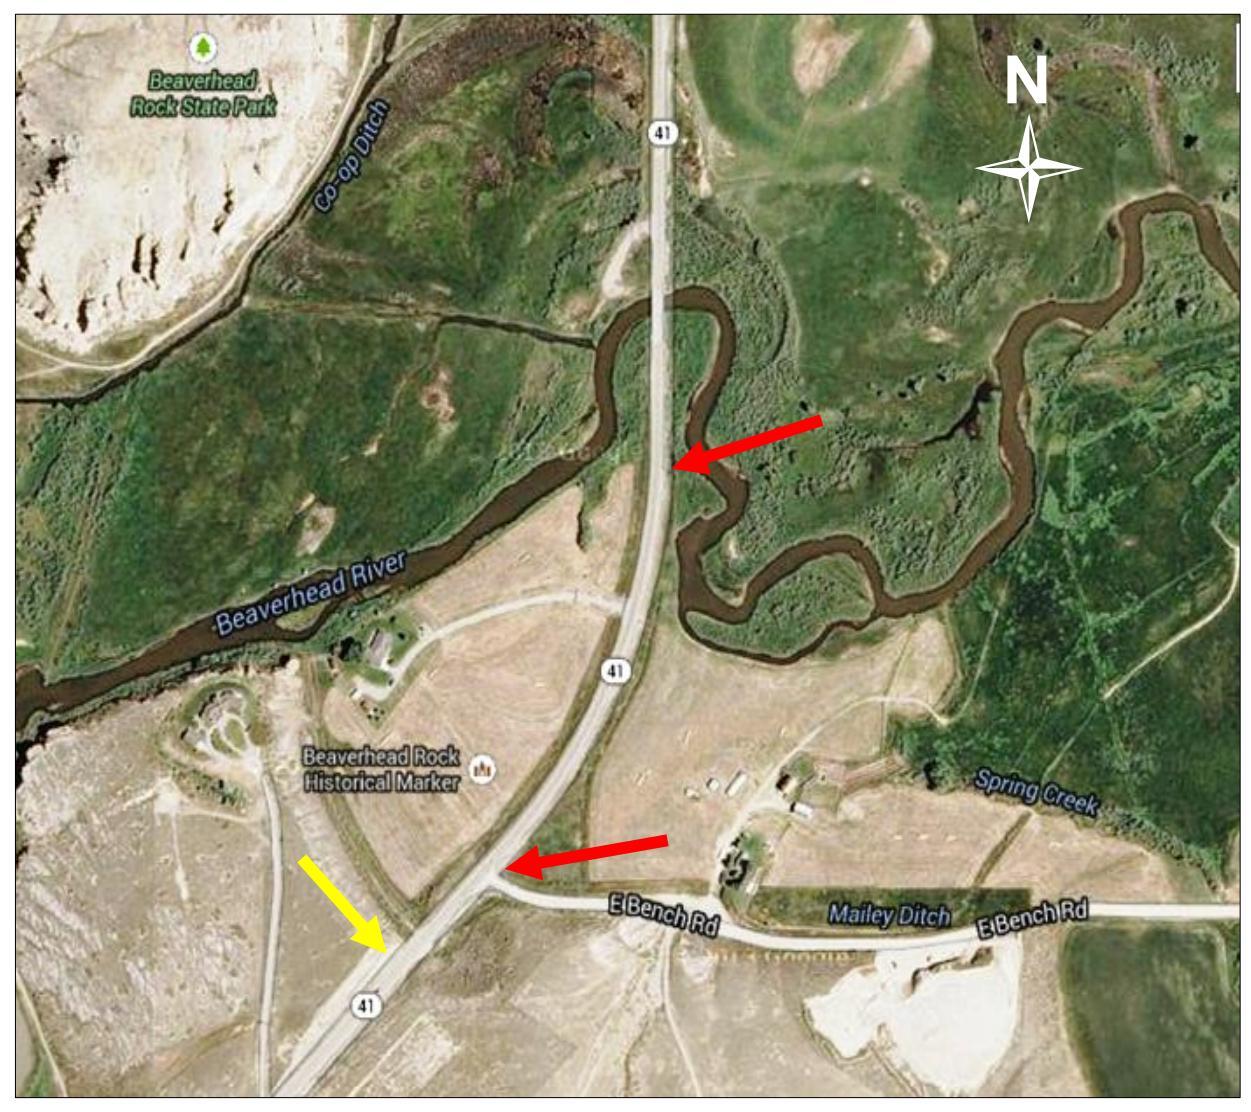
▲ Arial view of the TAPCO installation project location. Red arrows show the approximate placement of the chevron system.

The yellow arrow denotes the approximate point of the crest of the vertical curve in relationship to the northbound traffic. From this point the road slopes downward with minimum sight distance and reaction time to drivers approaching the curve.

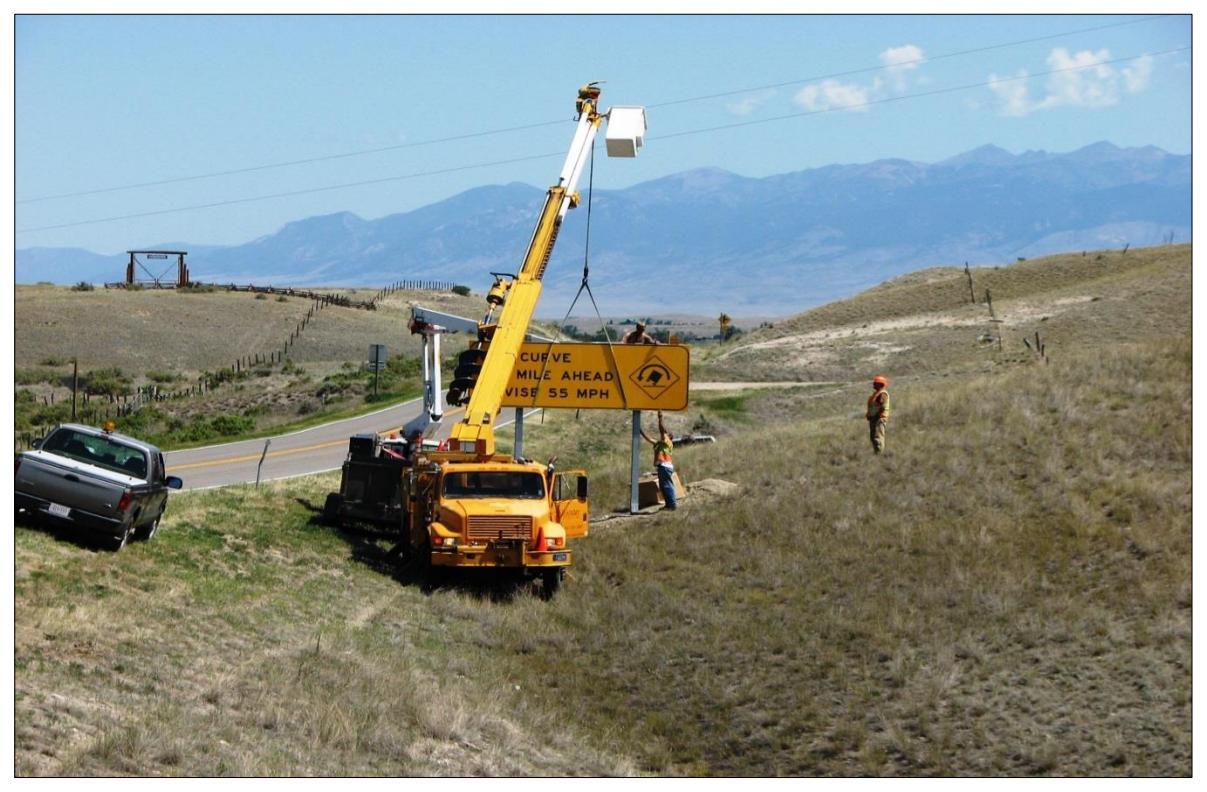
## <u>July 2013</u>

↑ Erection of the solar dual flasher warning approach sign assembly.

✤ Northbound (identical to the southbound approach) completed dual flasher warning sign with the larger wattage solar panel replaced in October.

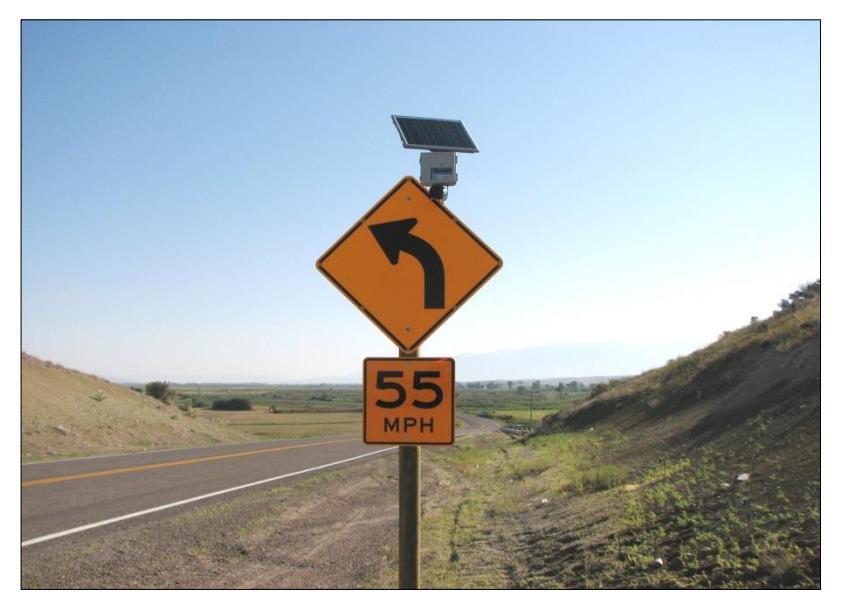
← This is the northbound advance-signal, wireless sequence master unit.

A similar unit is in place on the southbound approach to the curve.

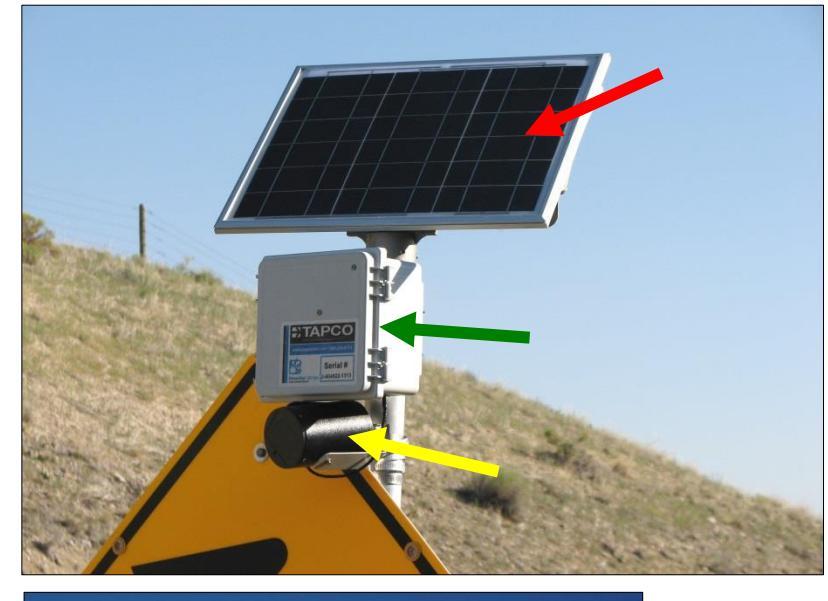
← Close-up of the 13 watt solar panel (red arrow), the radio sequence control master cabinet (green arrow); and the doppler radar unit (yellow arrow).

Although difficult to see in this image the sign boundary edge have eight (8) high-intensity LEDs which will activate upon approach of an oncoming vehicle.

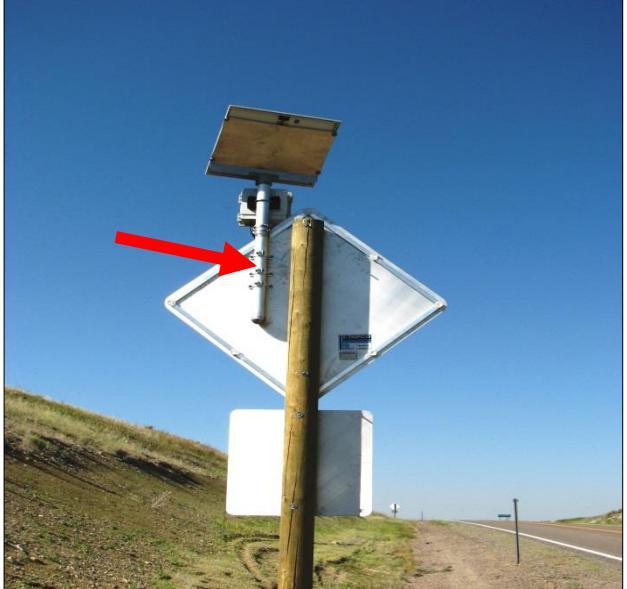
← Rear view of the northbound full system, radio sequence control unit.

The tube bracket (red arrow) which supports the solar panel and master control cabinet contains the unit's nickelmetal hydride (NiMH) battery.

Prior to installation the battery must be charge a minimum of 8 hours to function properly.

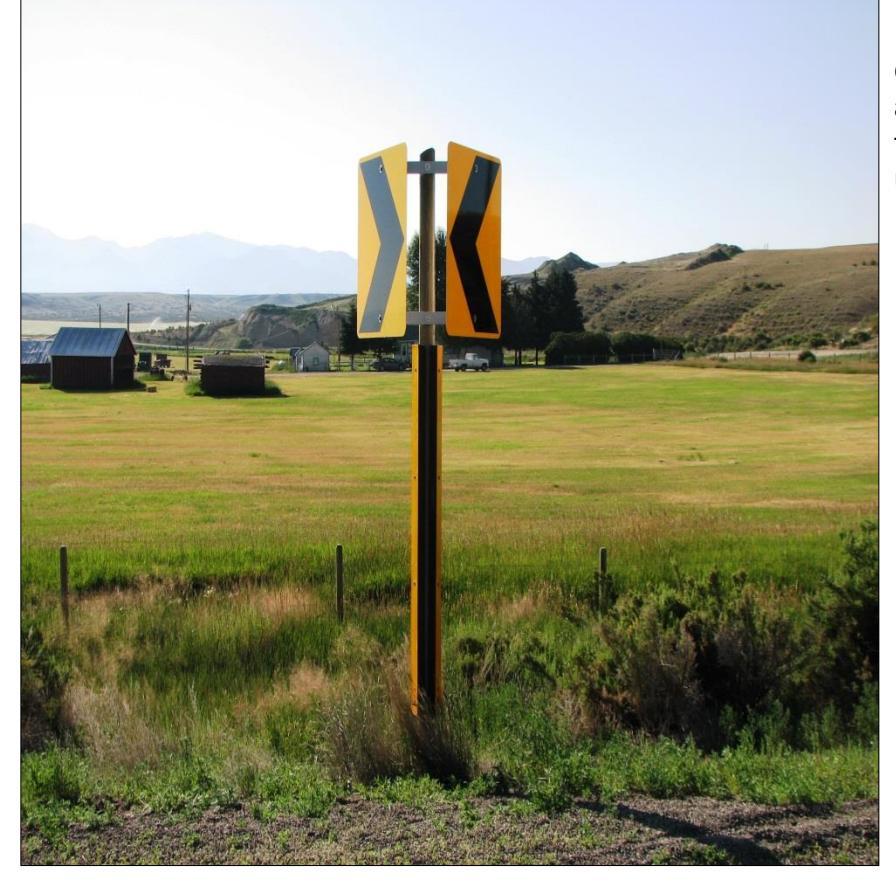
← Five (5) conventional chevron signage alternating with each of the six (6) radar-activated units.
