STRUCTURE INSPECTION REPORT

MDT ID - 02939
 NBI ID - L15672000+02001
 Feature Intersected - SWAN RIVER 110
 Facility - BRIDGE ST

Inspector - Edward Cinadr
 Inspection Type - Fracture Critical
 Inspection Date - 06/21/2023
 Inventory Direction - West to East

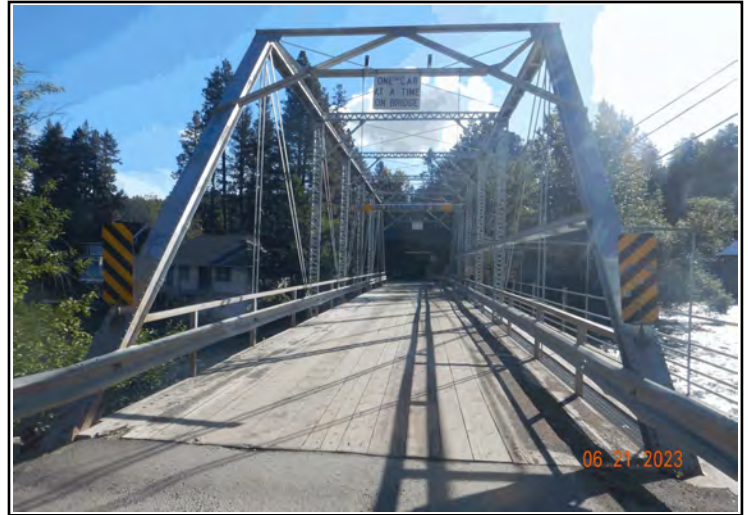
Looking northeast at west bridge end view AOL. Note: end markers in place.

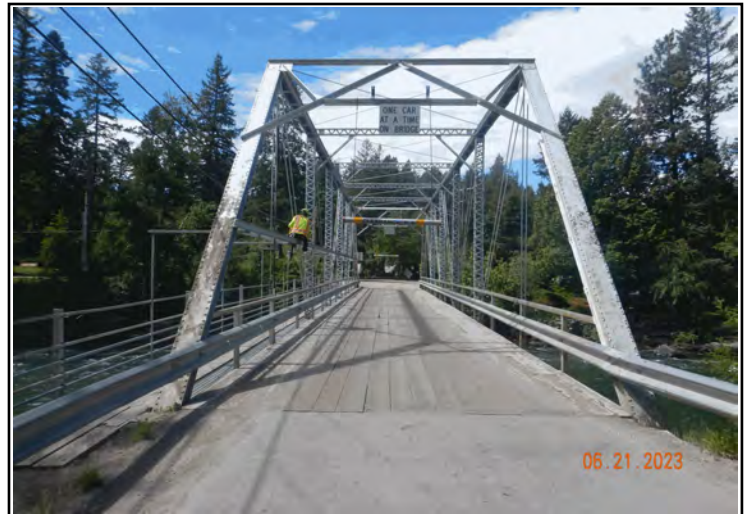
Photo Name:
02939_002.jpg

Looking west at east bridge end view BOL.

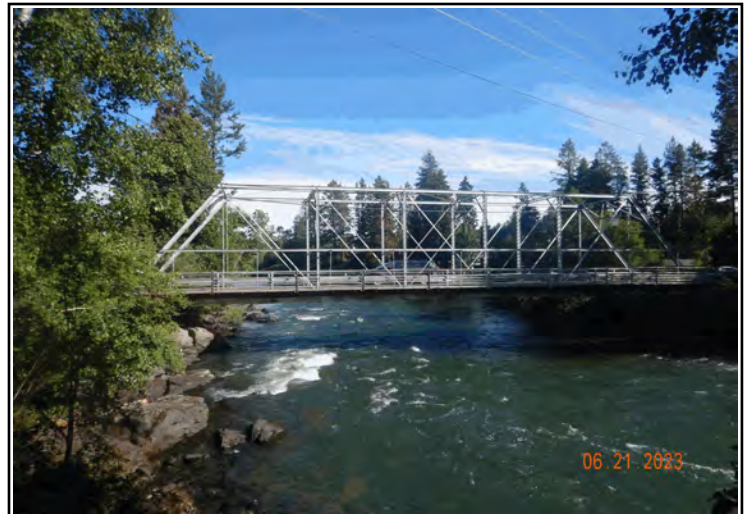
Photo Name:
02939_003.jpg

Looking north at the bridge elevation.

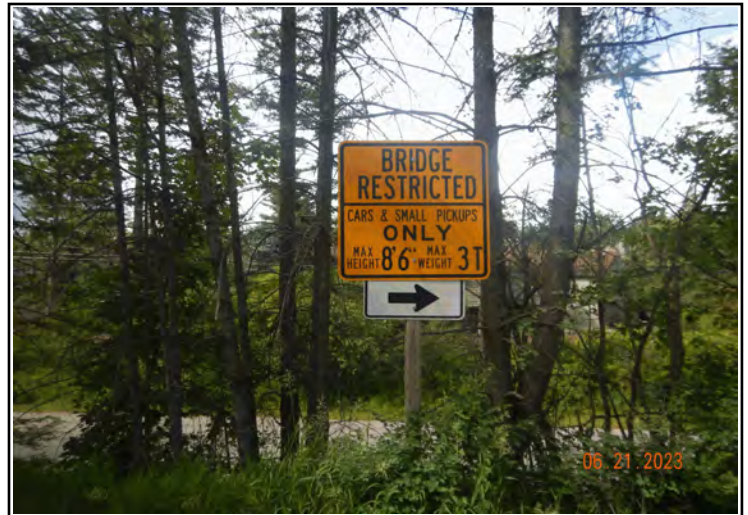
Looking north at "Bridge Restricted" sign on west approach.

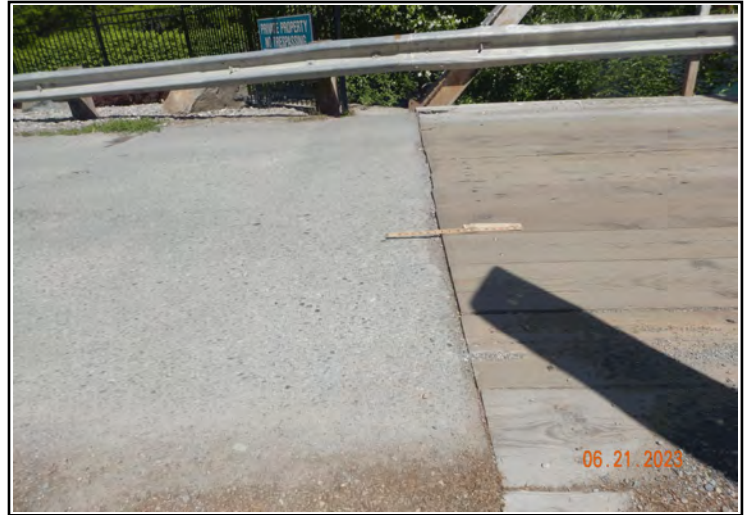
Looking north at transition over abutment 1. Note: up to 3/4" settlement in asphalt pavement.

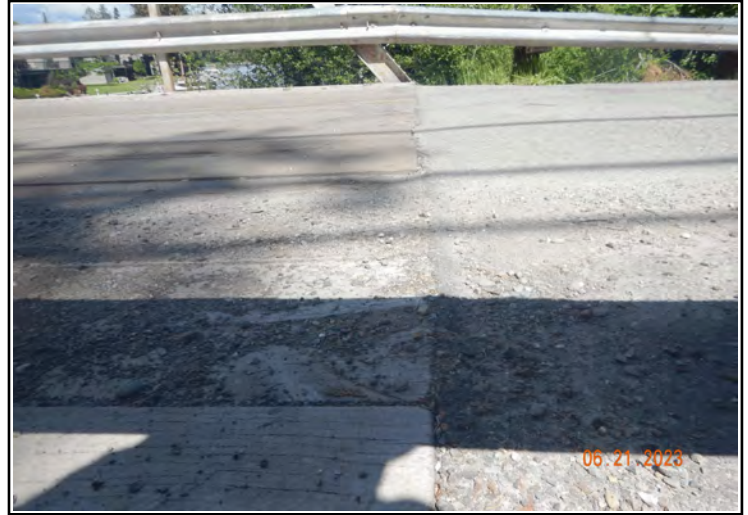
Looking north at transition over abutment 2. Note: minimal unevenness and no significant settlement.

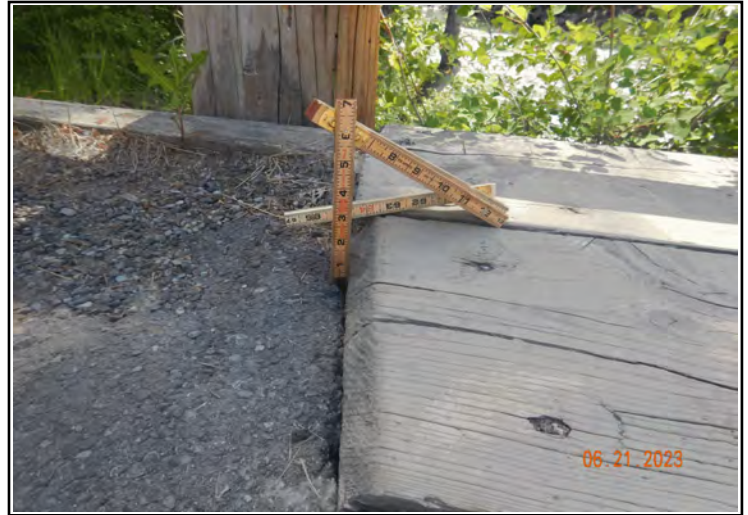
Photo Name:
02939_020.jpg

Looking south at abutment 2 sidewalk transition. Note: 2 inches of settlement at east approach sidewalk

Recommended By:	Date Recommended	Type	Status	Suggested Priority
	11/07/2017	Repair Suggestion	Repair Suggestion	Low
Comments				
Replace deteriorated wearing surface and sidewalk timber boards, secure loose timber boards, and level 2-inch settlement at abutment 2 sidewalk approach.

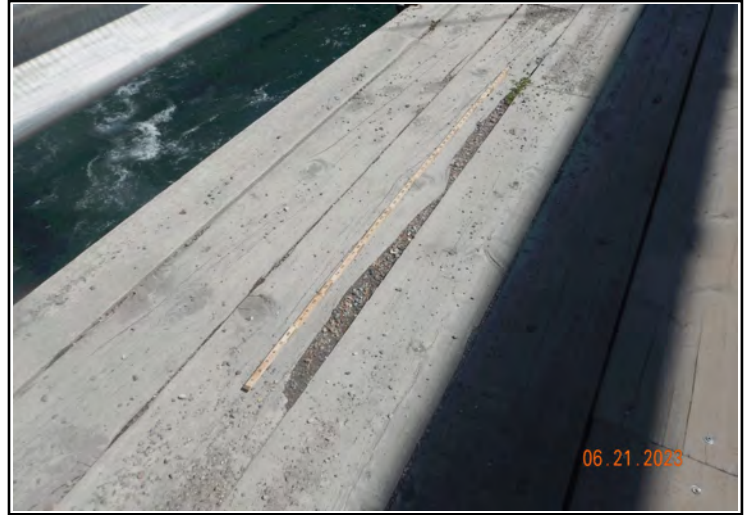
Looking northeast at timber runner near panel point 2 north truss. Note: 5-foot-long corner shake.

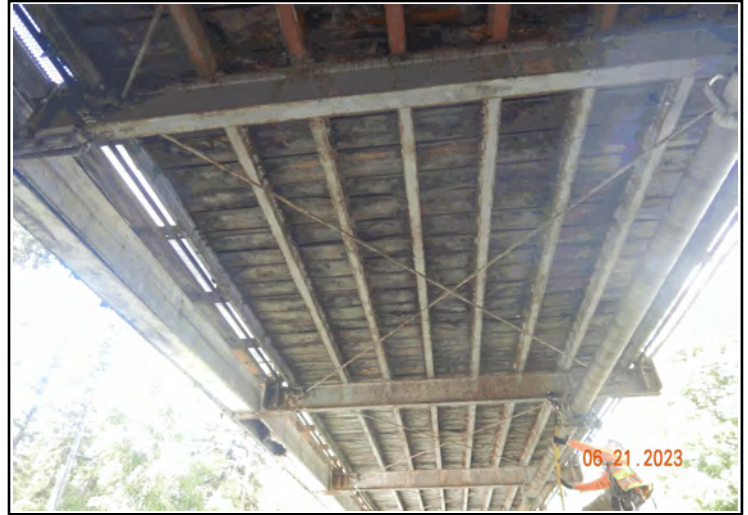
Timber deck soffit exhibits multiple partially failed planks that deflect under live load.

Looking west at overall of underside in bay 1'-2'. Note: multiple timber planks with wide splits and corner shakes. Some planks have up to approximately 10-20% loss of capacity.

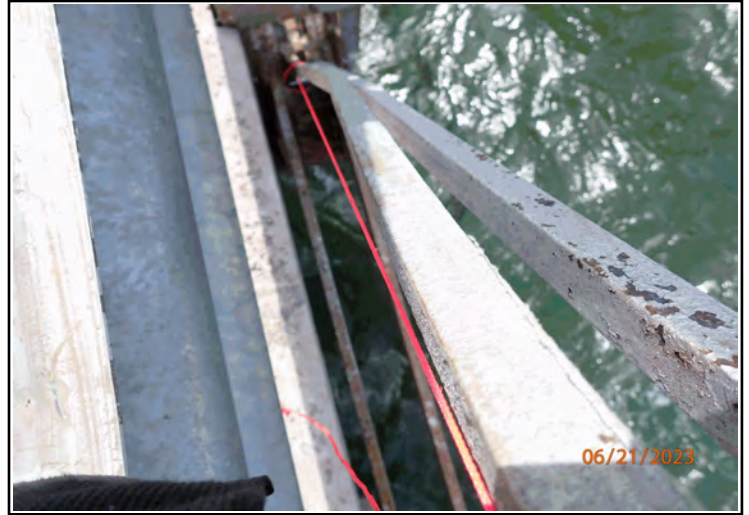
Looking west at north truss L3-U3' inboard eyebar about 2 feet from L3. Note: bent 1-inch outward and 1/2-inch upward over 2 foot length.

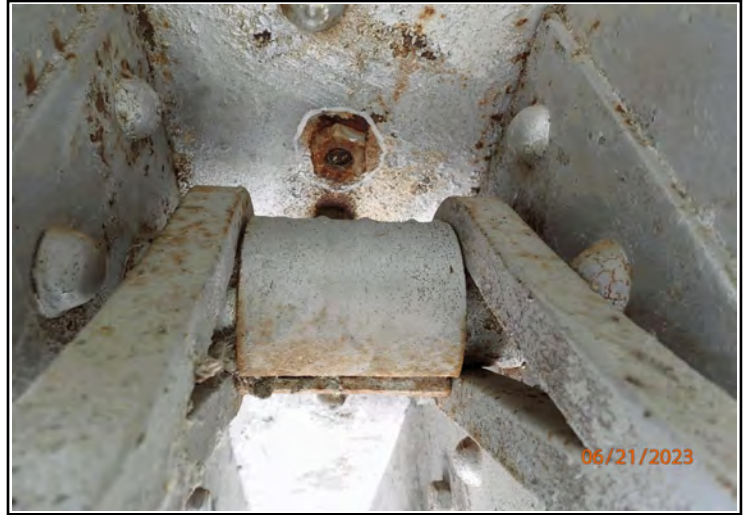
Looking east at U3' upper sway bracing connection plate underside at south truss. Note: one under engaged nut.

Recommended By:	Date Recommended	Type	Status	Suggested Priority
	11/07/2017	Repair Suggestion	Repair Suggestion	Low
Comments				
Replace missing truss connection hardware.

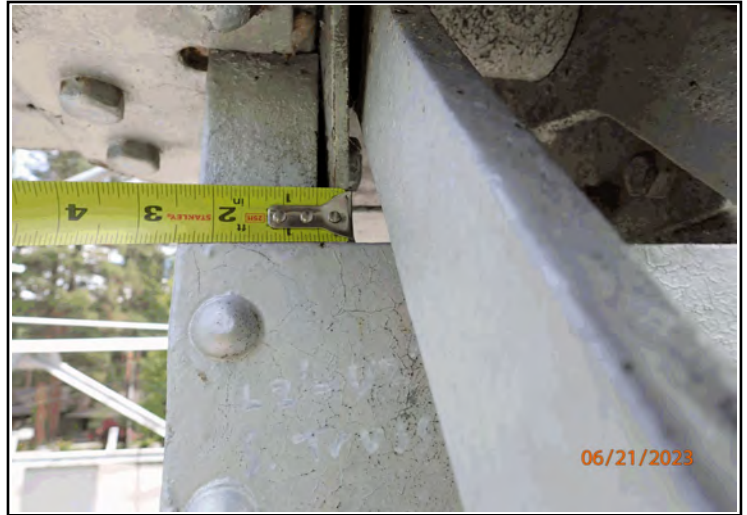
Photo Name:
02939_038.jpg

Looking east at south truss L2'-U2' inboard connection plate at U2'. Note: 1/4-inch distortion on west side.

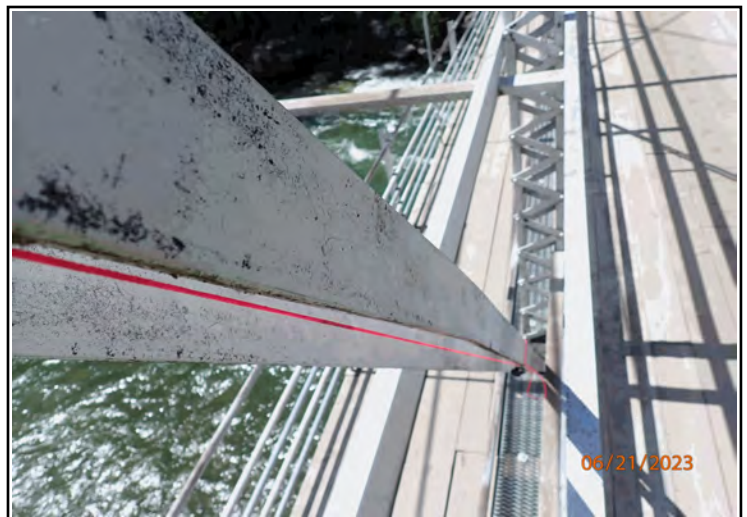
Photo Name:
02939_039.jpg

Looking west at south truss L2'-U1' inboard eyebar. Note: localized upward bowing up to 5/8-inch over a 3 foot length at midpoint.

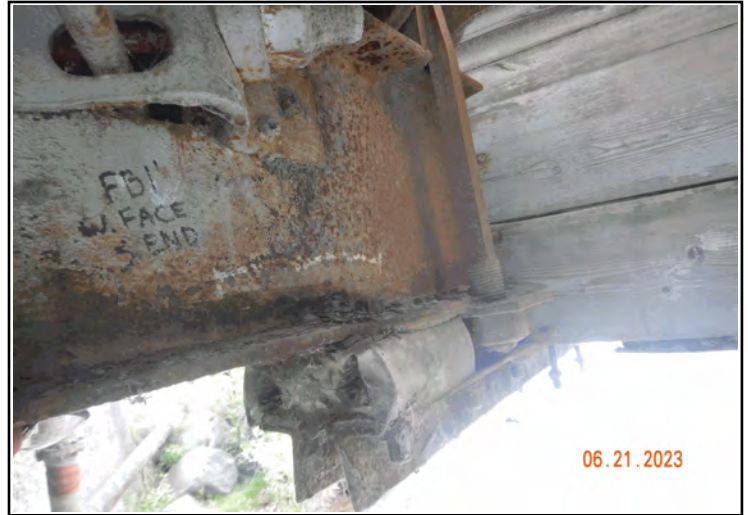
Looking southeast at FB1' web to bottom flange interface west face south end 2 feet. Note: 1/8-inch-deep section loss up to 1-inch high.

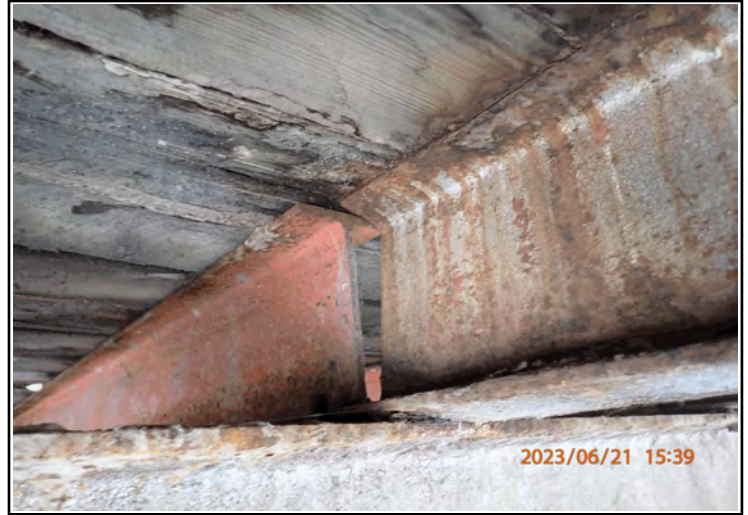
Looking west at end of stringer 5 top flange at FB1 east face.
Note: approximately 1-inch torsional displacement of stringer 4 and 5 at FB1.

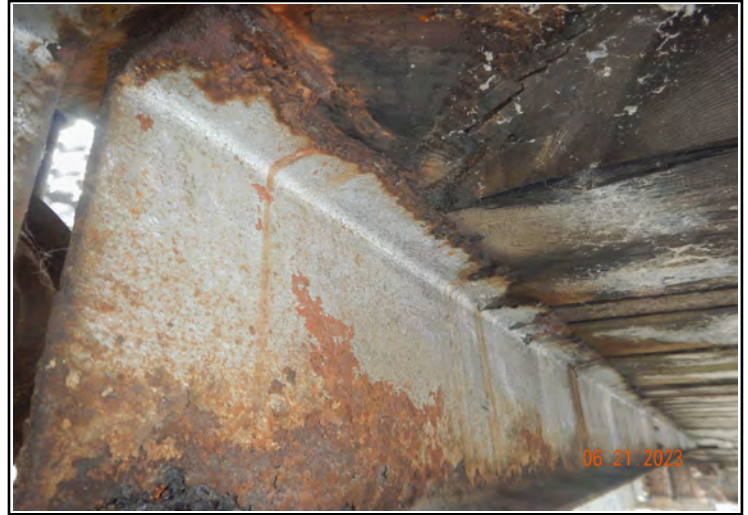
Looking southwest at stringer 8 top flange between FB2' and FB1'. Note: heavy section loss with through holes up to 1 1/4-inch wide with 1/8-inch remaining along top flange over the majority of the member worse at end 2 feet adjacent to FB1'.

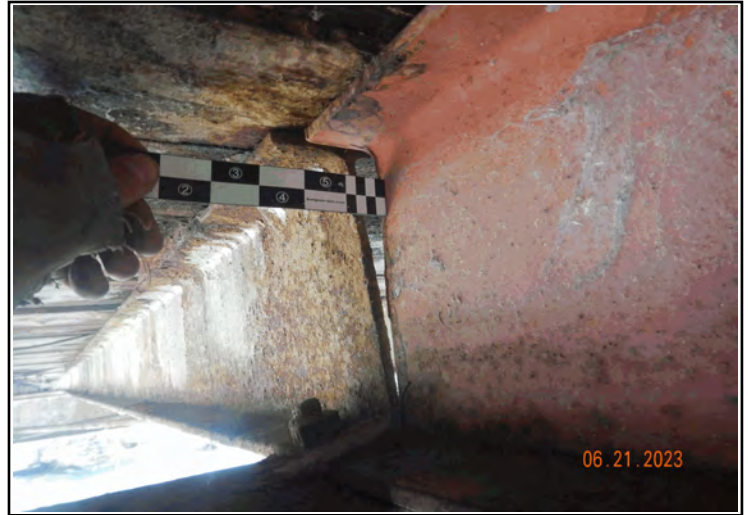
Photo Name:
02939_071.jpg

Looking northwest at stringer 4 at FB1' bay 2'-1'. Note: indication of lateral torsional buckling, stringer end is rotated approximately 3/4-inch to the south. Similar in approximately 10-15% of stringers.

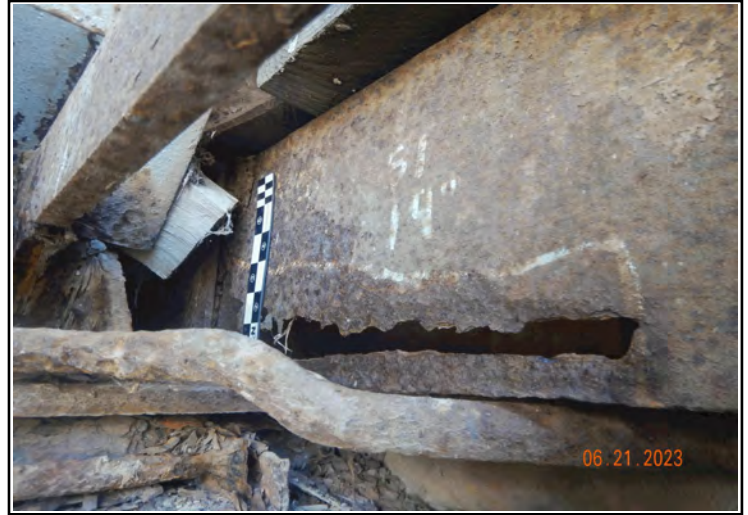
Looking southeast at stringer 1 at abutment 2. Note: 14-inch-long by up to 3-inch-high through hole in lower channel web.

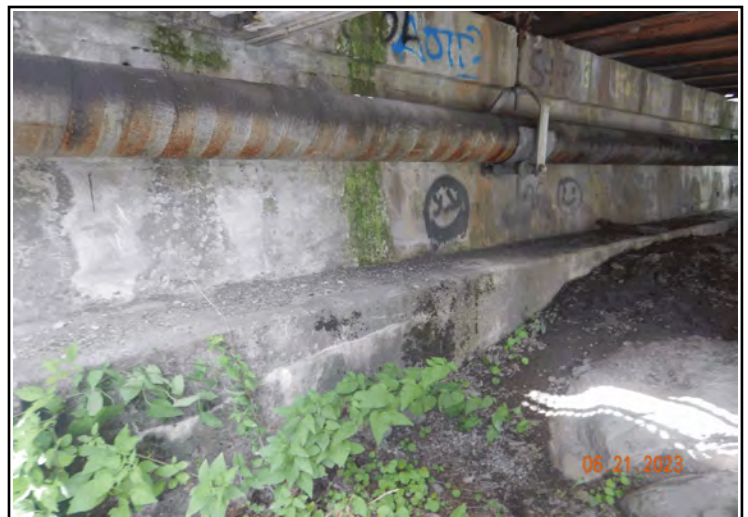
Looking northwest at abutment 1 overall.

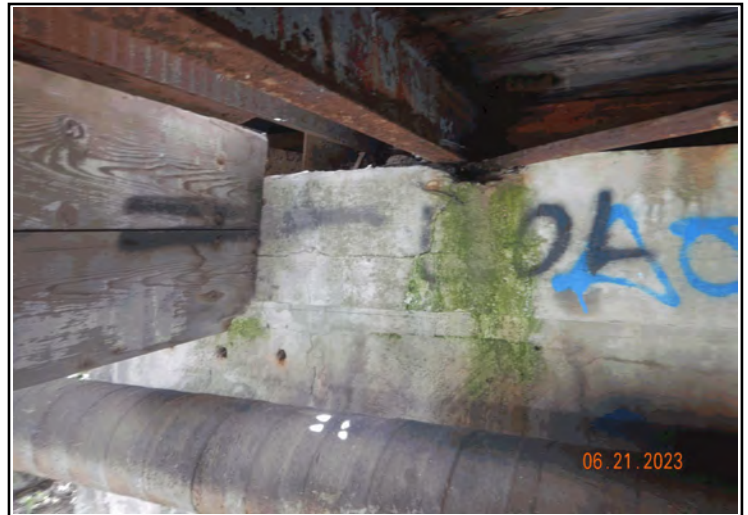
Looking southwest at south end of Abutment 1 breast wall. Note: up to 1/16-inch wide horizontal and vertical cracks and corner spall under lower lateral bracing measuring 7-inch wide by 2-inch high by 4-inch deep.

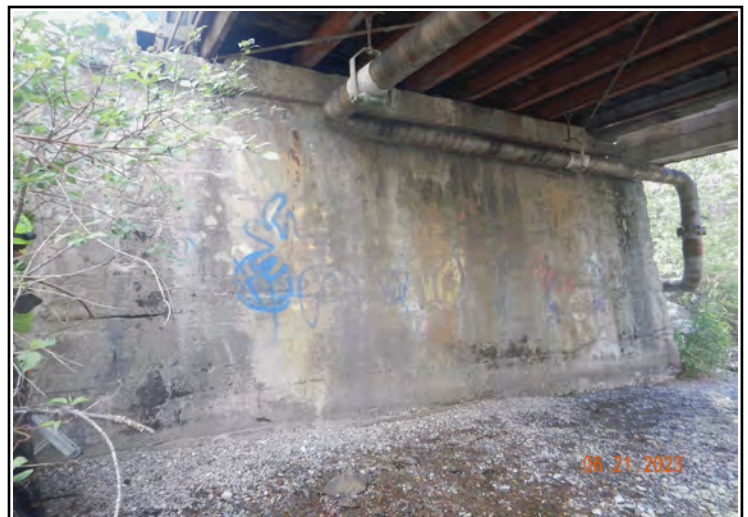
Photo Name:
02939_081.jpg

Looking southeast at abutment 2 overall.

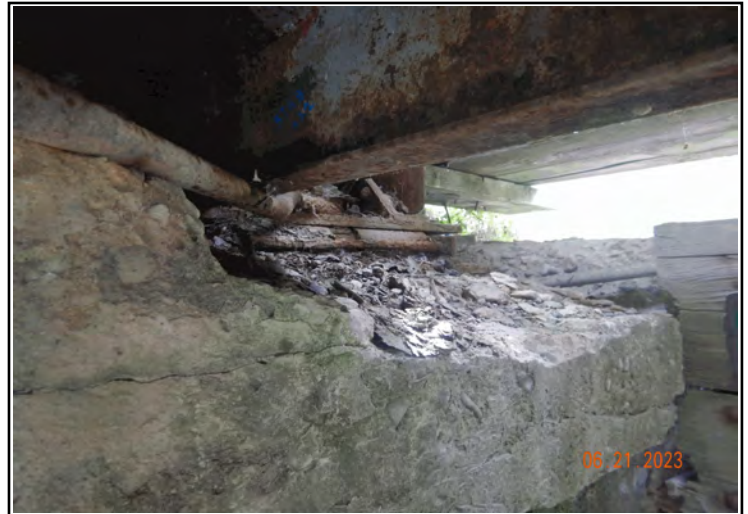
Photo Name:
02939_082.jpg

Looking southeast at abutment 2 wall. Note: bearing seat concrete is heavily raveling and spalled over 2-foot wide by 1-foot long up to 2-inch deep, slightly undermining the corner of the masonry plate.

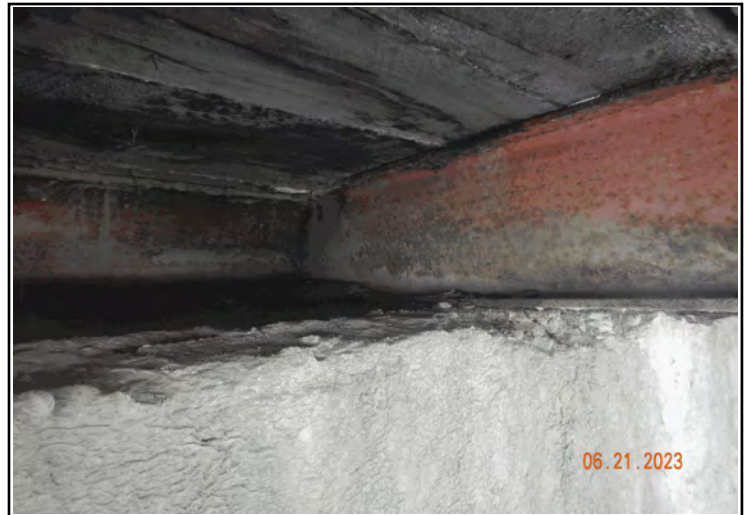
Photo Name:
02939_083.jpg

Looking southeast at abutment 2 wall. Note: up to 2-inch soil accumulation on the bearing seat. Also note, 1-foot-long by 1 1/2-inch-deep corner spall under stringer 3.

Recommended By:	Date Recommended	Type	Status	Suggested Priority
Drew Urban	06/21/2023	UBIV Access/Other DeRepair Suggestion		Medium
Comments				
Clear soil and debris off abutment bearing seats and truss bearings.

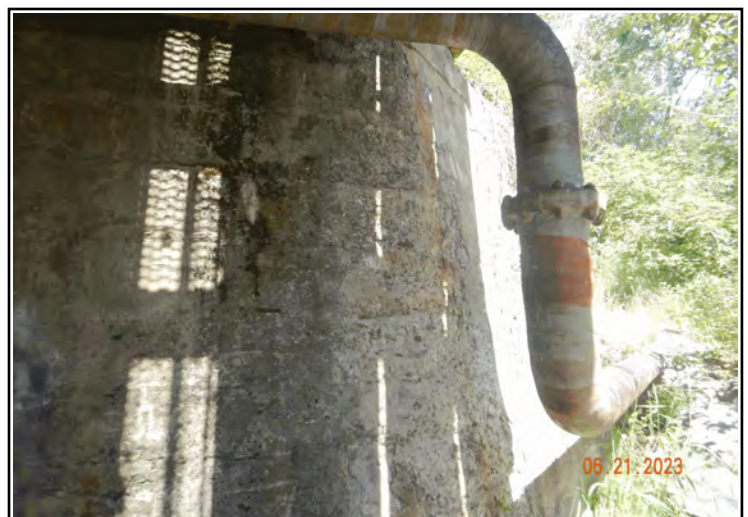
Photo Name:
02939_084.jpg

Looking east at abutment 2 south end. Note: deep raveling and scaling nearly full height extending into the southeast wingwall, up to 4-foot total width by 1-inch deep.

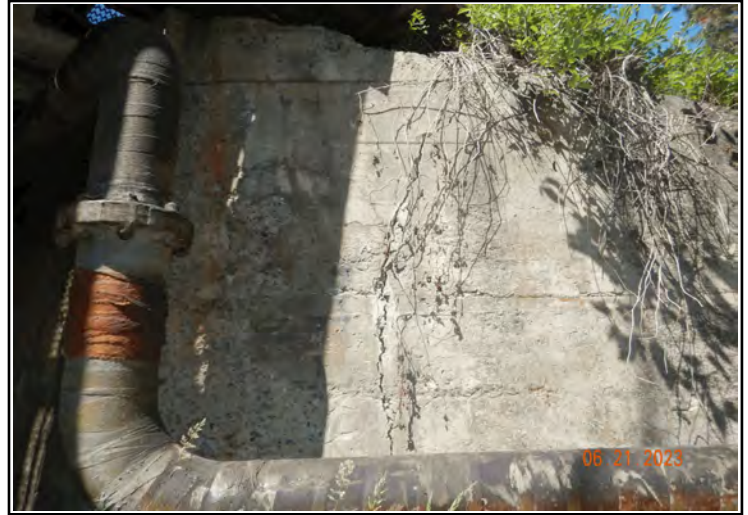
Photo Name:
02939_085.jpg

Looking northeast at abutment 2 south wingwall. Note 3/8-inch-wide full height vertical crack in unreinforced concrete.

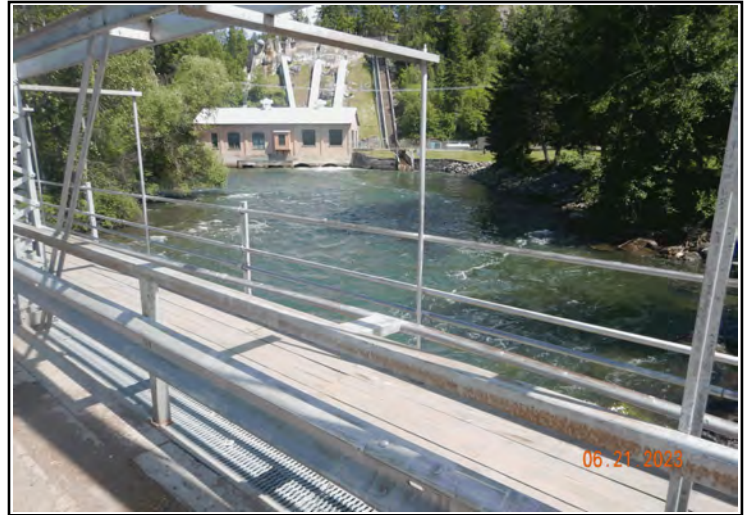
Photo Name:
02939_086.jpg

Looking southeast at upstream channel.

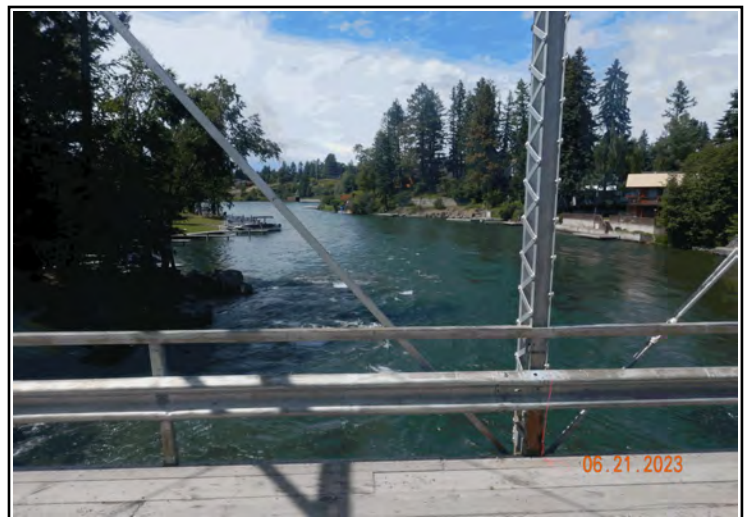
Photo Name:
02939_087.jpg

Looking north at downstream channel.
