1. TIMBER BORING TEMPLATES

1.6. Timber Boring Inspections

1.7. Timber Cap Boring Inspections

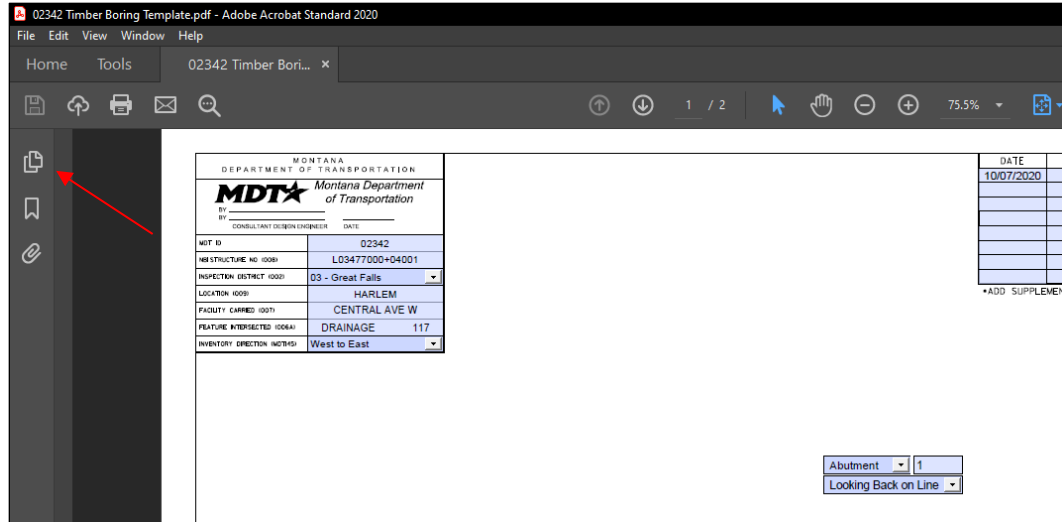
3. Open “0XXXX Timber Boring Template.pdf” in Adobe and on left side of screen click the multiple page button to open up Page Thumbnails (By default, thumbnails are turned off,. To turn them on go to “Edit > Preferences > General” and select “Enable PDF thumbnail previews in Windows Explorer.”)

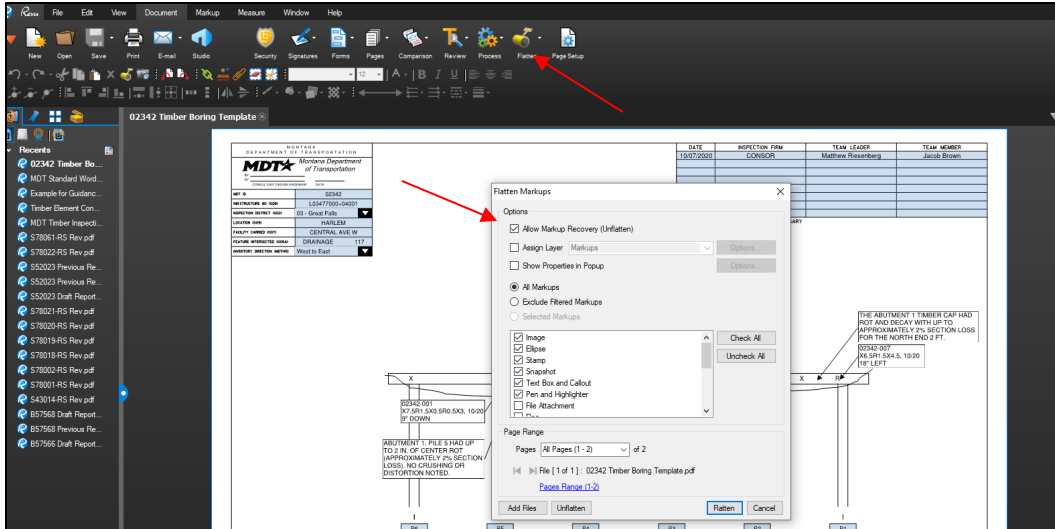
Before flattening mark-ups in Bluebeam, ensure that the correct settings are enabled. Click on the Flatten Button under the Document Ribbon. The top option titled “Allow Markup Recover (Unflatten)” should be selected.

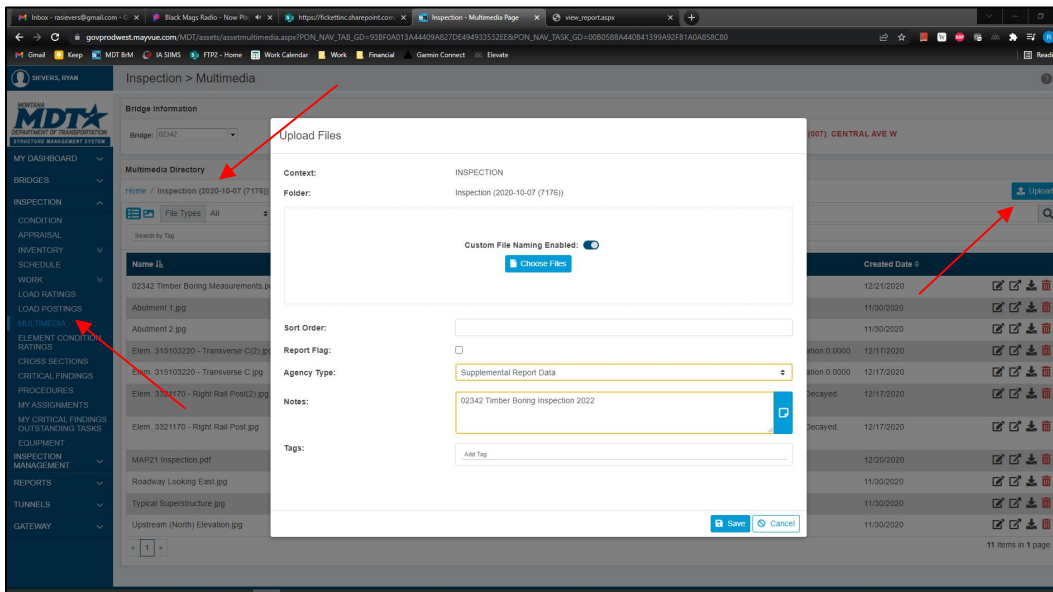
A flattened version of the Timber Boring Template will also need to be uploaded to the inspection specific folder in BrM. This involves printing all pages of the template to PDF, which will flatten all fields.

BrM > Inspection > Multimedia > Inspection (XXXX-XX-XX (XXXX))

Upload the template and follow the naming convention of “0XXXX Timber Boring Inspection (XXXX “year”)”

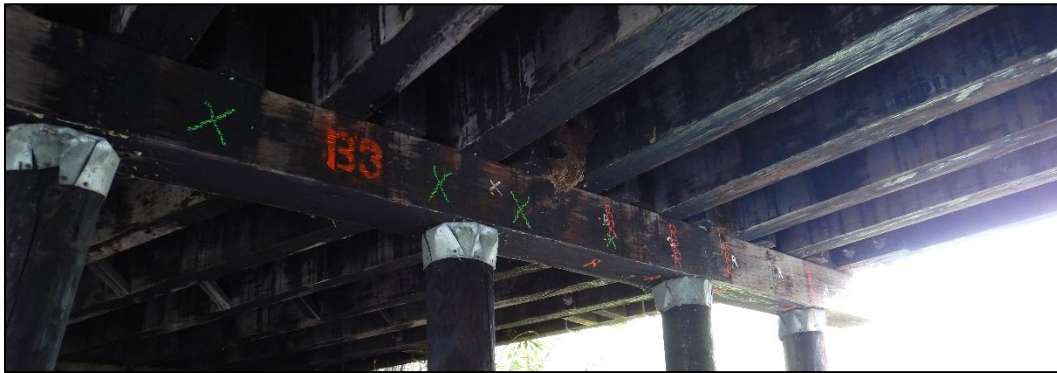
1. Use resistograph to bore timber cap along the neutral axis to find extents of decay.
2. Mark out areas to pattern drill, which will include areas of decay around piles, areas where cap is bulging or crushing, or where there was a significant change in section loss when bored at neutral axis. It will be necessary to chase the decay horizontally from the end of the cap with rot. It is recommended that pattern drilling occur on either side of each pile until sound cap is obtained.

3. Drill the cap at the mid-point and quarter-points on the vertical face of the cap (3, 6, 9 in. measured from top of 12 in. tall cap) and vertically through the bottom face of the cap, if accessible

Pattern drilling of caps will give MDT an accurate depiction of the section loss throughout a timber cap. A resistograph with the ability to digitally record graphs is required at a minimum of one pattern drilling location on each cap where pattern drilling is utilized.
