Experimental Feature Evaluation July 2023

Experimental Feature:	Electrified Wildlife Deterrent Mat
Location:	Butte District, Broadwater County, US Hwy 287, RP 85.9
	- 89.3
MDT Project Name:	Toston Structures
MDT Project Number:	NHIP-NHPBIP 8-4(66)86[7668]
Experimental Project Number:	MT-20-01
Principle Investigator:	Chad DeAustin, Experimental Project Manager (ExPM)
Technical Contact:	Deb Wambach, MDT Helena Environmental
Construction Date:	Fall 2020/Spring and Summer 2021
Date of Inspections	July 2022, June 2023

2023 Inspection – June

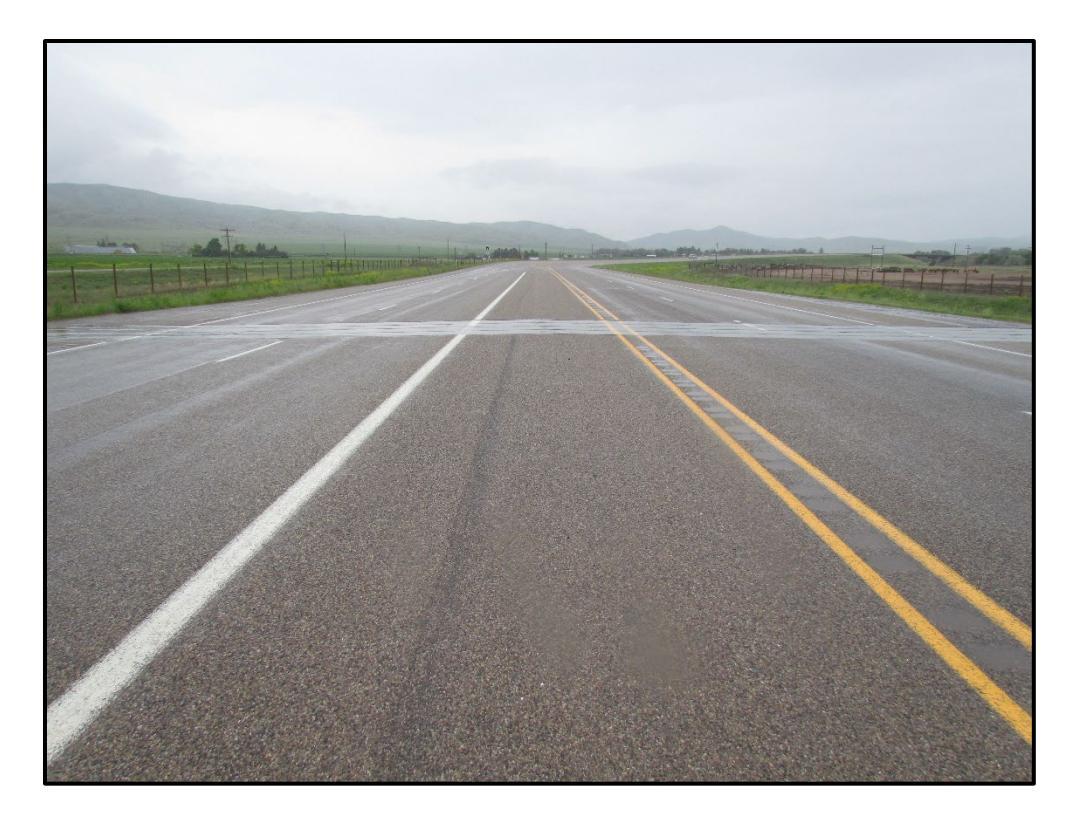
♠ North EWDM, view south.

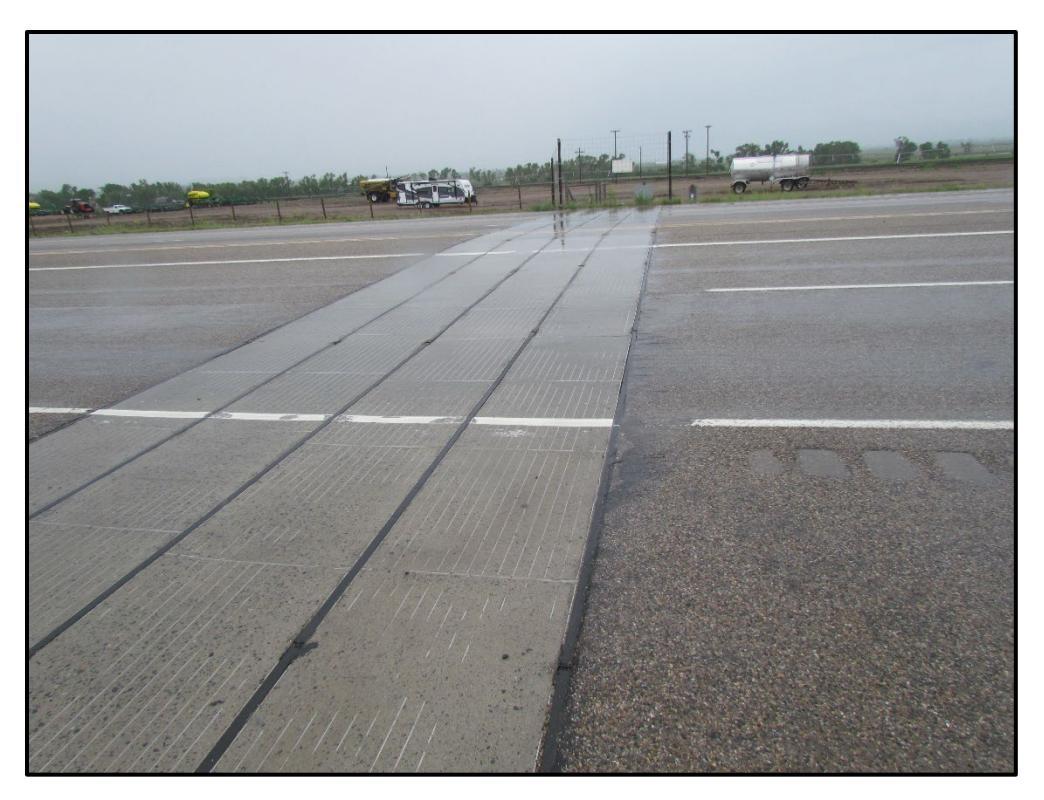
↑ North EWDM, transverse view.

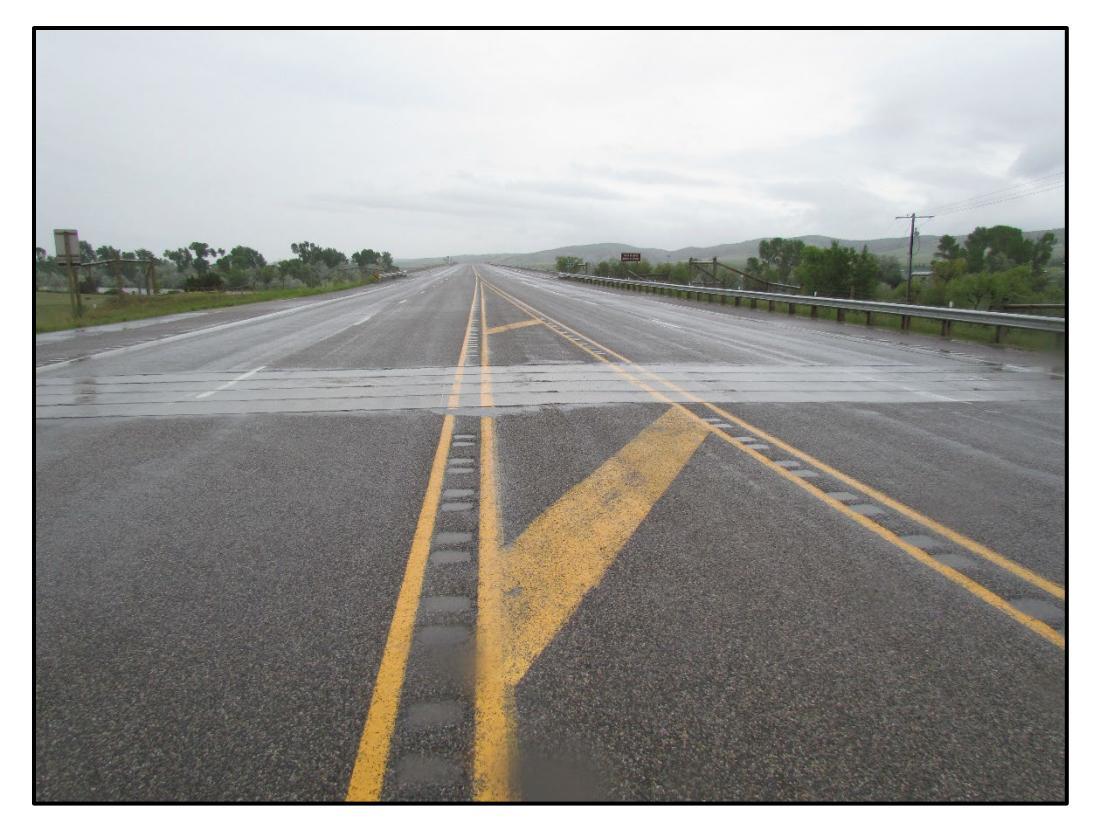
♠ South EWDM, view north.

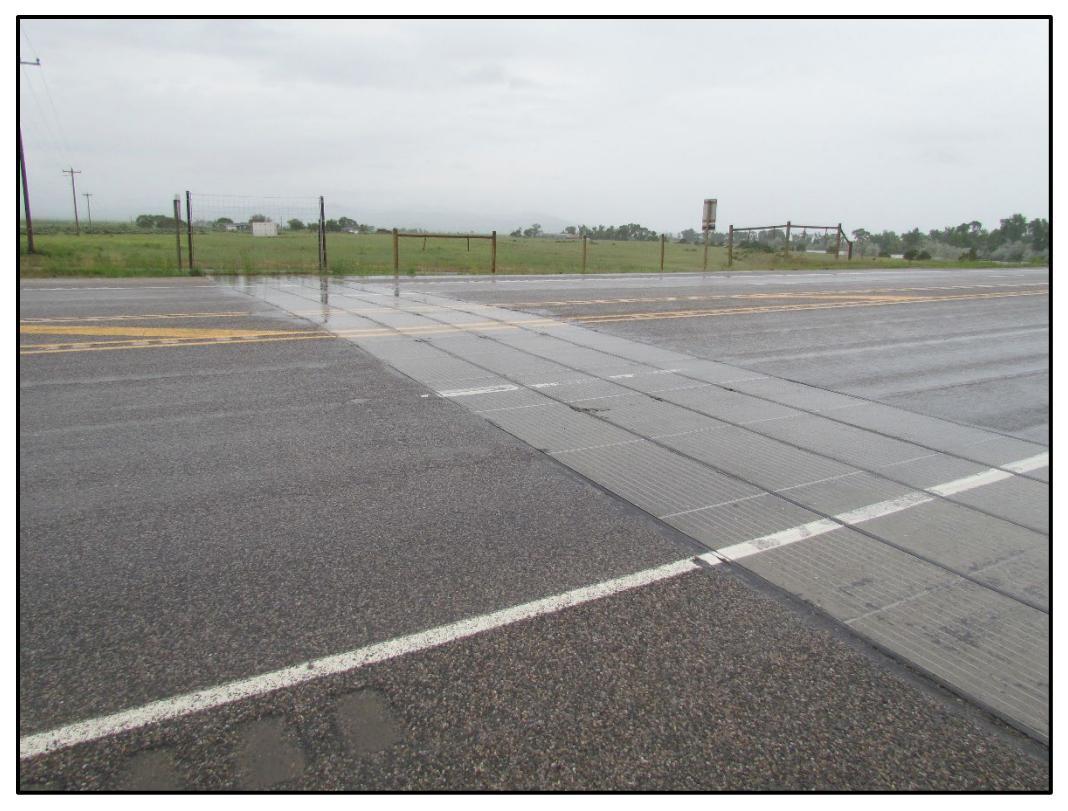
♠ South EWDM, transverse view.

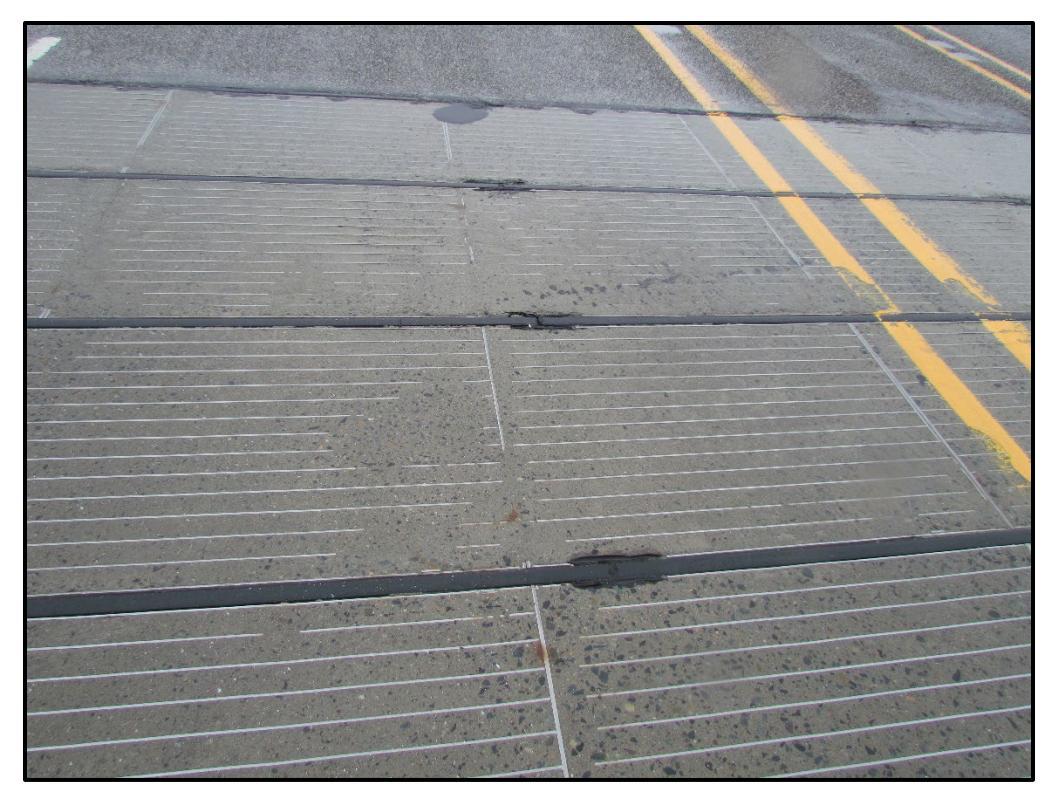
♠ South EWDM, closer view of the surface of the mat.

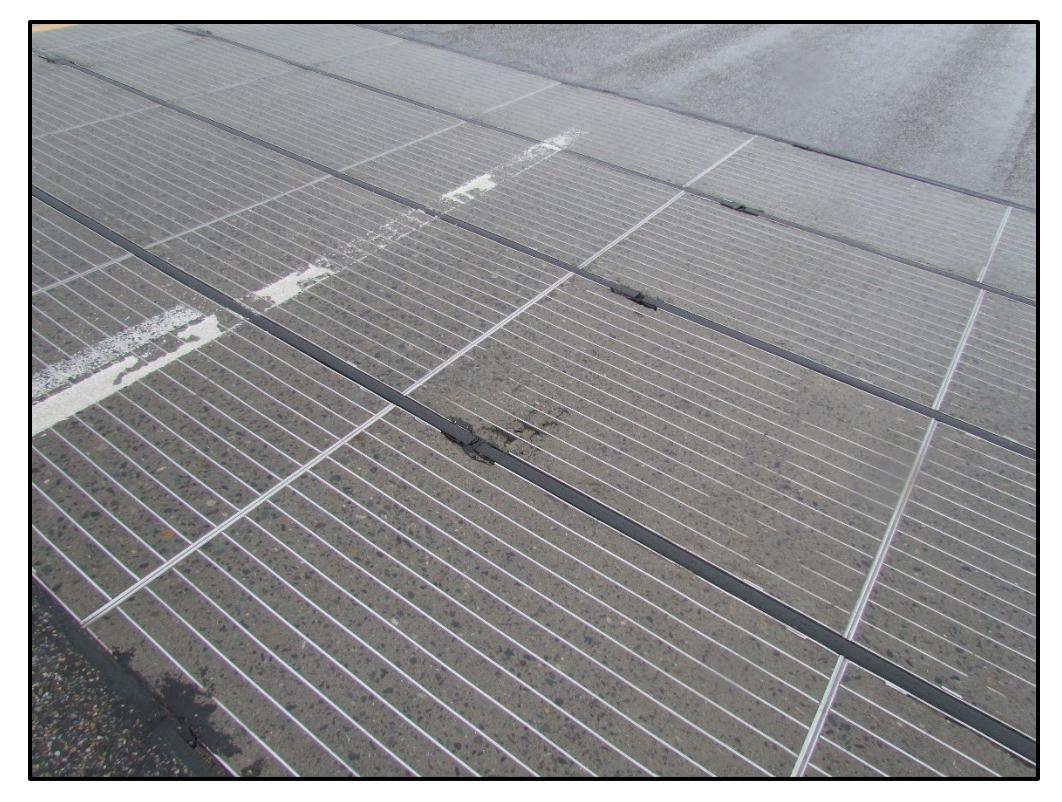
The small crack slightly increased in size. This was shared with MDT Maintenance staff. Other than that, the mats visually are in good condition and appear to be operating correctly.

↑ South EWDM, crack that was noticed during last year's visit. Other than this damage, little to no other damage was noticed.

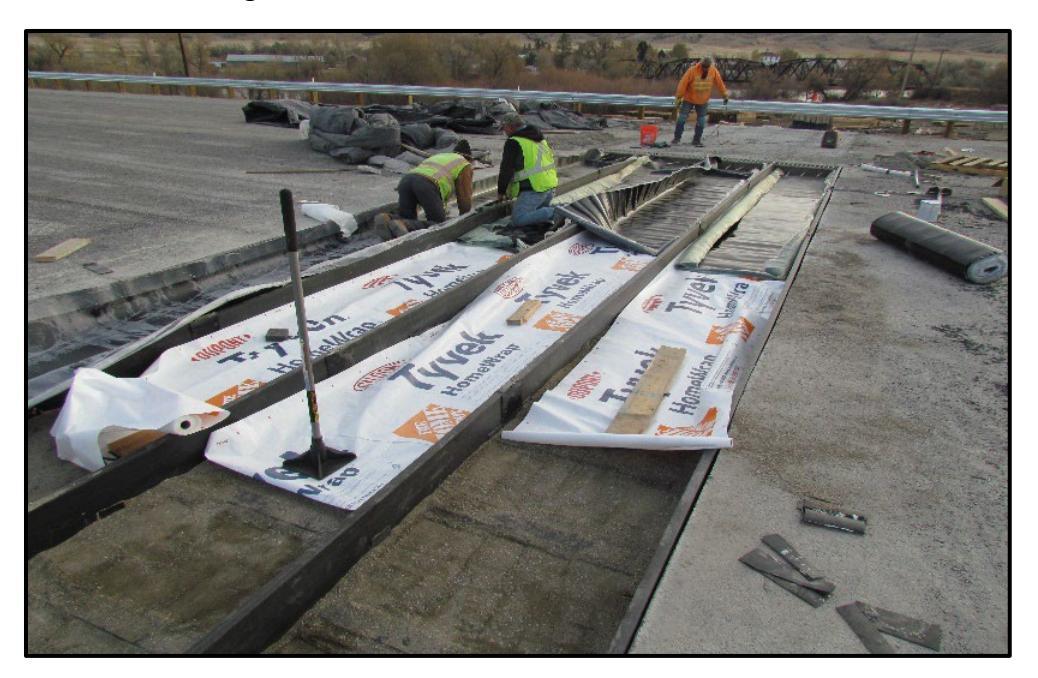
CrossTek, LLC began the process of placing the EWDM after the paving was completed. They cut the plant mix and removed material for a total depth of 10" below the plant mix surface. The base was then covered with a layer of crushed fines and compacted. Then a thin layer of sand was placed to aid in leveling the forms.

↑ Tyvek was laid to aid in the separation of the mat and mitigate moisture seepage. A neoprene mat was also laid to aid in moisture seepage mitigation.

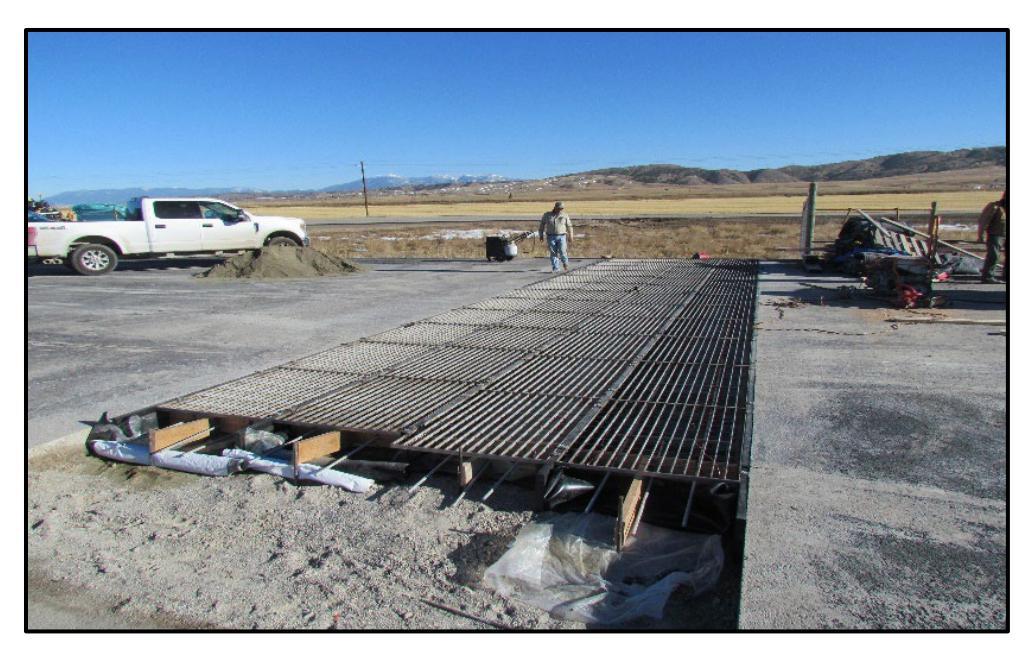
♠ View of grid layout after rebar and form placement.

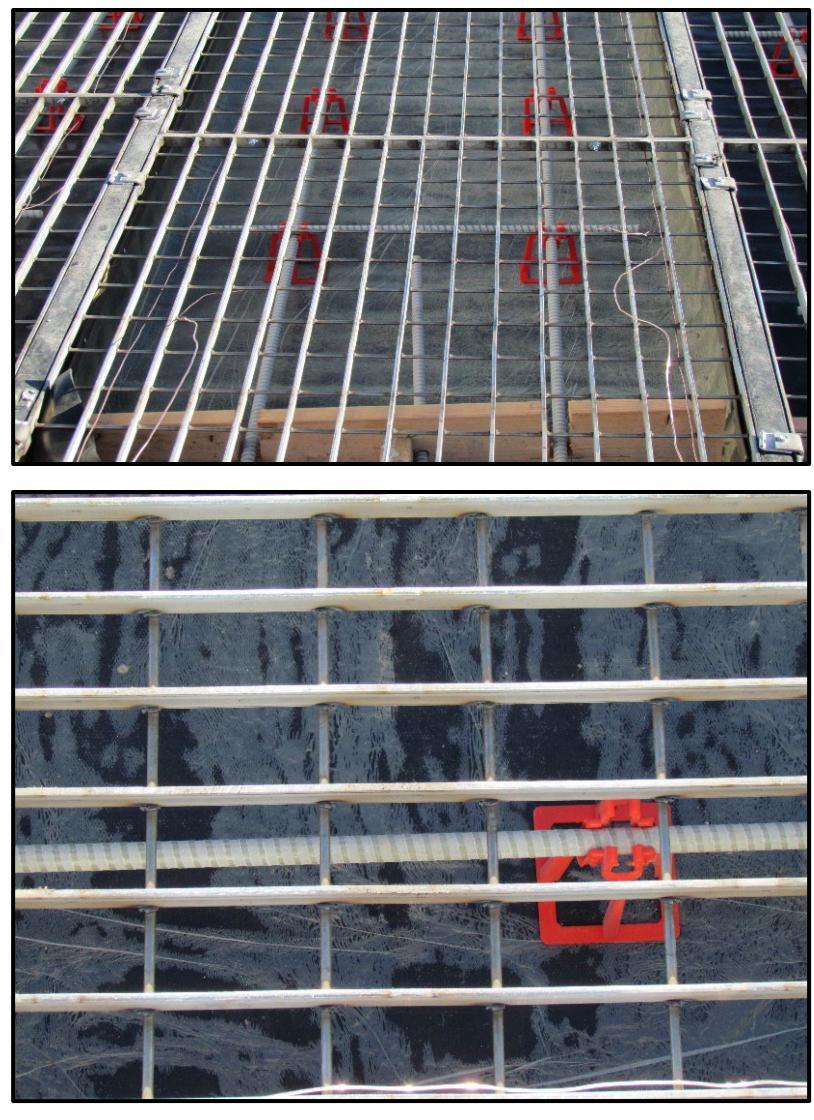
← ♥ Close-up view of grid with the rebar seen below. The rebar was set on stands that keep it 3-4" above the neoprene mat.

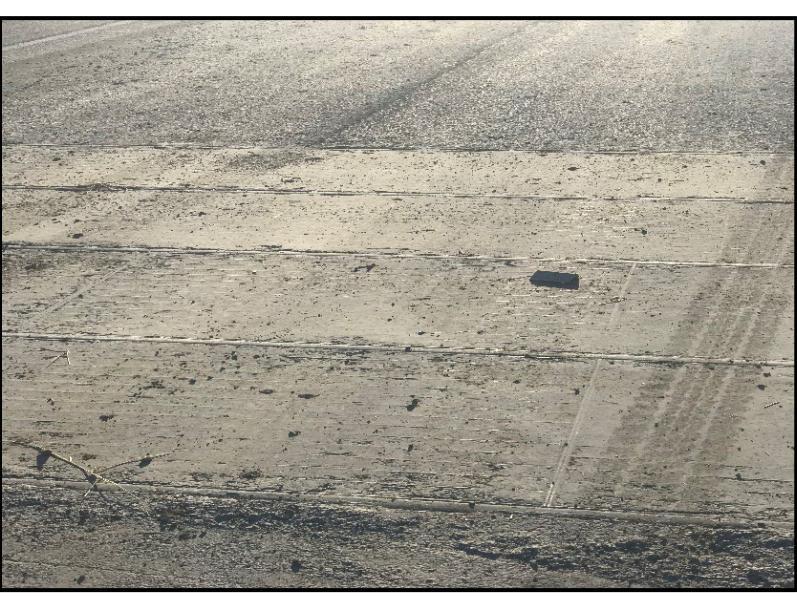
← View after concrete was poured. The grid is completely covered during this process then the surface is ground off to expose the grid.

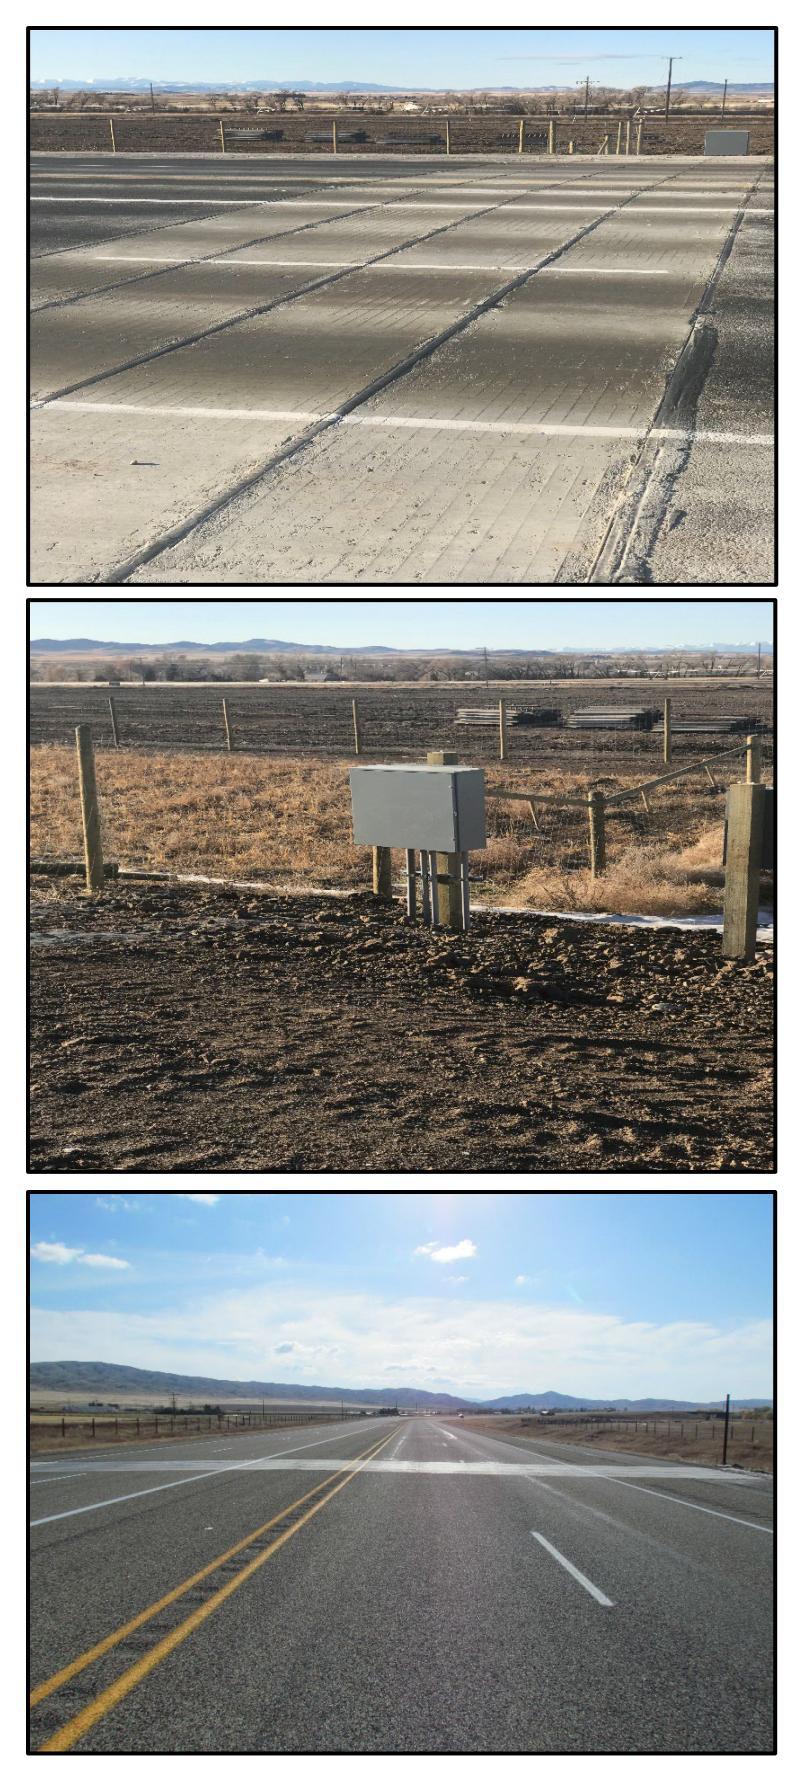
← Transverse view of the EWDM after grinding was completed.

← View of the electrical control box.

Completed north EWDM, view south.

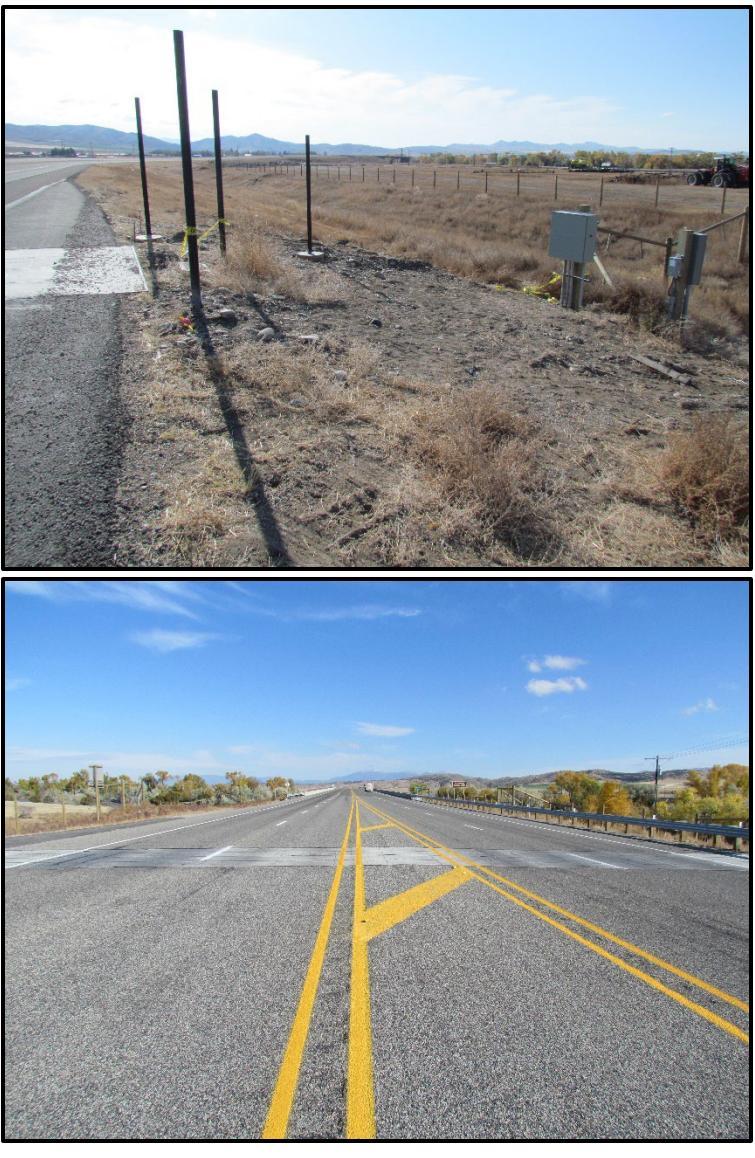
← North EWDM, fencing at EWDM that wasn't completed but when finished will create the wildlife free zone in tandem with the EWDM.

← South EWDM, view north.

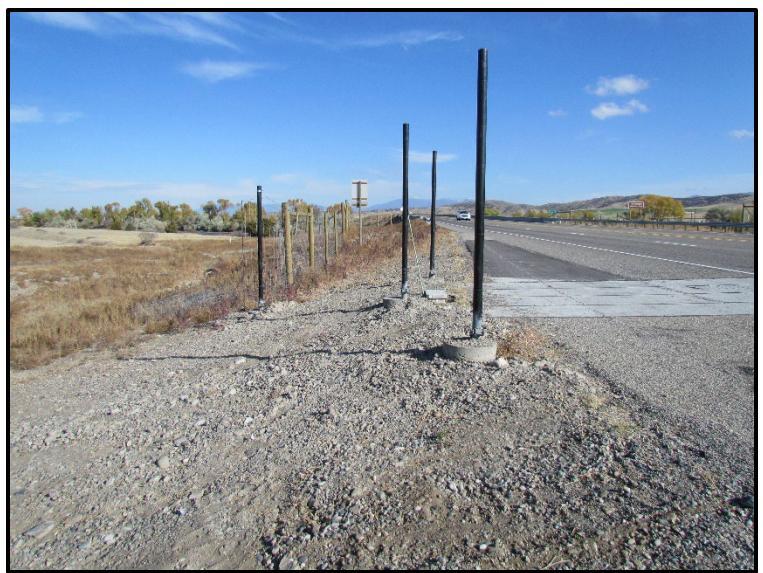
← South EWDM, fencing at EWDM that wasn't completed but when finished will create the wildlife free zone in tandem with the EWDM.
