Montana Department of Transportation
Research Programs
November 2006

EXPERIMENTAL PROJECT

**EVALUATION OF RADAR SPEED DISPLAY (RSD) TRAILER-MOUNTED DEVICE
FOR SPEED REDUCTION FOR USE IN CONSTRUCTION WORK ZONES**

Project Name: Bear Canyon

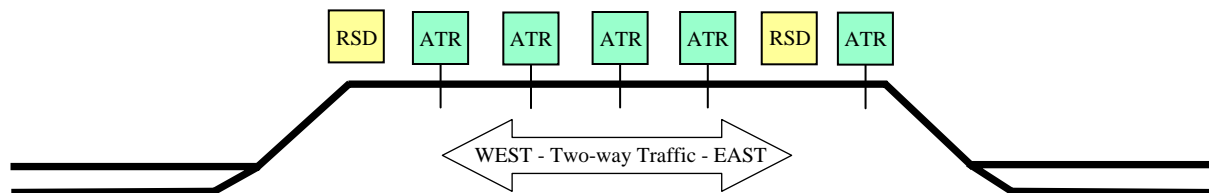
Figure 1: Representative Diagram of the I-90 Work Zone Crossover Schematic of Approximate Placement of the RSD Units and ATR's

Evaluation will consist of collecting data with automatic traffic recorders (ATR) to determine if
the devices are a factor in speed reductions. Research worked with the Departments Traffic
Engineering Section in the coordination and scheduling of the data collection process.
ATR data will be collected at evenly spaced distances throughout the work zone crossover

(figure 1). ATR speed data will be collected prior to initiating the RSD's to provide base data comparison. The MDT Traffic Engineering section was responsible in determining the necessary frequency and duration of speed data collection to present a statistically defensible performance evaluation. The average length of the work zone is five miles.

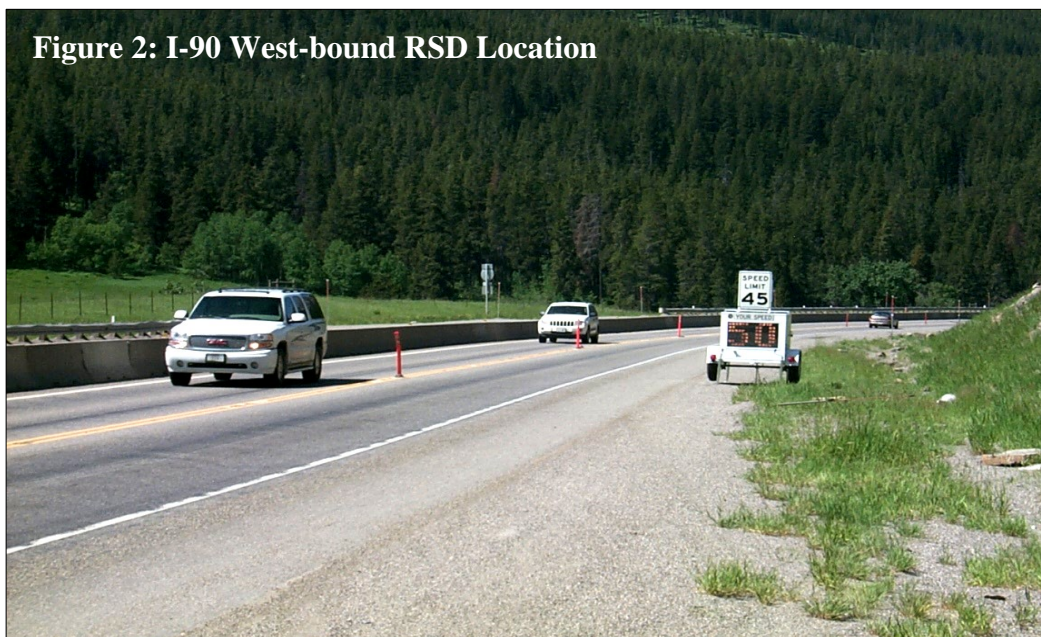
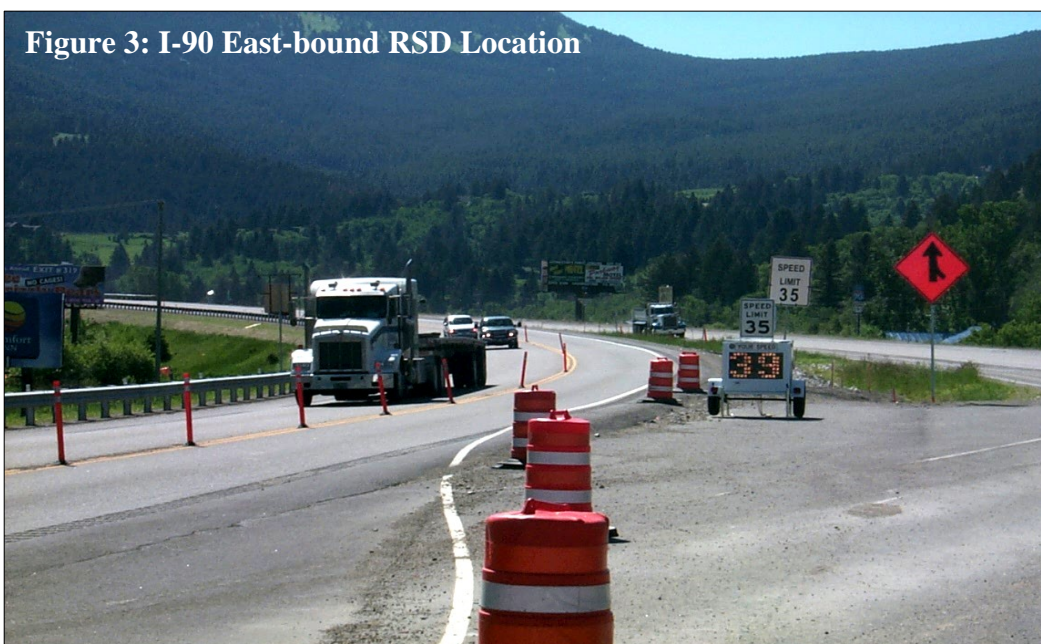
the geometrics of the work-zone travel lanes. The westbound lanes had the advantage of a full lane and shoulder width, whereas there was jersey rail located adjacent to the eastbound travel lane (refer to figure 2). The speed data revealed that the traveling public was exceeding the posted speed limit by an average of six mph; however, the placement of the RSD's did drop the ATS by 2-3 mph.
