Montana Department of Transportation Stream Mitigation Monitoring Report  
**FOY'S BEND FISHERIES CONSERVATION AREA NH\_MT5-3(50)109F UPN #: 2038013**

**Monitoring Year:** 2021

**Monitoring Conducted By:** Confluence Consulting Inc.

**Monitoring Dates:** August 13th-14th, 2021

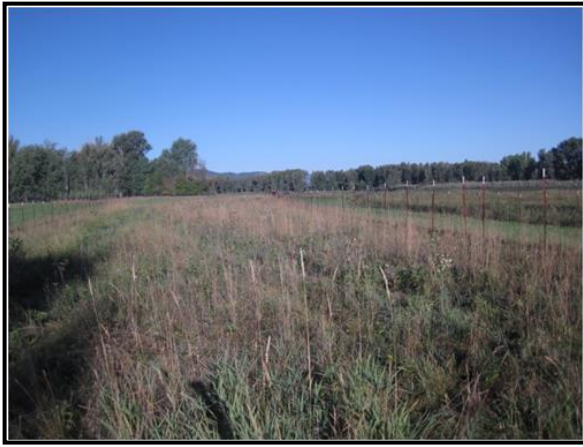
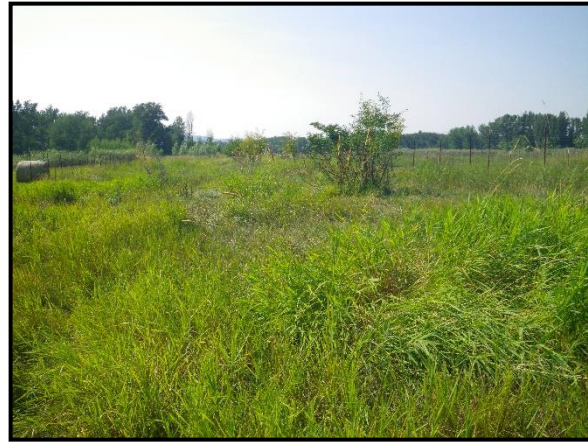
**Photo 1:** Exclosure 4, looking northwest.

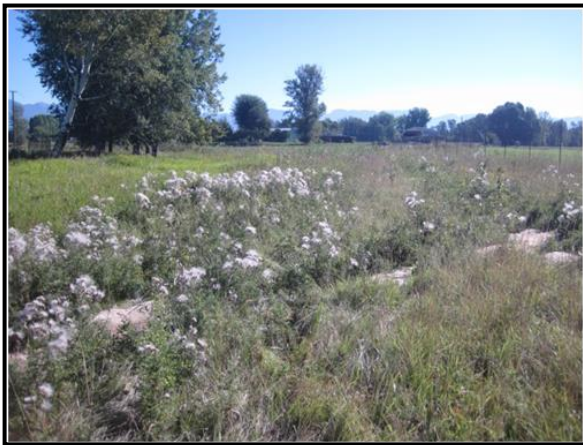
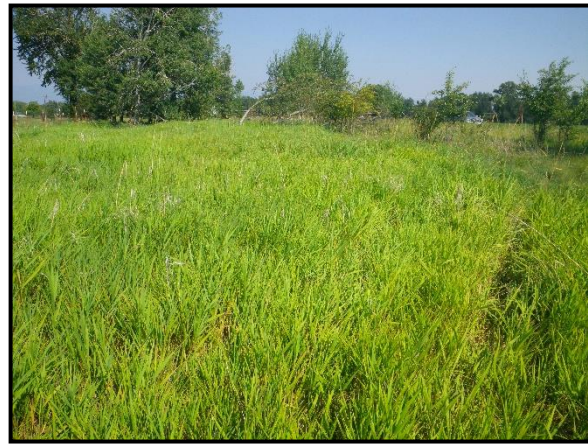
**Photo 2:** Exclosure 6, looking east.

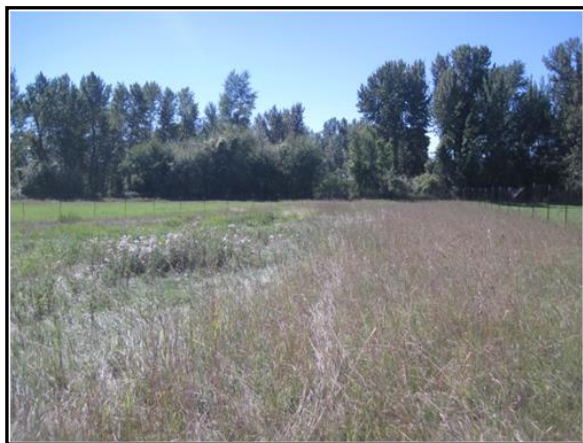
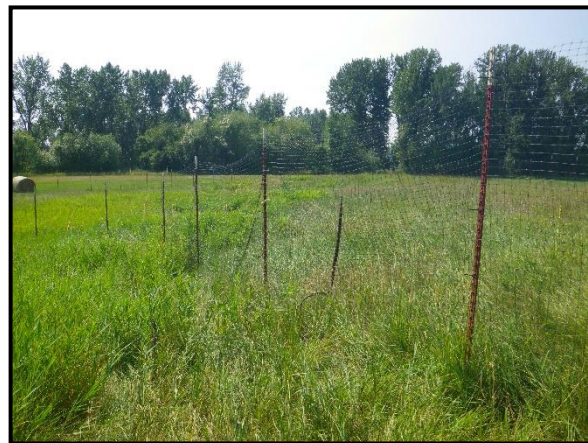
**Photo 3.2:** Exclosure 8 looking south-southeast.

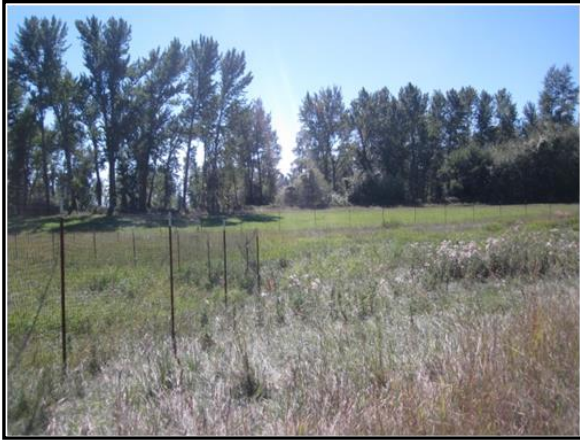
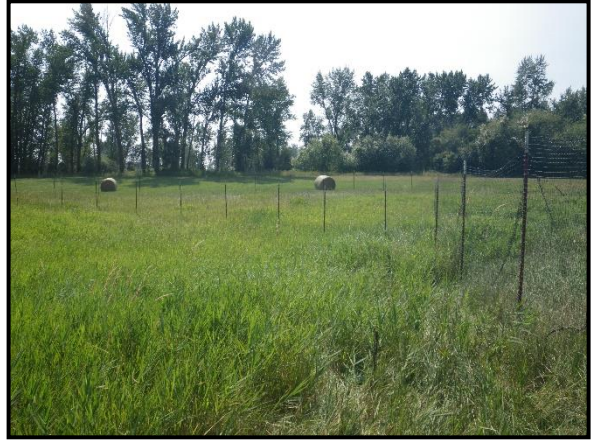
**Photo 3.3:** Enclosure 8, looking south-southwest.

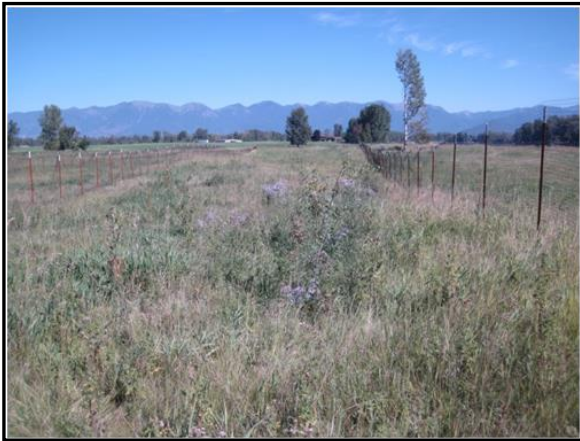
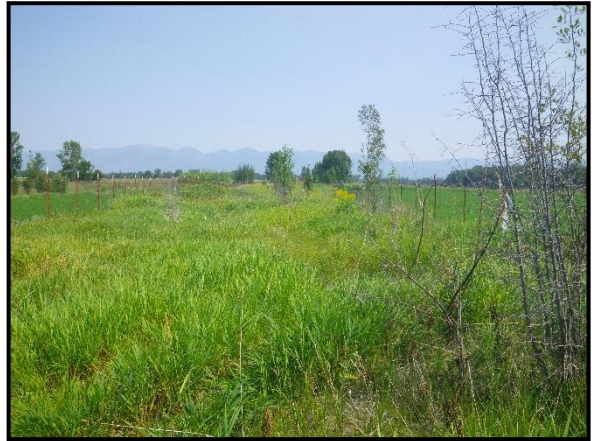
**Photo 4:** Enclosure 14, looking east.

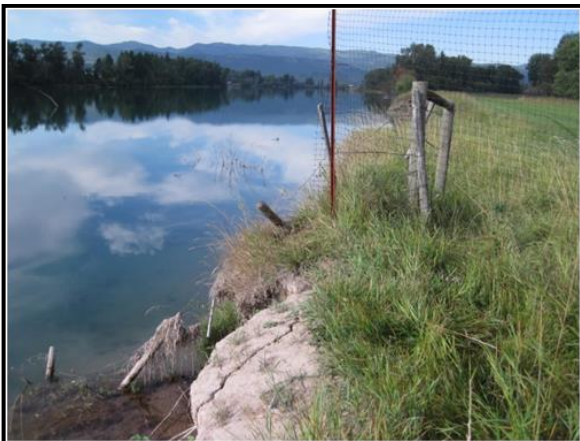
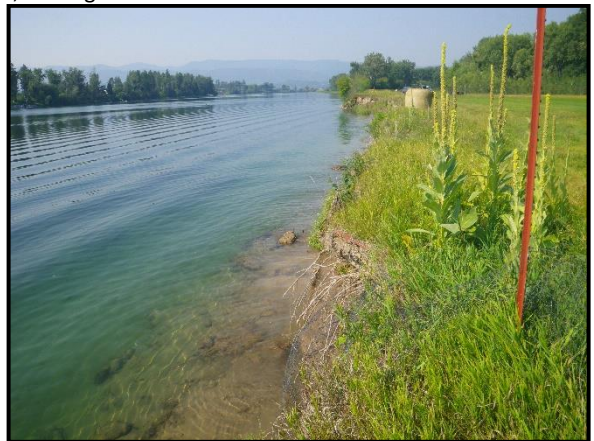
**Photo 5.1:** Upstream extent of restored stream bank looking upstream (west).

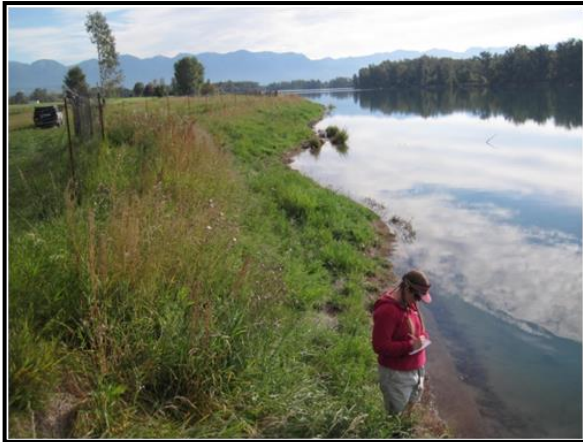
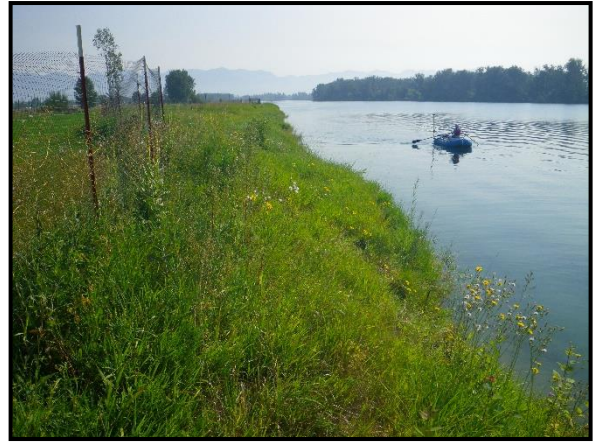
**Photo 5.2:** Upstream extent of restored stream bank looking downstream (northeast).

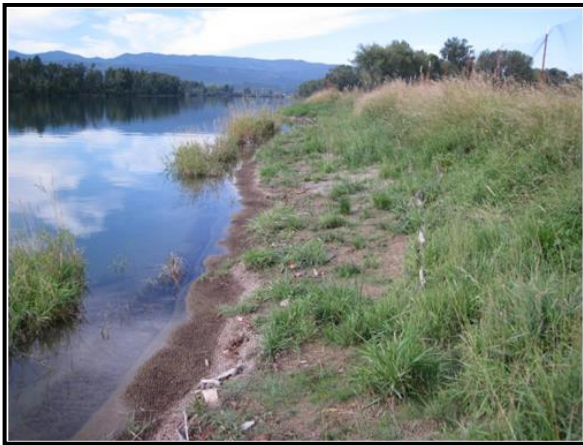
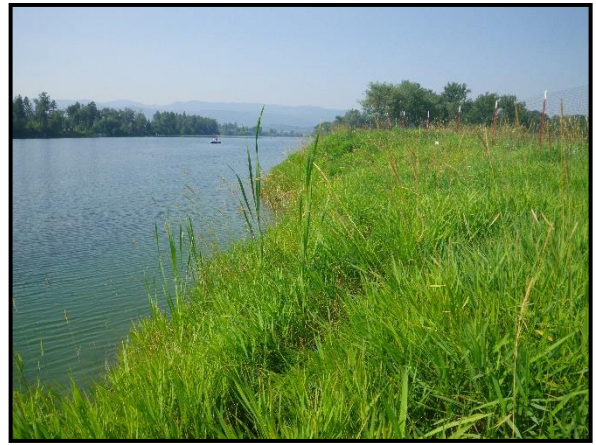
**Photo 6.1:** Middle of restored stream bank, looking upstream (west).

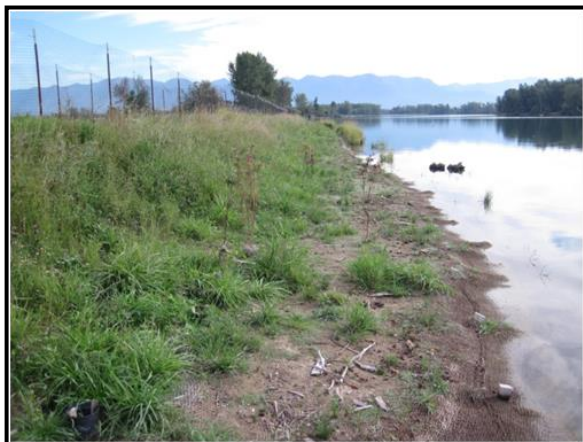
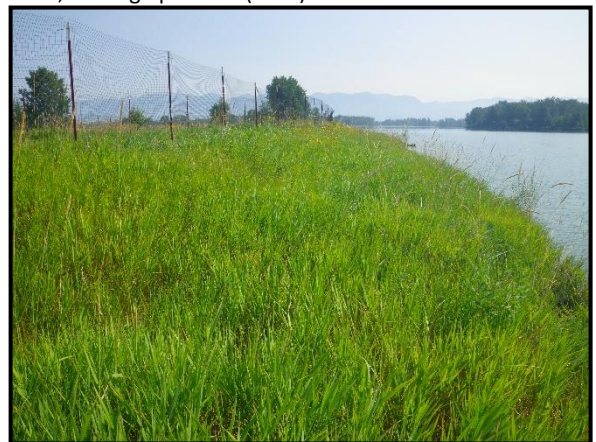
**Photo 6.2:** Middle of restored streambank looking downstream (northeast).

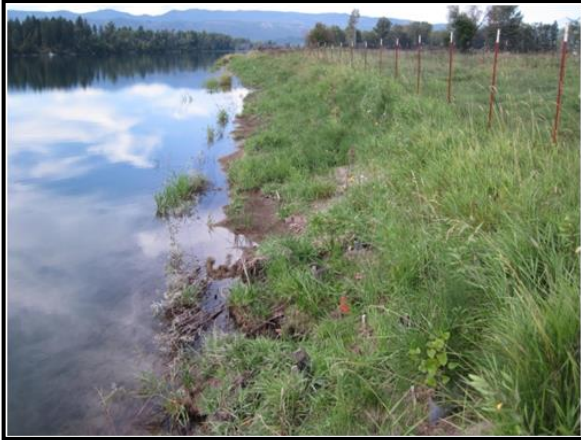
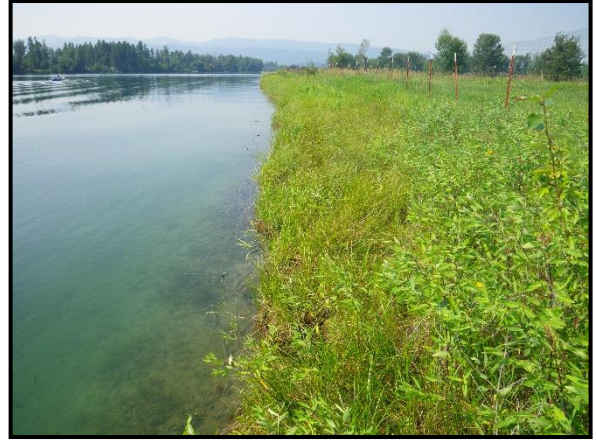
**Photo 7:** Downstream end of restored stream bank, looking upstream (west).

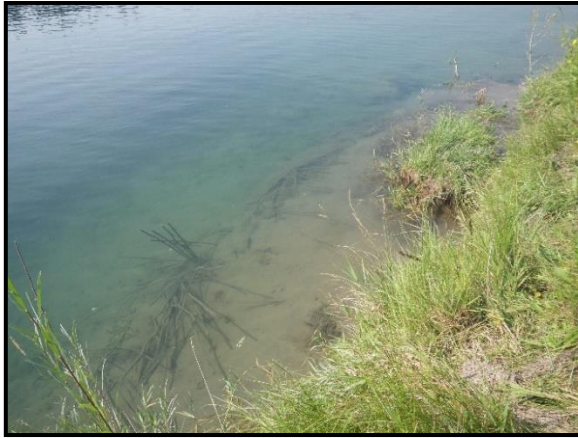
*Reach 1* – Reach 1 spans the upstream 235 feet of reconstructed bank and contains five transects (Appendix A, Figure 2). For several years, annual surveys of these transects indicated that upper portions of the reconstructed bank remained stable while lower portions of the bank retreated by an average of 6.8 feet since 2013 (Table 7). Bank survey data collected in 2021 indicates that the lower bank has now eroded enough to affect the upper bank (Appendix G, pages G-8-G17). Bank failures were first observed at Transects 2.5 and 3 in 2020 when the bank had retreated past the edge of the coir mat at these transects. Bank failure continued at these transects over the winter of 2020-2021, and in April of 2021 the fascine could no longer be located and had likely washed away (Additional Photo 3, Appendix B). Between April and August 2021, the bank retreated again by an average of two feet across all Reach 1 transects (Table 7). The bank erosion observed in this reach is primarily attributed to undercutting beneath the reconstructed portion of the bank. Erosion is expected to continue at a relatively rapid pace along these transects now that the bank is no longer protected by stabilization treatments.

**Additional Photo 1:** Fascine underwater at T-1.

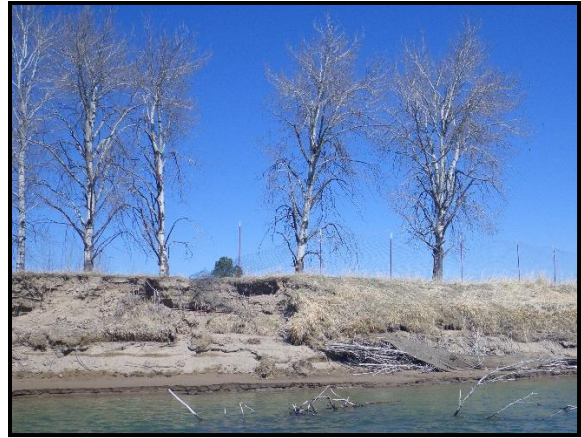
**Additional Photo 2:** Bank Erosion and fence entrapment at T-1.

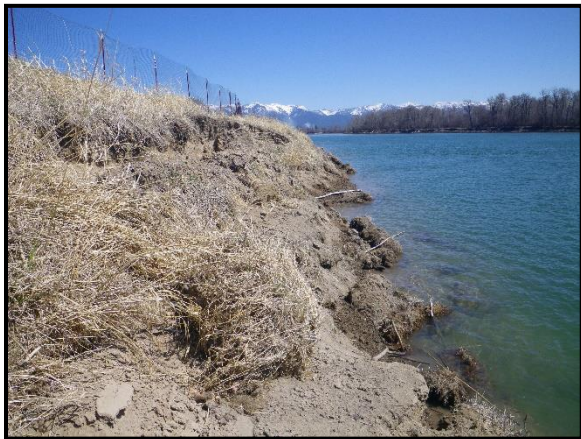
**Additional Photo 3:** Looking downstream (East) from T-2 at bank erosion. Note the absence of the fascine.

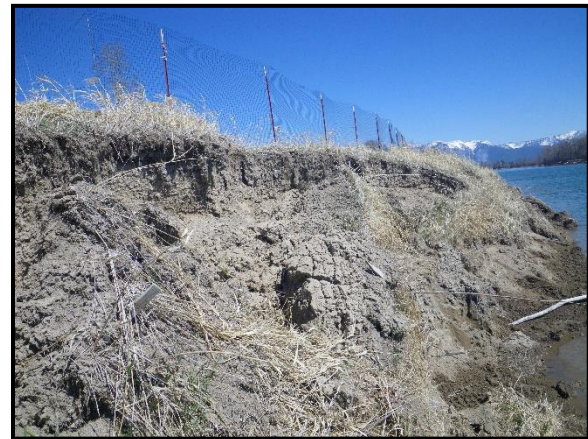
*Reach 2* – Reach 2 is 135 feet long and is represented by Transects 3.5 through 4.5 (Appendix A, Figure 2). Between 2013 and 2017, severe bank erosion beneath the woody fascines was observed in Reach 2, and the woody fascine eventually became detached from the bank. The elevation of the fascine in Reach 2 has continued to drop over the past four years and as of April 2021, the fascine had washed away and could no longer be identified (Table 7). Due to the loss of bank protection from the fascines, the bank has eroded more rapidly over the past four years. Extended transect surveys indicate that the submerged toe of the bank has moved northward approximately 5 feet between 2016 and 2021 and is therefore likely contributing to the soil loss beneath the bank treatment in Reach 2 (Appendix G, pages G-19, G-21, & G-23). The lower banks have eroded enough to begin to affect the upper portions of the bank, especially at Transect 4 where 3-6 feet of the upper bank has slumped off (Additional Photo 4, Appendix B; Appendix G, page G-20). The leading edge of the bank has retreated by average of 12.7 feet since monitoring began in 2013 (Table 7).

**Additional Photo 4:** Looking downstream (East) at severe bank erosion at T-4.

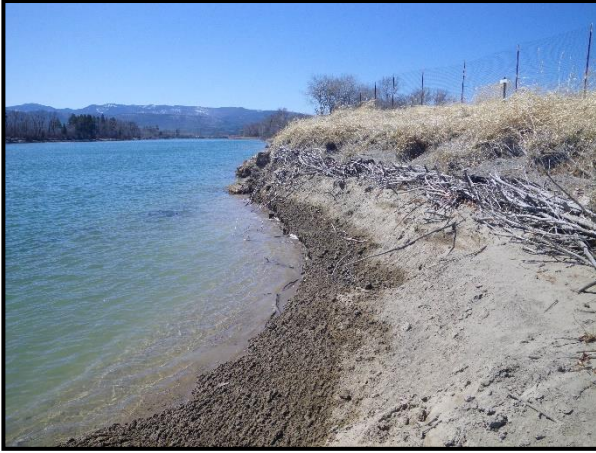
Reach 3 – Reach 3 contains 1,000 feet of the reconstructed bank and is represented by transects 5-14 (Appendix A, Figure 2). The upper, re-sloped portion of the reconstructed bank above the soil lift in Reach 3 has maintained a stable configuration with no documentation of lateral erosion. The lower portion of the bank has eroded some, but at much lower erosion rates than in the other two reaches, with lateral erosion ranging from 1-4.6 feet over the monitoring period. On average, the bank has laterally eroded by 3.3 feet since 2013 as of the August 2021 monitoring event (Table 7). Averaged across all monitoring years, this equates to an average annual erosion rate of 0.15 feet per year. This erosion rate is considered “functional” in the performance standards. On average, the elevation of the woody fascine in Reach 3 has only dropped by approximately 0.2 feet since 2019 and has dropped less than 1 foot since 2013 (Table 7). However, increased erosion of up to 2.0 feet was observed at individual transects in Reach 3 between the April and August 2021 monitoring events, indicating that the lower banks in this reach may be destabilizing. If this trend continues, the fascine will likely begin to destabilize within this reach.

**Additional Photo 5:** Looking upstream at exposed fascine and unprotected bank exposed to erosion between T-8 and T-9.
